REPORT OF INVESTIGATIONS/1995

Evaluation of an Alternative Longwall Gate Road Design

By John P. McDonnell, David P. Conover, and Robert M. Cox

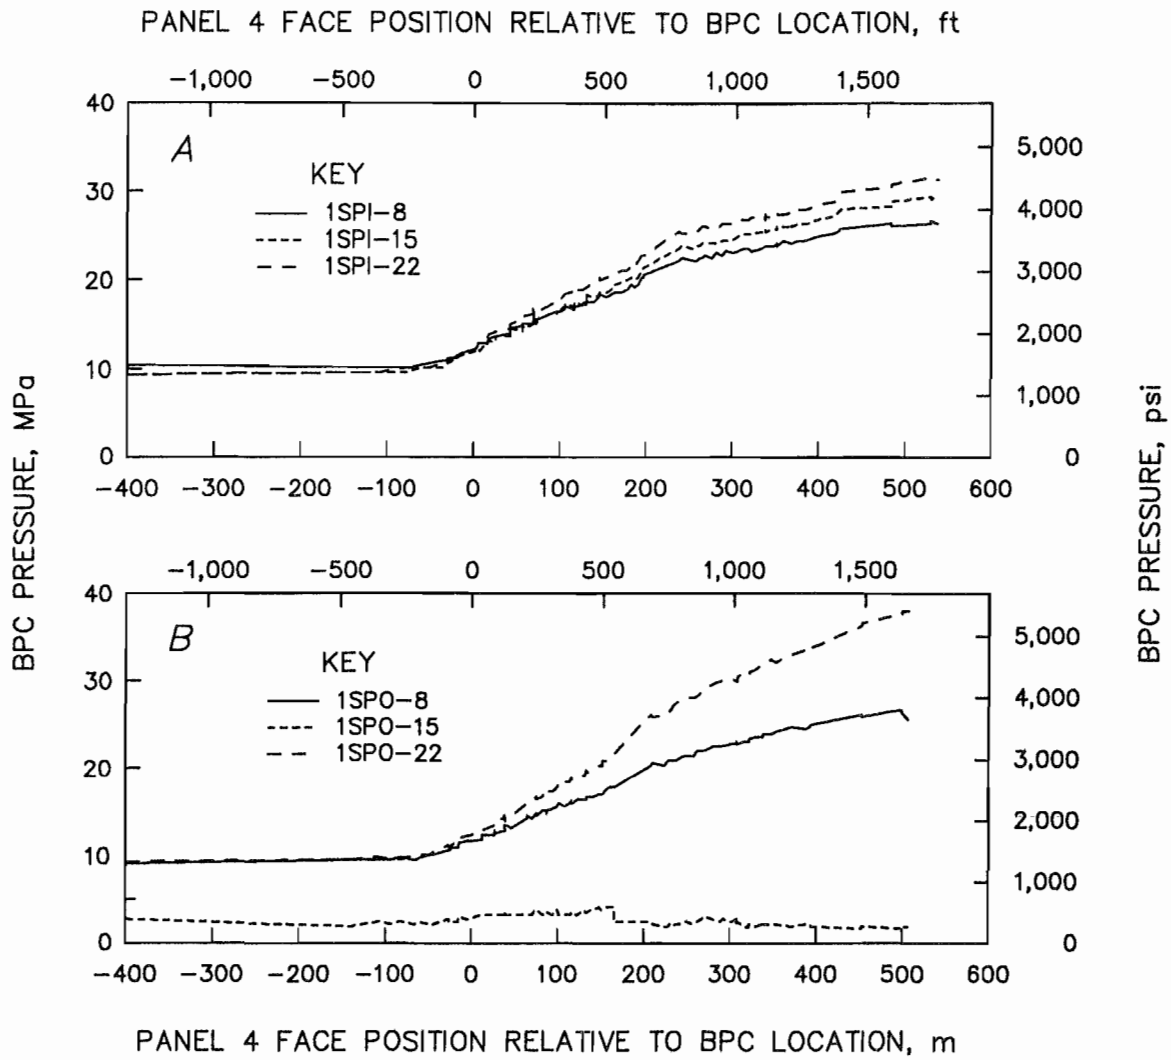
Figures 3 and 4 illustrate BPC pressure changes at site 7 as a result of panel 4 mining. Figure 3 shows the vertical-stress-change history of the inby and outby small pillars, and figure 4 shows the results of the big pillars. Site 7 monitoring during panel 4 mining began soon after panel 4 start-up and continued until panel 4 had been mined a considerable distance past (or outby) the site. BPC pressures at site 7 stabilized after panel 4 had mined about 518 m (1,700 ft) past the site, and monitoring of site 7 was discontinued until panel 5 mining began. Periodic checks of the BPC pressures during the remainder of panel 4 mining indicated only minor pressure changes throughout site 7.

Site 7 small pillar BPC results during panel 4 mining. A, BPC results from the inby small pillar; B, BPC results from the outby small pillar.

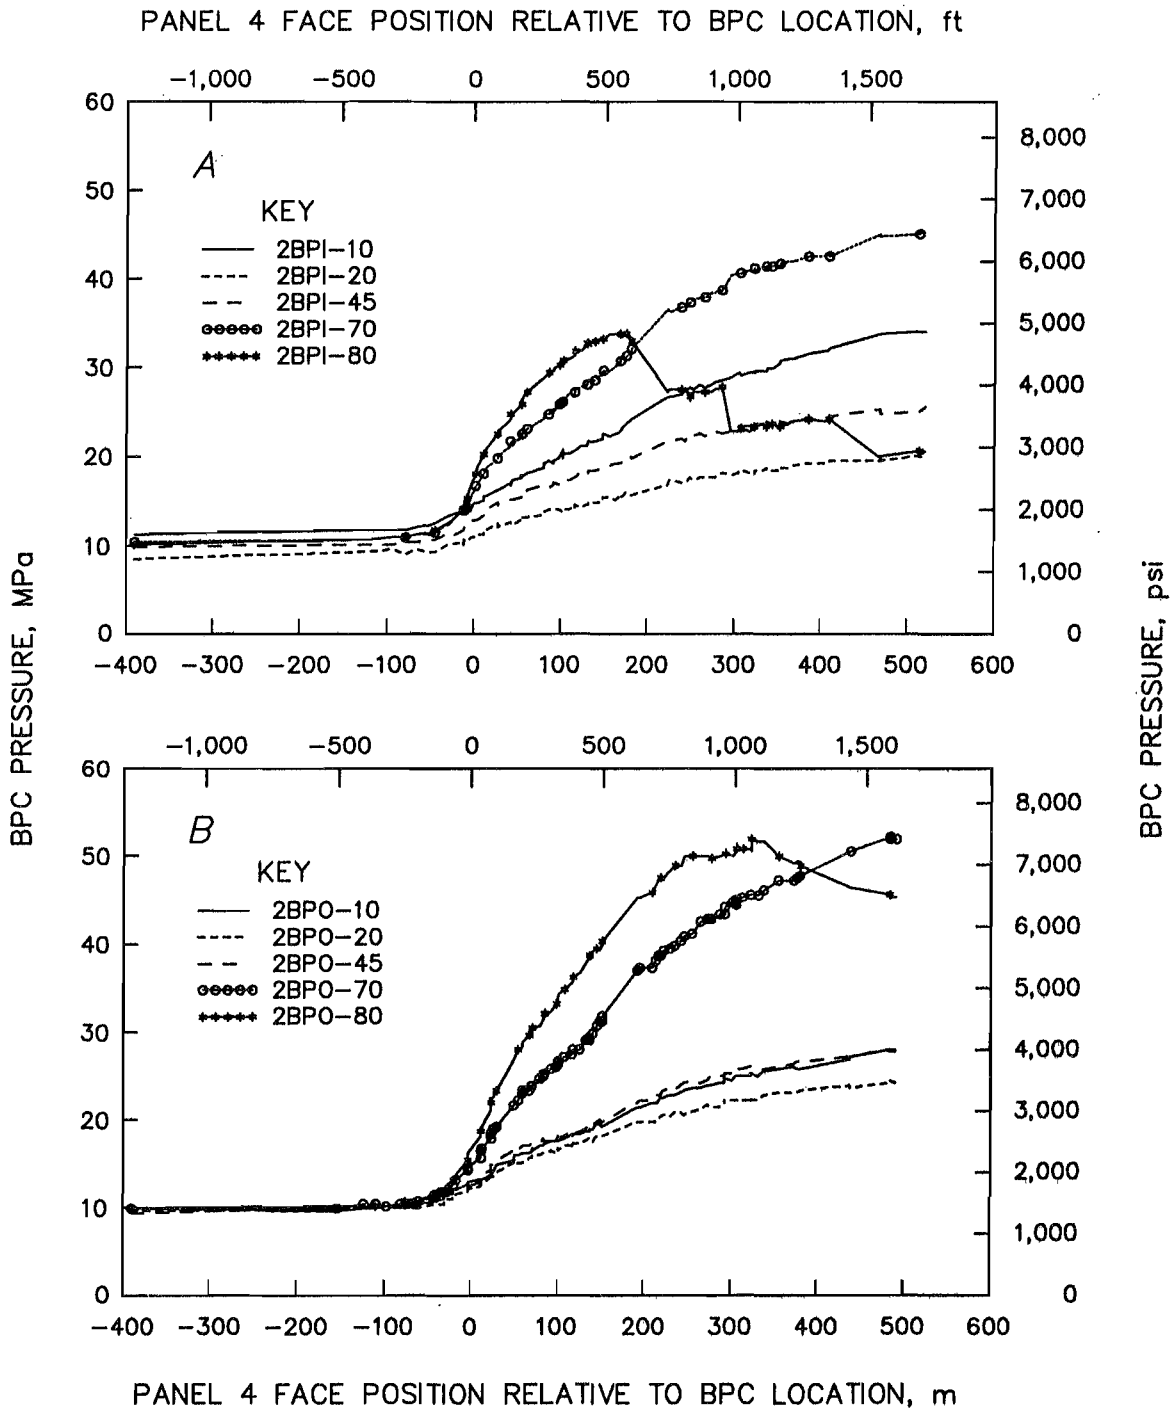
Figure 4

While panel 4 was retreated past the site 7 area, significant pressure changes occurred in the panel 4 side of the big pillars with moderate pressure increases observed in the small pillars and the entry 2 side of the big pillar. Figure 4*A* shows that the BPC 3 m (10 ft) from the entry 3 side of the inby big pillar (2BPI-80) dropped pressure when the panel 4 face was about 183 m (600 ft) outby the BPC instrumentation location. This type of pressure decrease indicates yielding of the entry 3 edge of the inby big pillar.

Site 7 big pillar BPC results during panel 4 mining. A, BPC results from the inby big pillar; B, BPC results from the outby big pillar.

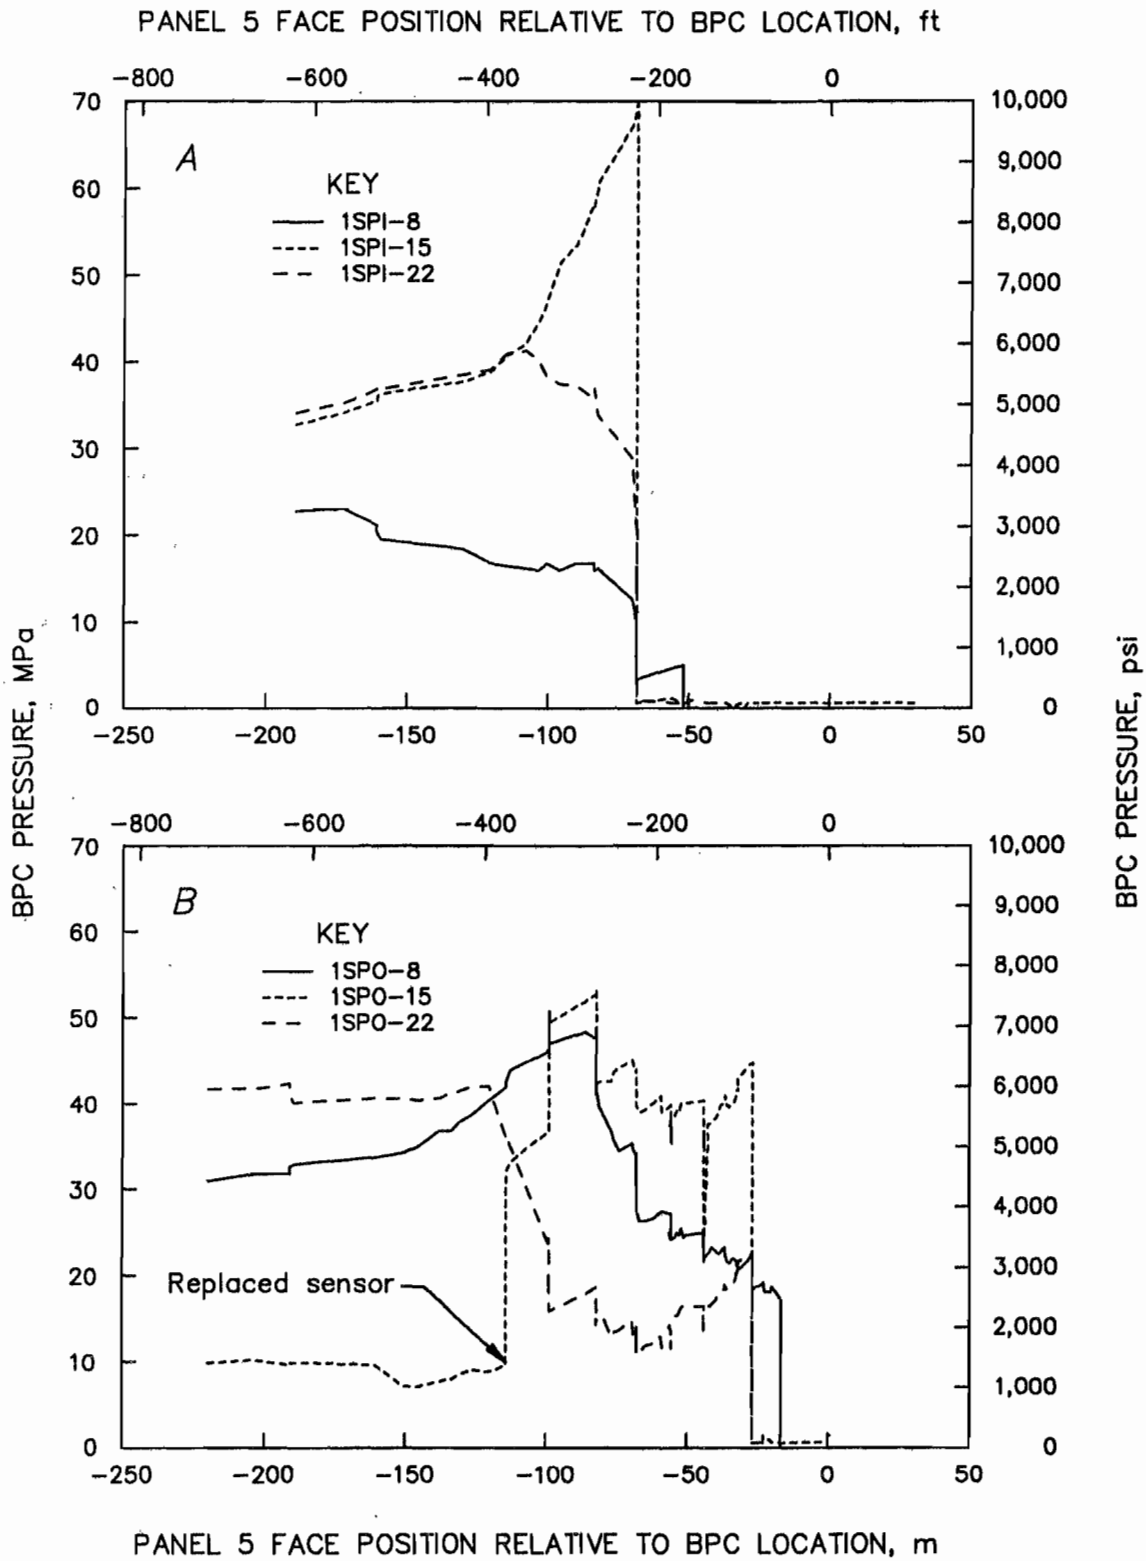
Figure 5

While the panel 5 face was still 91 m (300 ft) inby the first row of pressure cells, pressure increased significantly in the core of the inby small pillar (1SPI-15) (figure 5*A*), entry 1 edge of the outby small pillar (1SPO-8) (figure 5*B*), and the entry 3 side of both big pillars (2BPI-70 and 2BPO-70) (figure 6). In addition, pressure decreases were observed in both sides of the inby small pillar (1SPI-8 and 1SPI-22) (figure 5*A*) and the entry 2 side of the outby small pillar (1SPO-22) (figure 5*B*).

When the panel 5 face was still more than 61 m (200 ft) from the inby row of BPC's, the inby small pillar core pressure increased to approximately 69 MPa (10,000 psi), whereas pressure continued to decrease on the edges of the pillar. In fact, pressures continued to change even several hours after mining had stopped. Approximately 10 h after a production shift ended, the pressure decreased on all three BPC's in the inby small pillar while the longwall face was still idle.

Site 7 small pillar BPC results during panel 5 mining. A, BPC results from the inby small pillar; B, BPC results from the outby small pillar.

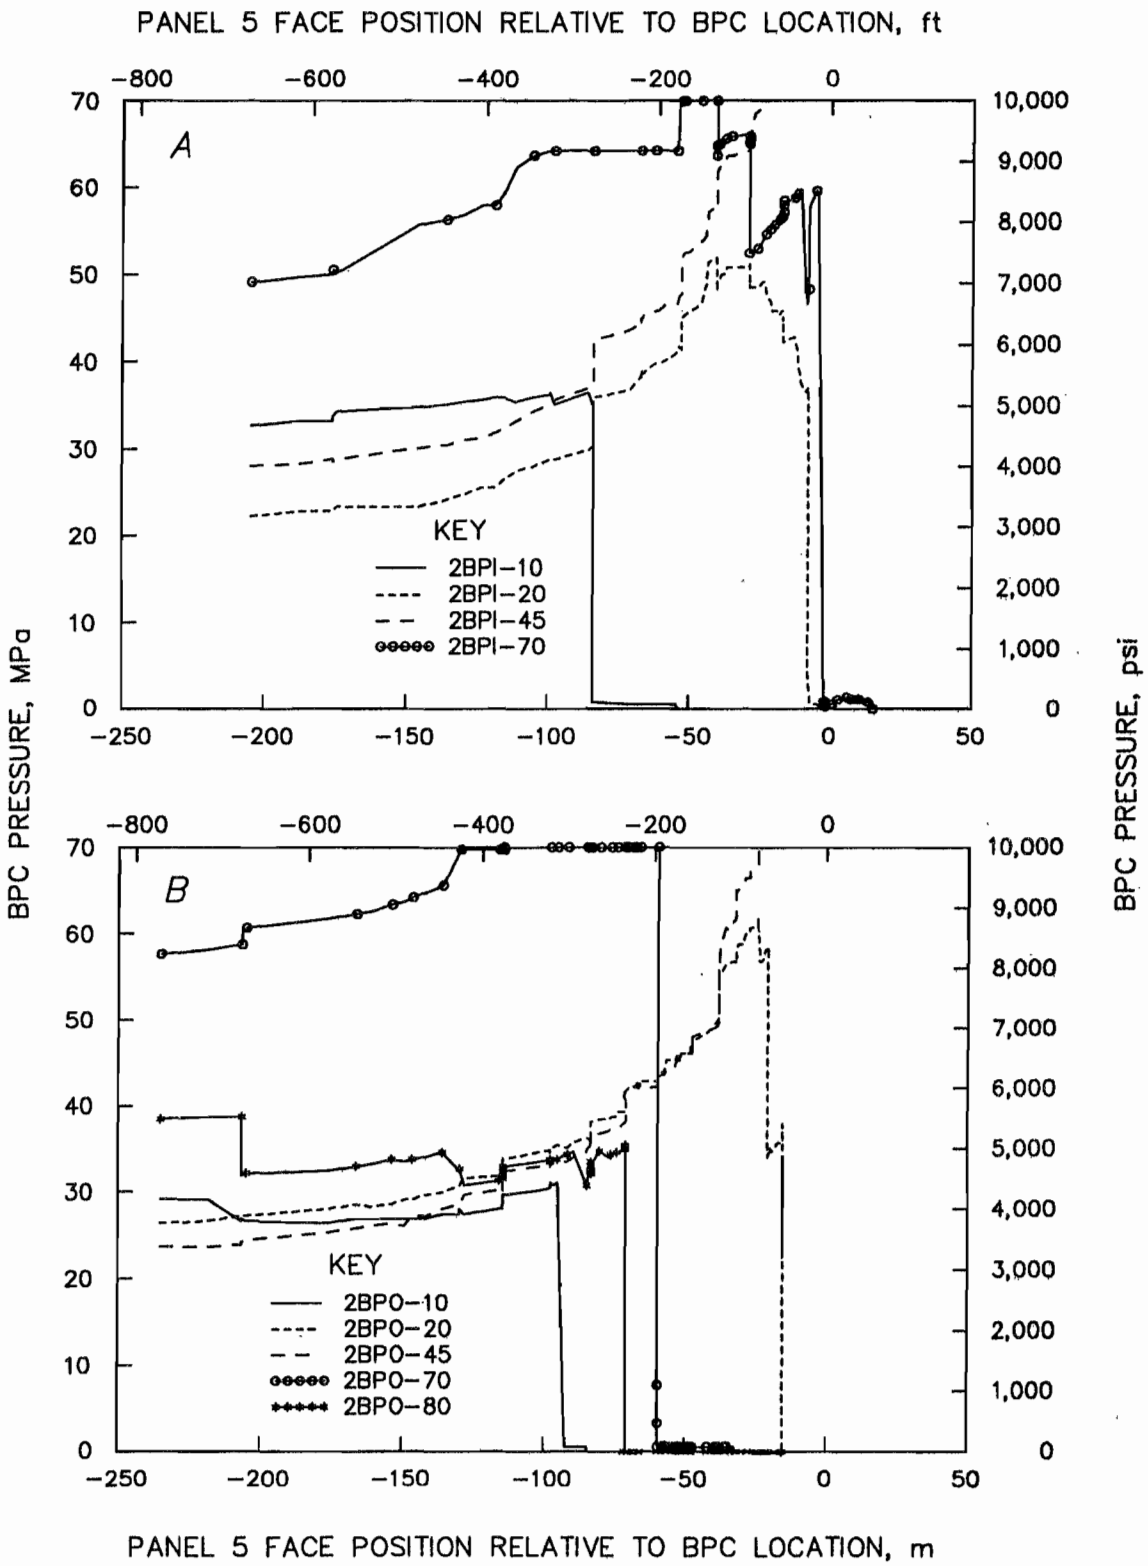
Figure 6

Site 7 big pillar BPC results during panel 5 mining. A, BPC results from the inby big pillar; B, BPC results from the outby big pillar.

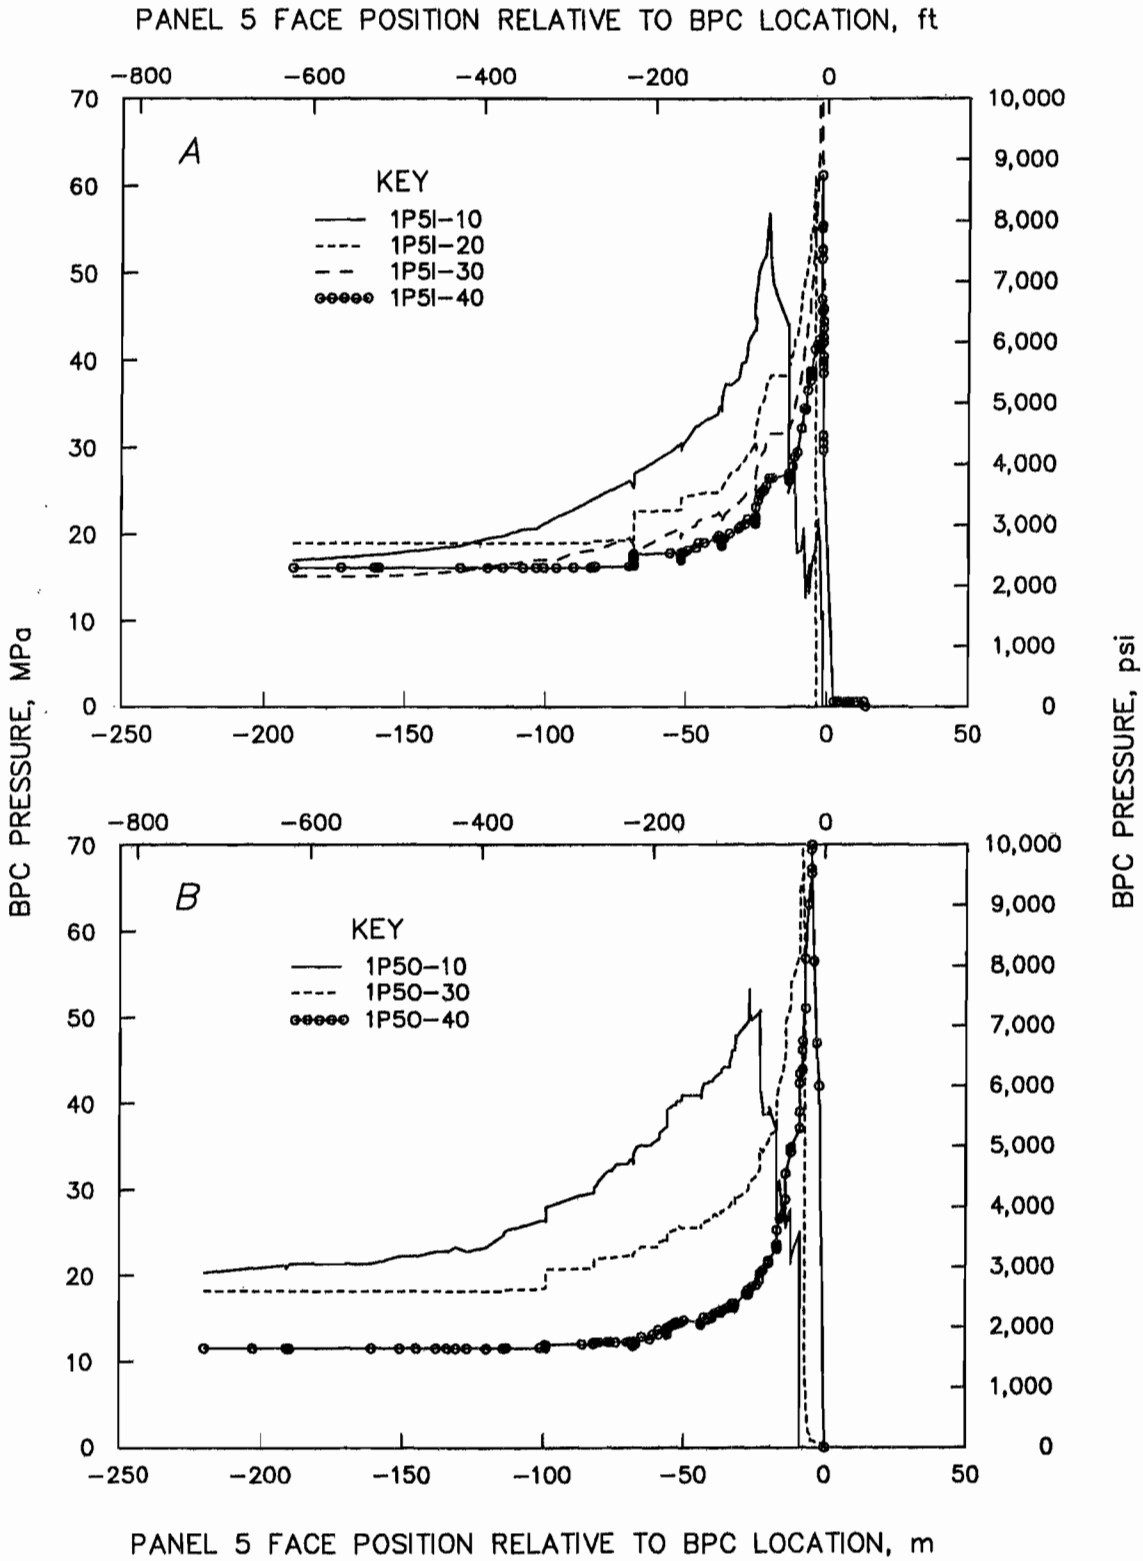
Figure 7

When mining resumed after the idle week, significant pressure increases were observed in the panel 5 BPC's (figure 7) as the longwall face mined within 61 m (200 ft) of the test site. However, as the face approached to within about 24 m (80 ft), the pressure in the panel edge began to decrease. Detailed pressure changes in the panel 5 BPC's are illustrated in figure 8. The tailgate edge of panel 5 at site 7 (1P5I-10 and 1P5O-10) experienced a pressure decrease when the face was still more than 12.2 m (40 ft) inby the BPC location.

Site 7 panel 5 BPC results during panel 5 mining. A, BPC results from the inby row of panel 5 cells; B, BPC results from the outby row of panel 5 cells.

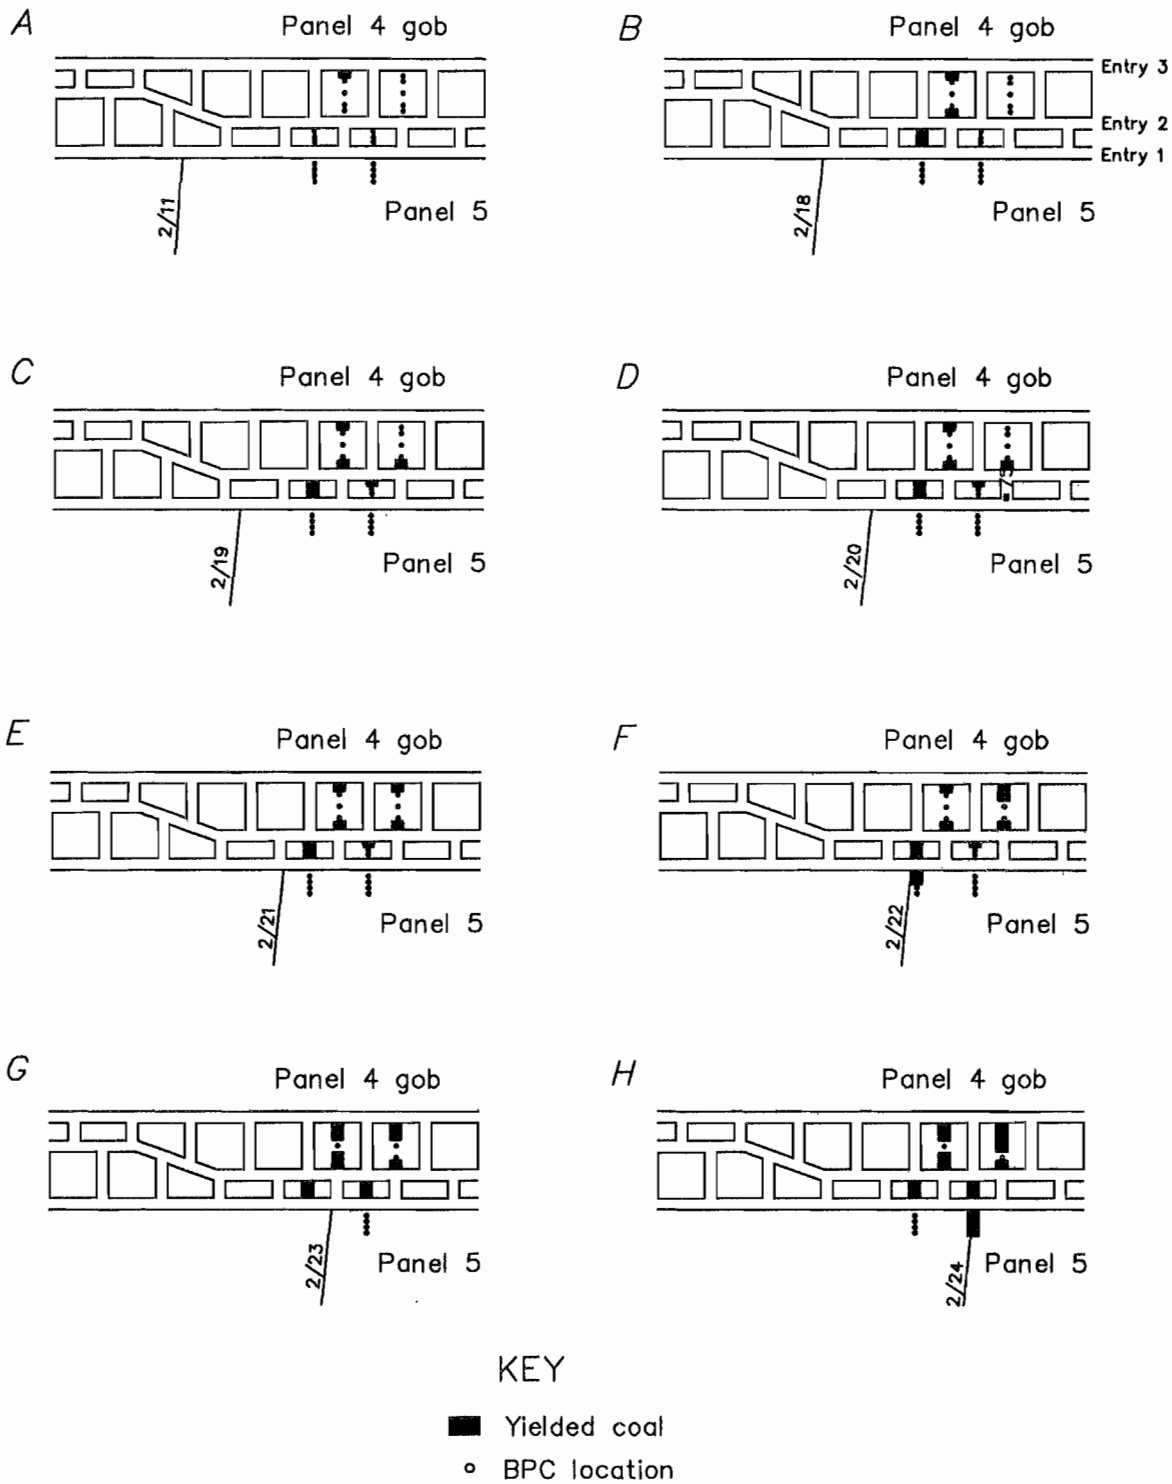
Figure 9 shows the overall yield sequence (based on BPC pressure decreases) of test site 7 with respect to different panel 5 face positions. Figure 9*A*, for example, shows the panel 5 face position on February 11 at the end of the day shift; the only zone yielded at this point was the entry 3 edge of the inby big pillar. By February 18 at the end of the day shift, figure 9*B*, the yielded zones included the inby small pillar and the entry 2 and 3 edges of the inby big pillar. Small pillar yielding, combined with a yielding in the panel 5 edge, outby the face was observed in the site 7 BPC behavior. Yielding of the coal structure around the tailgate entry immediately outby the face occurred as a result of the modified pillar arrangement. The result of the modified pillar layout was a stress-relieved tailgate entry ahead of (outby) the longwall face. As indicated in the earlier figures, both sets of small pillar cells at site 7 had already dropped pressure when the panel 5 face was approximately 61 m (200 ft) inby the respective row of cells. The abutment loads created by longwall mining were transferred to the big pillar away from the entry 1 adjacent to panel 5 as noted in the BPC pressure changes (decreased pressure in the small pillar coinciding with pressure increases in the big pillar). As a result, the pressure around the tailgate entry 1 adjacent to panel 5 was reduced during panel 5 mining at the test pillar zone.

Overall yield sequence of site 7 during panel 5 mining. Face positions are given at the end of the day-shift from 2/11 to 2/24/93.

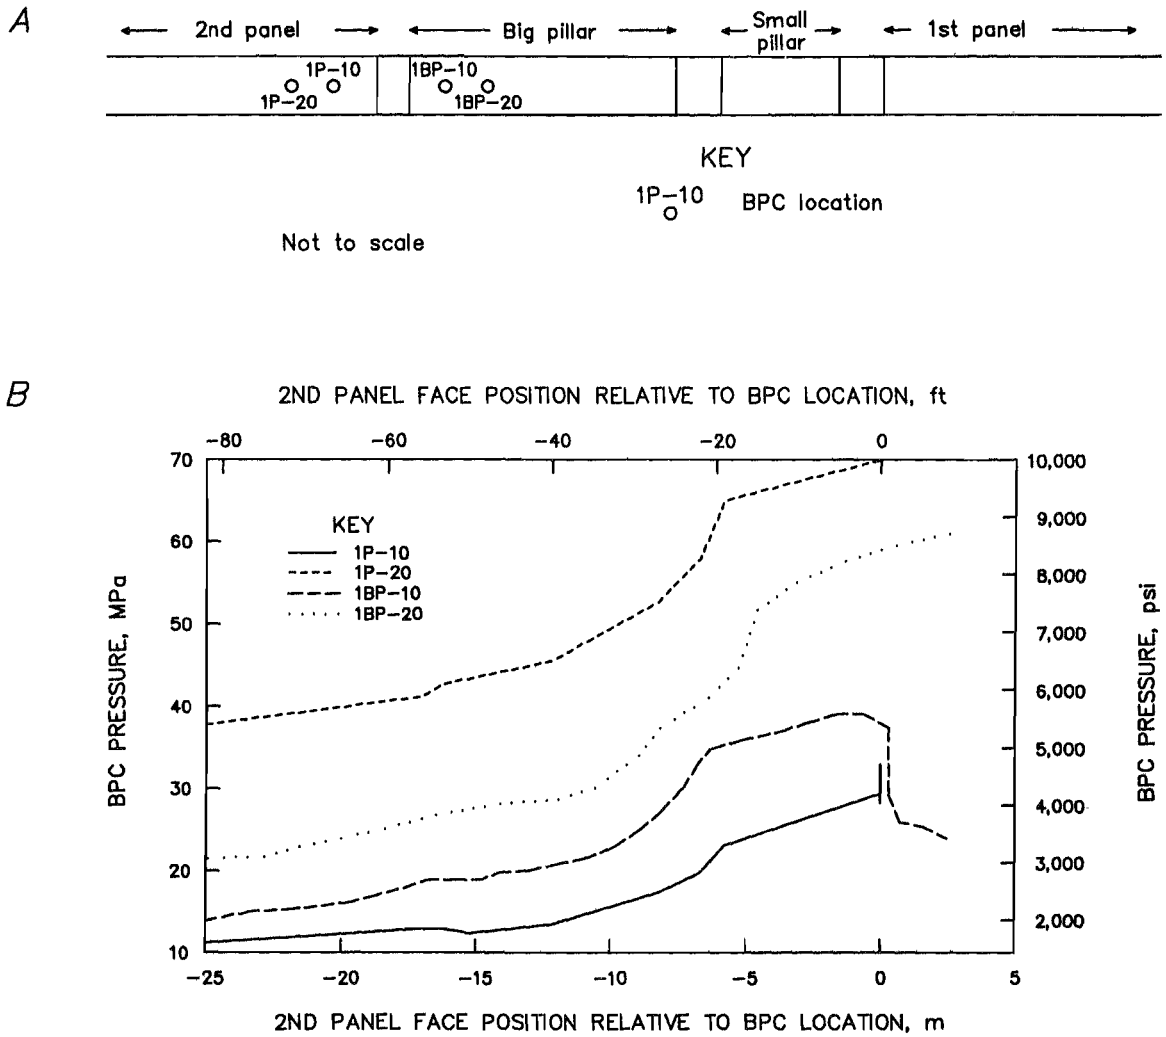
Figure 10

The results from test site 7 were compared with combined results from previous instrumentation sites at different locations in the mine with the more typical pillar arrangement (sites 2, 4, 6, 8, and 9 in figure 1). Instrumentation layouts at the particular sites were similar to the site 7 instrumentation location with BPC's installed in the pillars and panels. Figures 10 and 11 show a summary of BPC data from the other instrumentation sites during second-panel mining[7] to illustrate the difference between the typical pillar behavior and the modified pillar area results. In contrast to the site 7 results during panel 5 mining, the combined second-panel BPC data indicated high pressure near the panel edge even as the second panel mined through the BPC instrumentation; there was no pressure decrease in the second-panel edge out ahead of the face. In fact, the second-panel BPC's typically maintained pressure until the longwall shearer cut through the instrumentation.

Combined BPC results from typical pillar gate road instrumentation sites during second-panel mining. A, General cross section of typical pillar layout; B, average BPC results from typical pillar instrumentation sites.
