Bureau of Mines Report of Investigations/1988

Effects of Various Longwall Chain Pillar Configurations on Gate Road Stability

By J. M. Listak, J. C. Zelanko, and T. M. Barton

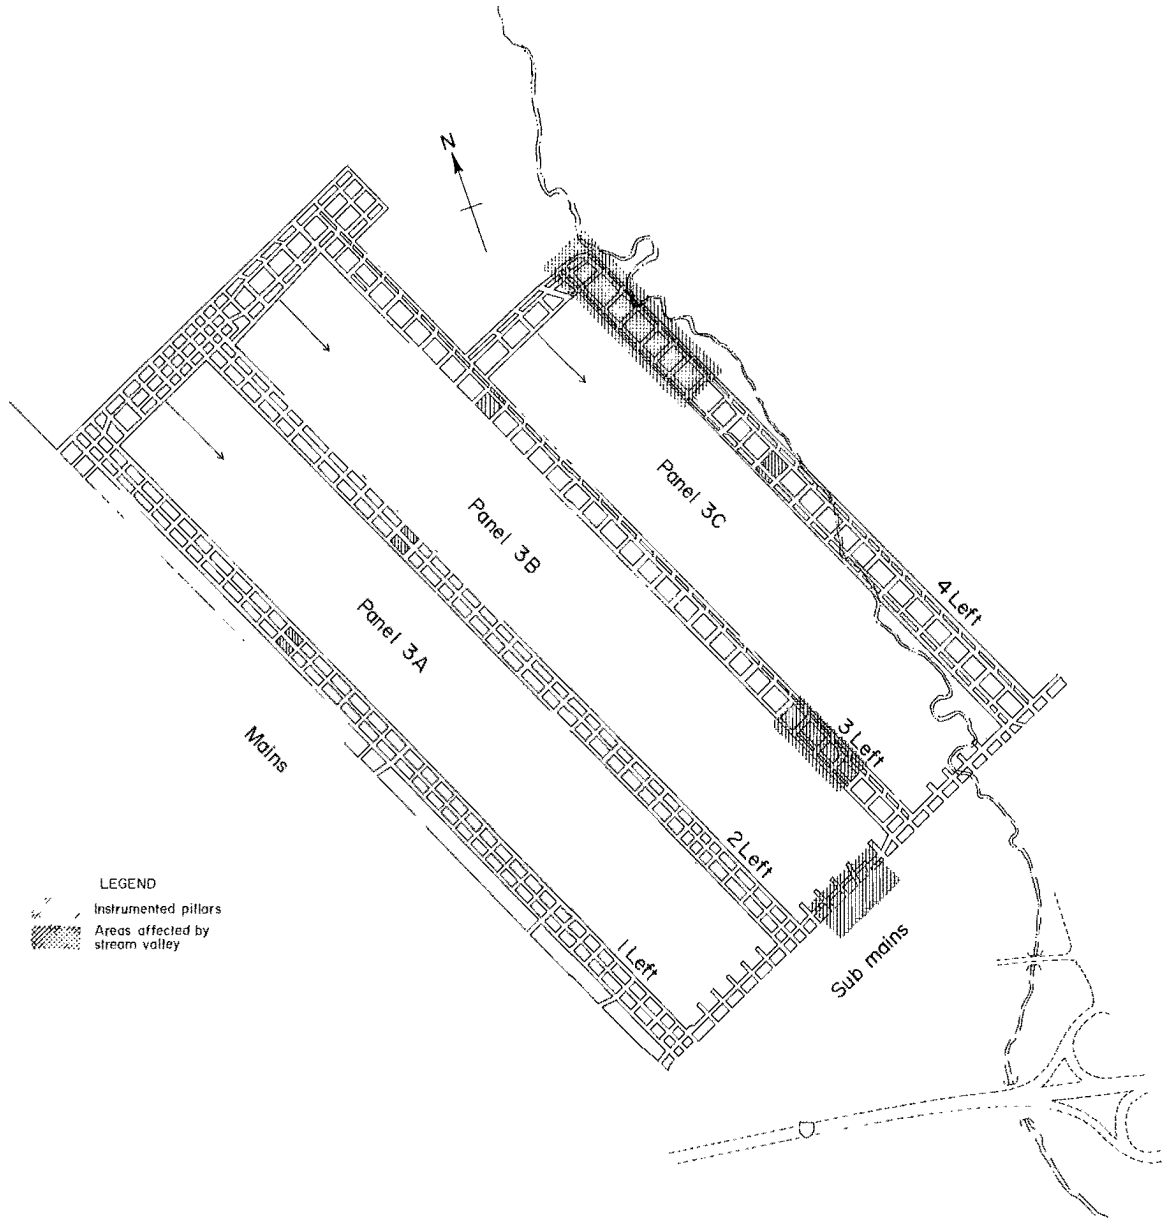
FIGURE 3.—Areas affected by topographical relief associated with stream valley.

Overburden thickness above the instrumented pillars in 3 and 4 left were 600 and 455 ft, respectively. The variation in overburden thickness was caused by the occurrence of a stream valley on the surface. This surface feature is important because severe roof control problems were associated with it when 4 left was being developed. Because of the slow advance through this area and because no roof improvement was evident, panel 3C was shortened. Consequently, the shortening of the panel prevented meaningful VWS data from being obtained from the 3 left tailgate. However, visual observations in this tailgate revealed that ground control conditions were significantly improved as compared to the 2 left tailgate. Mine personnel described the behavior of the 3 left tailgate as excellent in that excessive pillar sloughing and roof deterioration were not a problem and the panel was extracted without incident.

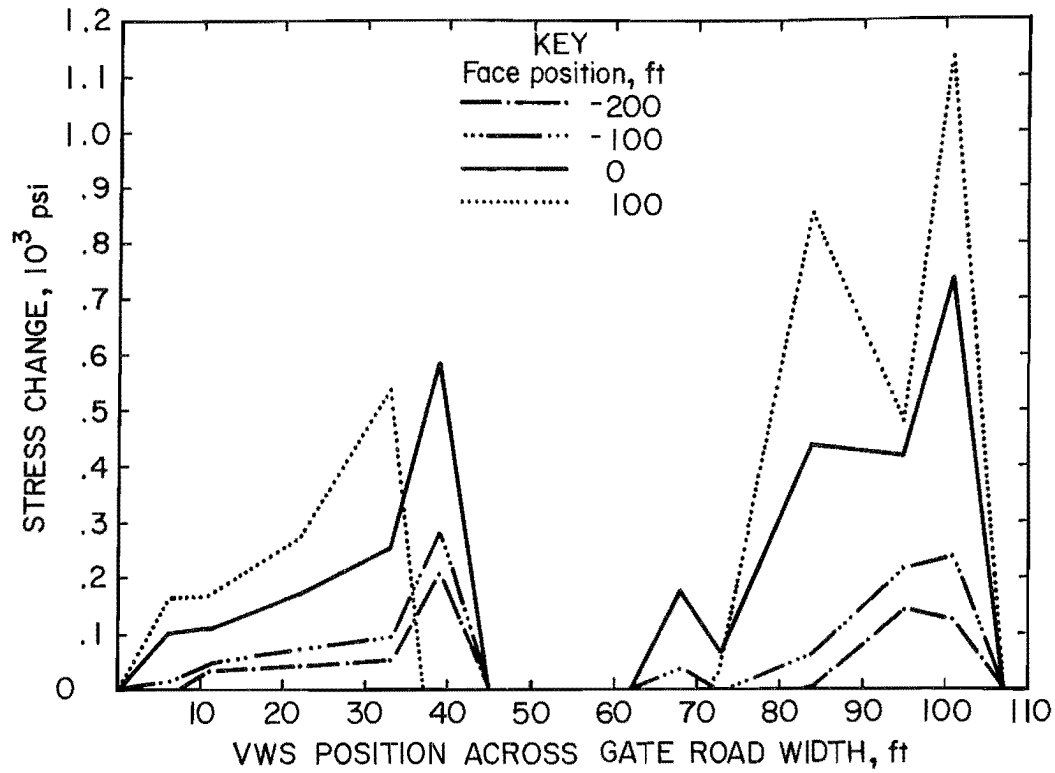
Since panel 3A was the first of the series of three to be mined, pillar loading in 1 and 2 left should have been similar. However, this was not the case. Higher pillar loads were experienced in 1 left as the face approached and passed the instrumented pillars. The higher stresses experienced in 1 left may have been attributed to the influence of the main development entries, which were separated from 1 left by a 70-ft barrier pillar. After the longwall panel had passed the instrument site, difficulties were encountered with several stressmeters. Pillar sloughing damaged the stressmeters' lead wires preventing further data collection. The stress averages at the subsequent face positions were affected by the lack of data and accurate comparisons between 1 and 2 left beyond 100 ft of face retreat could not be made. An example of stress profiles obtained from pillars in 1 and 2 left are illustrated in figures 6 and 7.

FIGURE 6.–Stress change profiles across width of pillars P1 and P2 relative to longwall face position in 1 left.

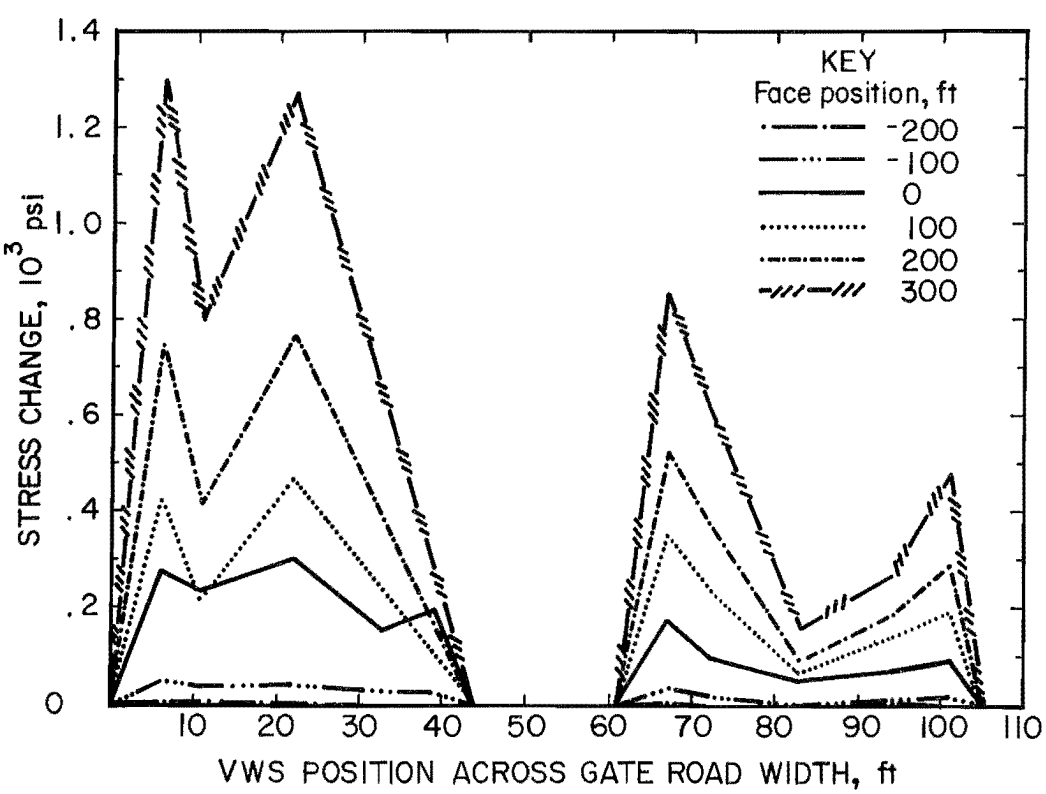
FIGURE 7.–Stress change profiles across width of pillars P1 and P2 relative to longwall face position in 2 left.

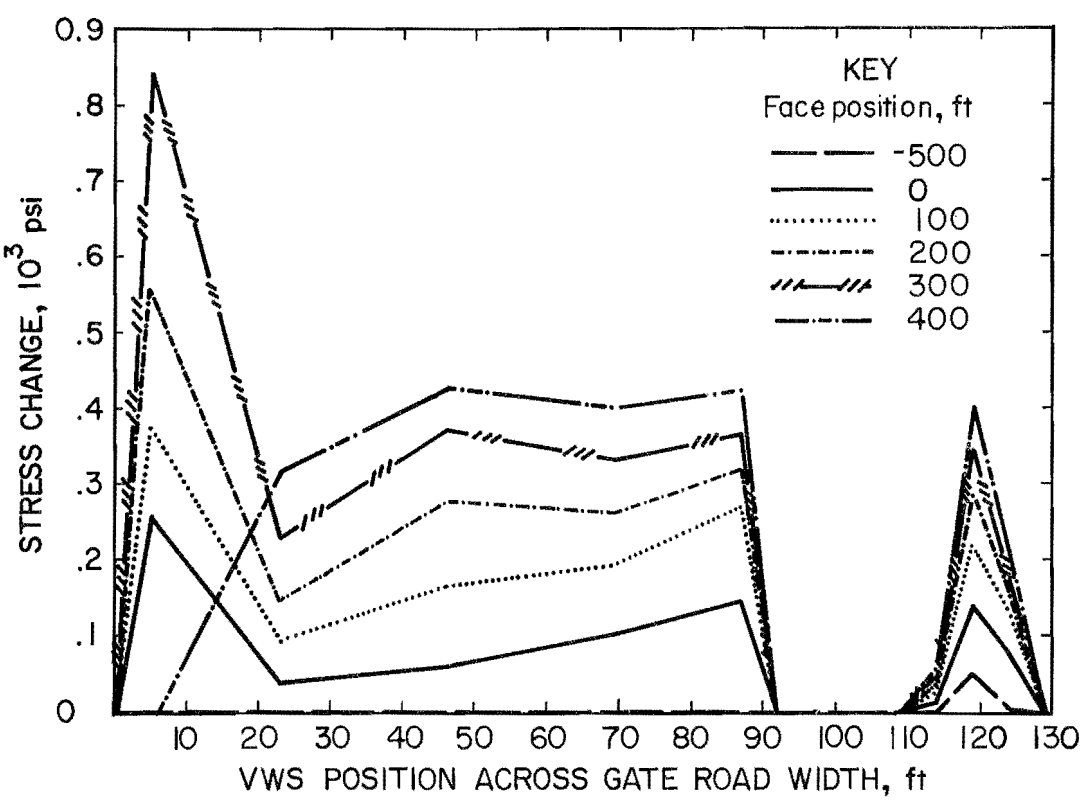
permissibility on the stressmeter readout unit was temporarily revoked and monitoring had to be discontinued. Although the small pillar appears to have yielded (as indicated by the lack of pillar edge loading (fig. 9)), the behavior of this pillar, while the face drew near, cannot be determined. Fortunately, the permissibility problem was resolved and data collection resumed when the face was adjacent to the instrumented pillars. With the exception of the pillar edge closest to the working panel, the abutment pillar loading was low and uniformly distributed. Once the face had retreated a distance of 300 ft past the instrumented pillars, the loading appeared to stabilize.

FIGURE 9.–Stress change profiles across width of pillars P1 and P2 relative to longwall face position in 3 left.

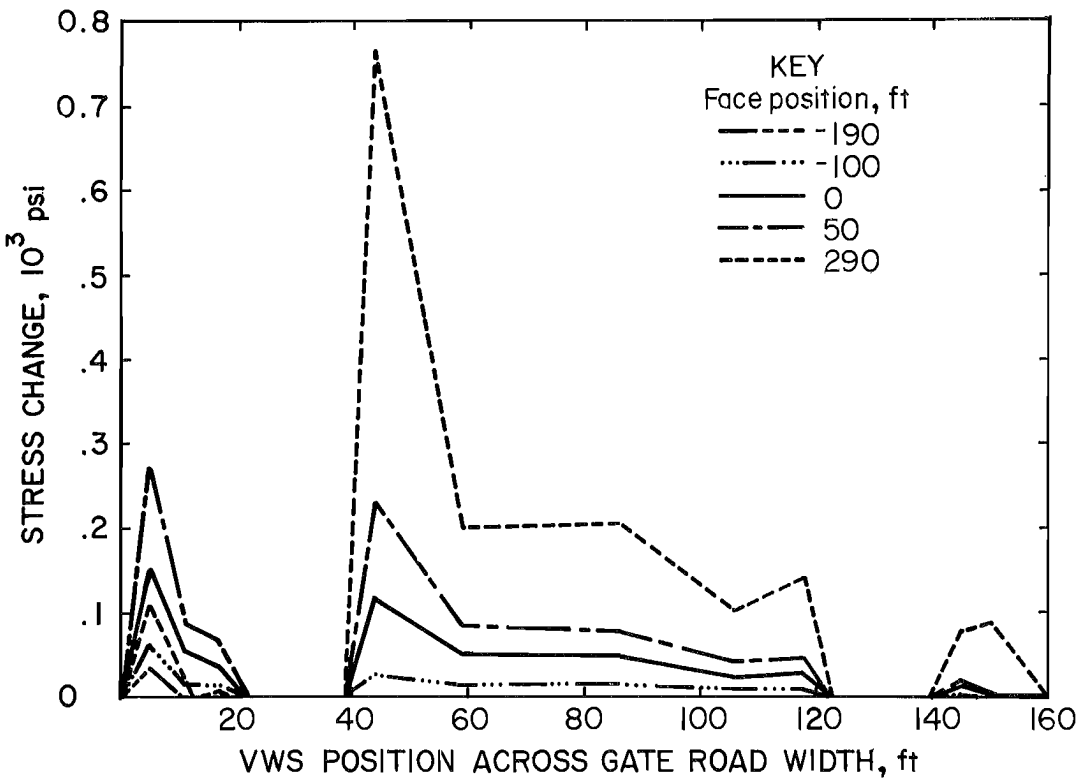
When comparing headgate data, pillar stresses experienced in 4 left were small relative to 2 left, but followed similar loading patterns experienced in 3 left, where comparisons could be made. This evidence suggests that the use of both the abutment-yield and yield-abutment-yield pillar configurations were effective in controlling stress in the headgates during panel extraction.

FIGURE 11.–Stress change profiles across width of pillars P1, P2, and P3 relative to longwall face position in 4 left.

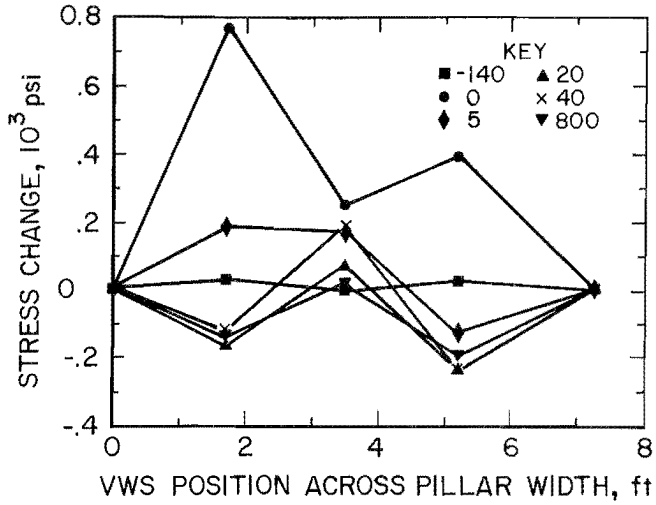
FIGURE 13.–Stress change profiles across width of experimental yield pillar relative to longwall face position in 3 left.

about midway along the length of the panel, the area around the yield pillar was working (i.e., there was strong visual and audible evidence of roof strata and pillar activity). This activity was characterized by cracking and popping in the roof and by pillar sloughage. Stressmeter data collected at this time revealed that the pillar edges were experiencing increased loads. Four hours later, when the face had progressed approximately 5 ft, the same area was quiet and stress change data showed an unloading of the pillar (fig. 13). These visual and audible observations made while the face was progressing past the pillar indicated that the pillar transferred or "shed" its load to surrounding support members. The authors believe that this pillar's behavior was indicative of true pillar yielding.

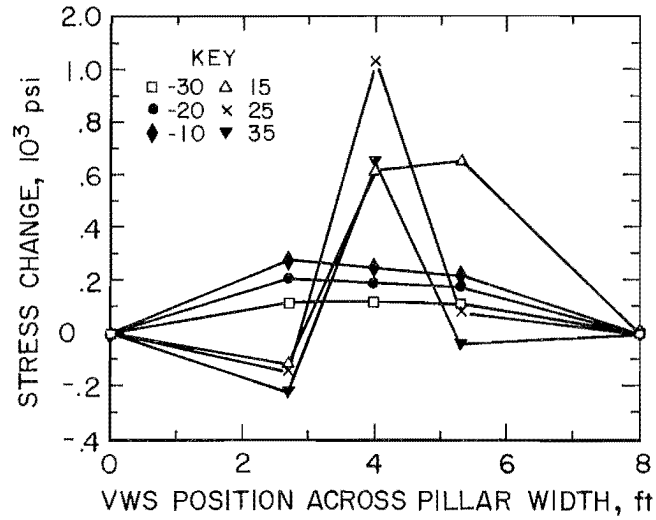
FIGURE 14.–Stress change profiles across width of yield pillar relative to longwall face position in 3 left.

The small pillar at this site experienced very high loading at its core, and as similar to the experimental yield pillar, appears to have experienced yielding and load transfer (fig. 14). By comparison, the abutment pillar experienced very low, uniformly distributed stress changes. Although extremely poor roof conditions had been encountered during development in this area, only routine problems were prevalent during panel retreat.

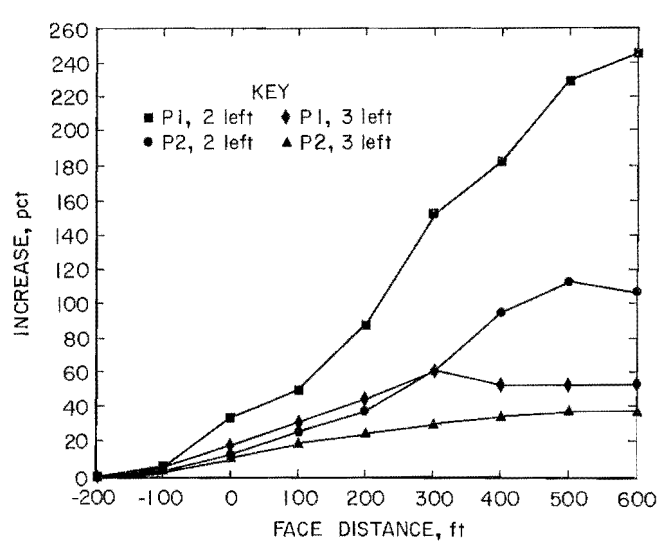
The deterioration of pillar stability was more readily apparent when 2 left acted as a tailgate. As discussed earlier, pillar and roof instabilities became so severe that extreme measures were required to maintain the tailgate for ventilation. In several instances caving occurred ahead of the face and supplemental support in the form of solid concrete cribs (formed and poured in place) were installed as the face was retreated.

In contrast, 3 left conditions were entirely different. Although safety factors for the 20-ft-wide pillar approached levels where instabilities would be expected, no extreme signs of deterioration were apparent. In addition, when 3 left acted as a tailgate no serious problems were encountered. The stress increases in 2 left as compared to 3 left is illustrated in figure 15.

FIGURE 15.–Pillar stress change in 2 and 3 left as percent of average estimated overburden stress.
