A Case Study of the Collapse of Slender Pillars Affected by Through-Going Discontinuities at a Limestone Mine in Pennsylvania

Abstract

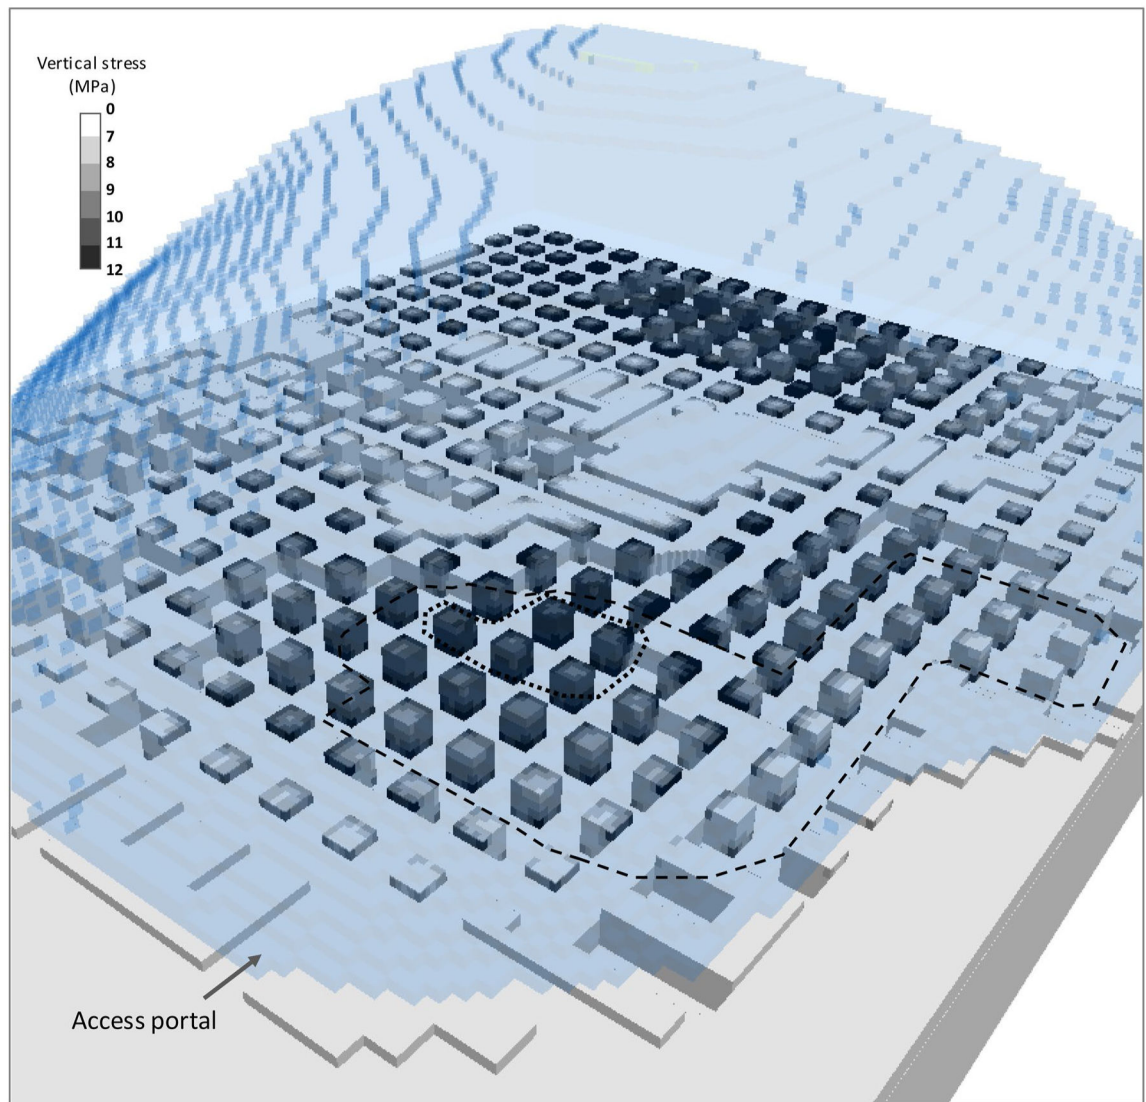
The model stress results showed that there was a cluster of five pillars near the edge of the collapsed area, under the ridge of the mountain that had the greatest vertical stress. The calculated average vertical stress in each of these pillars varied from 10.0 to 11.7 MPa, with an average value of 11.0 MPa for the five pillars combined. It was assumed that the collapse initiated when one or more of these pillars failed.

Fig. 9.
Numerical model of the mine and overlying mountain shaded by the vertical stress magnitude. The collapsed area is outlined with dashed lines, and the cluster of pillars with the highest average vertical stress is outlined with a dotted line

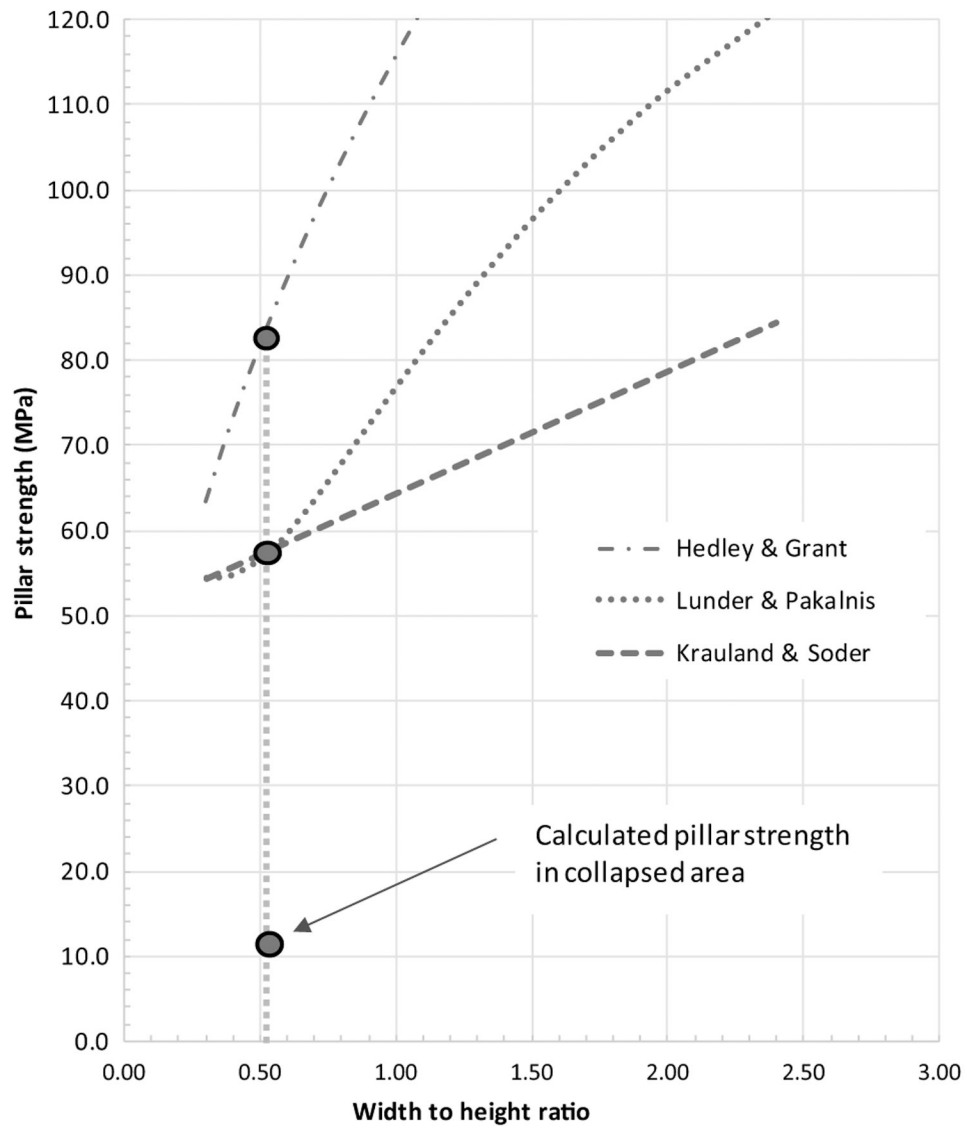
In these equations, k is the large-scale rock strength, w is the pillar width, h is the pillar height, σ_c is the uniaxial compressive strength of the intact rock, and κ is a confinement parameter. The pillar strengths for 17.7-m-high pillars of various widths were calculated using each equation and are shown in Fig. 10. For the Hedley and Grant equation, the strength factor relating the large-scale rock strength to the laboratory-scale UCS is 0.58, and for the Krauland and Soder equation the strength factor is 0.354. The calculated 11.0 MPa pillar strength from this case study is also shown in Fig. 10. It is clear that the empirically

based strength equations would have grossly overestimated the actual pillar strength and would have predicted stable conditions at the mine.

The reason for the discrepancy between the empirical equations and the actual pillar strength at the case study mine is ascribed to the presence of large angular discontinuities cutting through the slender pillars. It appears that the case studies that were used to develop the empirical equations did not include any cases of such slender pillars with large through-going discontinuities. The impact of large through-going discontinuities is also not explicitly included as an input parameter in the selected pillar strength equations.

Fig. 10.
Calculated pillar strength in the collapsed area compared to predictions using established hard-rock pillar strength equations

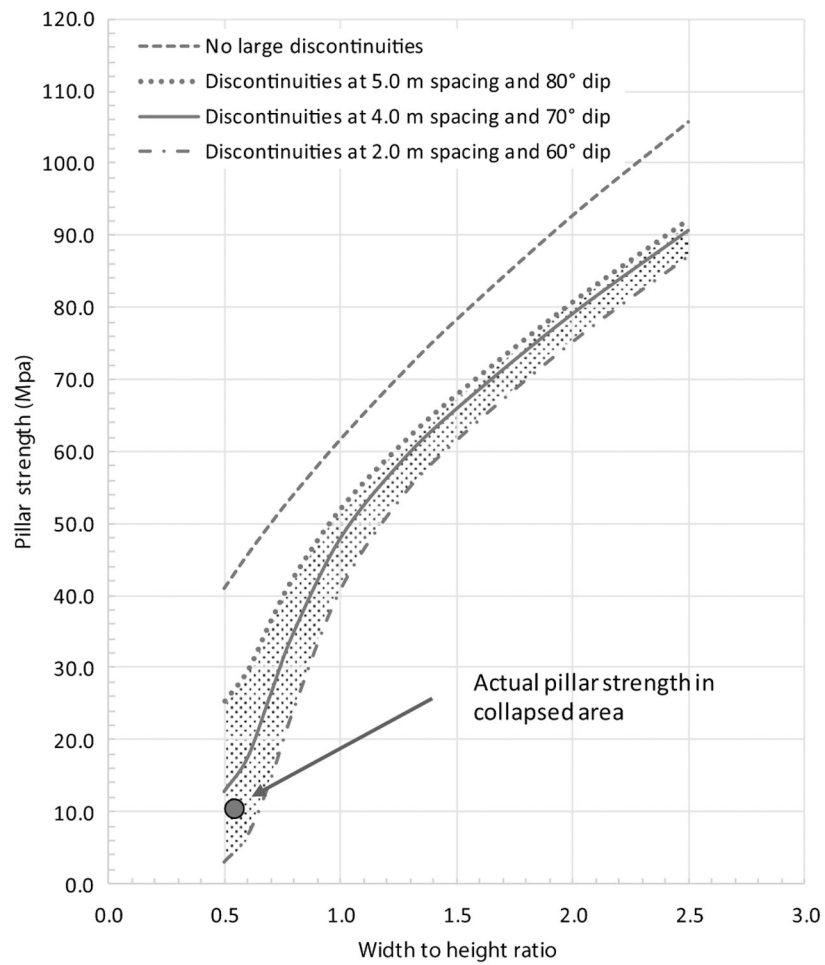
The range of pillar strengths predicted by the equation varied between a minimum of 3.9 MPa for the most unfavorable combination of parameters to 25.3 MPa for the most favorable combination. The range of results obtained is shown in Fig. 11. The indicated range of strengths was determined by varying only the large discontinuity spacing and dip. The

equation predicts minimum strength when the discontinuity dip is 60°. The upper solid curve is obtained by selecting the maximum discontinuity spacing of 5.0 m and a dip of 80°. The figure also shows the pillar strength curve predicted by Eq. (4) in the absence of any large discontinuities.

The results show that Eq. (4) predicts a significant drop in pillar strength at the lower width-to-height ratios. Also, the range of likely strengths based on the variability of the large discontinuity geometry brackets the actual pillar strength of 11.0 MPa. If the average dip and spacing of the most prominent joint set is used as input, at 70° and 4.0 m, respectively, the equation predicts a pillar strength of 12.9 MPa, clearly indicating the potentially critical loading condition of these pillars. By comparison, the Krauland and Soder (1987) pillar strength equation developed for limestone pillars predicts a strength of 57.8 MPa for these pillars, while Eq. (4) predicts a strength of 42.8 MPa in the absence of any large through-going discontinuities.

Fig. 11.
Graph showing the likely range of pillar strengths for different width-to-height ratios at the
case study mine calculated using Eq. (4). The range of likely pillar strengths is shaded and
the actual strength of 11.0 MPa of the collapsed pillars is indicated on the graph
