PROCEEDINGS OF THE 1ST CANADA–US ROCK MECHANICS SYMPOSIUM, VANCOUVER, CANADA, 27–31 MAY 2007

Observations and evaluation of floor benching effects on pillar stability in U.S. limestone mines

G.S. Esterhuizen, D.R. Dolinar & J.L. Ellenberger.
National Institute for Occupational Safety and Health, Pittsburgh, USA.

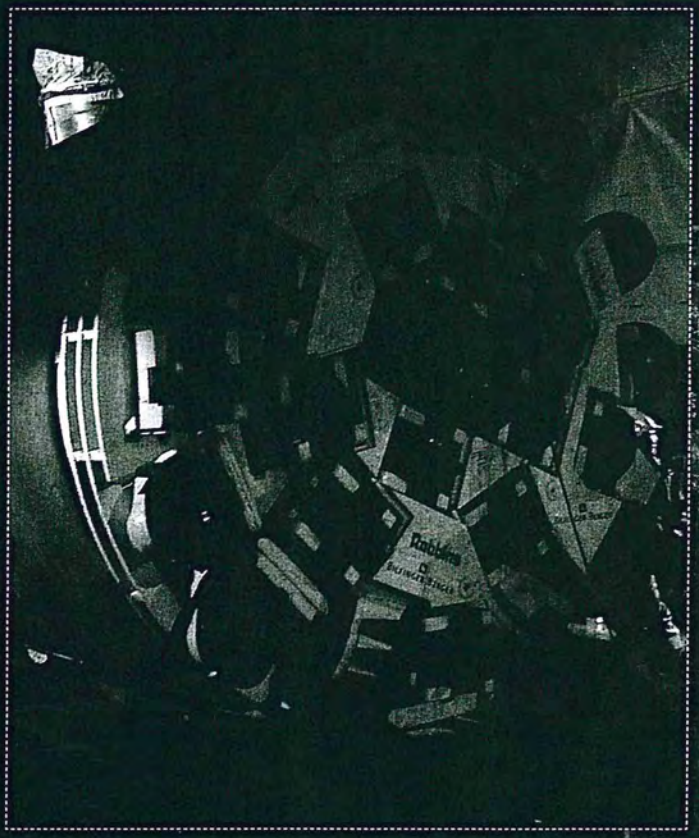
Underground limestone mines in the U.S. make use of the room and pillar method of mining. Bench mining of the floor between the pillars is sometimes carried out to improve utilization of the reserves. Figure 1 shows an area where bench mining of the floor is underway. The benched pillars are in the foreground and the original development pillars are seen in the background. The National Institute for Occupational Safety and Health (NIOSH), Pittsburgh Research Laboratory is investigating pillar and roof stability in U.S. limestone mines. Observations of pillar conditions carried out as part of this study revealed that the condition of pillars around the perimeter of bench mining operations can be worse than elsewhere in the mine. Unstable pillar ribs represent a rock fall hazard to mine personnel. Over the decade from 1996 through 2005, ground falls were the cause of 36% of fatalities and 12% of all injury related lost workdays in underground limestone mines (Mine Safety and Health Administration, 2006). In addition, failure of a single pillar can result in overloading of the adjacent pillars, possibly resulting in the collapse of multiple pillars.

Figure 1. Example of bench mining of the floor between pillars in a limestone mine.

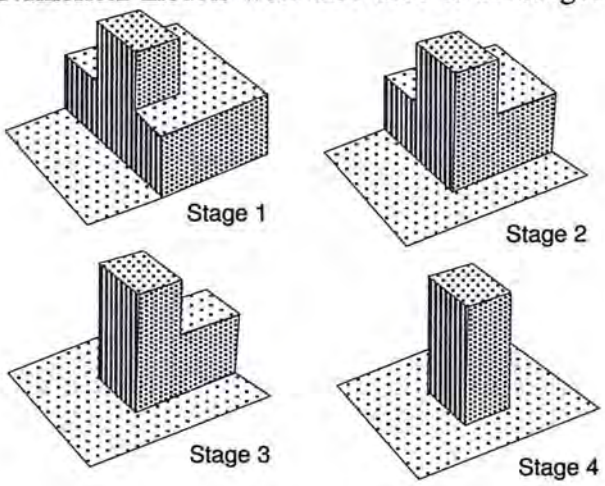
Figure 2. Stages of bench mining around a pillar considered in the numerical models.

The progressive reduction in pillar strength during bench mining was assessed using the FLAC3D finite difference program (Anon, 2005). Models were set up to simulate square pillars with initial W:H ratios of 1.0 and 1.5. The benching stages shown in Figure 2 were modeled by progressively removing the floor rocks on each side of a pillar until it is fully benched on all sides. The benching depth was selected so that the pillar height was doubled during the benching procedure. The model geometry for the pillar with initial W:H = 1.0 is shown in Figure 3. Model element sizes were kept constant during all the runs to avoid element size effects on the results.

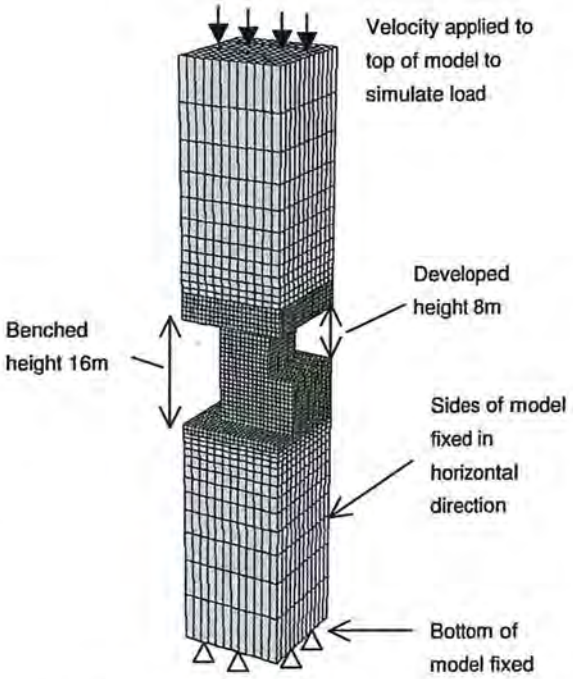
Figure 3. FLAC3D model of a partially benched pillar

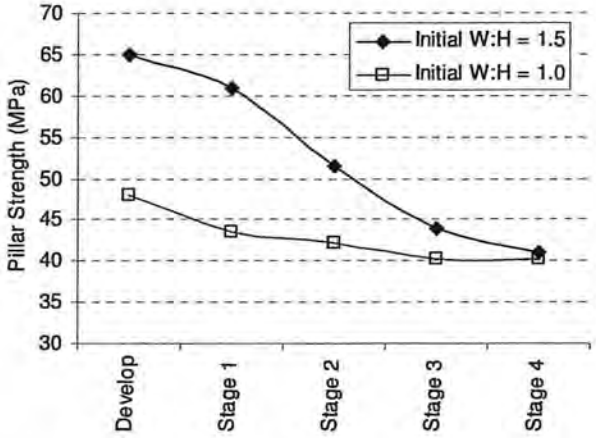
Model results for pillar strength at the various stages of bench mining are presented in Figure 4, which shows how the pillar strength is progressively reduced as bench mining is carried out around the pillar. The model results show that strength of the pillar with W:H=1.0 is reduced by about 16%, from its initial value of 48 MPa to a final value of 40 MPa. The pillar with W:H=1.5 experiences a

Figure 4. Results of FLAC3D modeling showing strength reduction of pillars with initial W:H=1.0 and 1.5 from initial development through various stages of bench mining. Final W:H ratios at Stage 4 are 0.5 and 0.75 respectively.

reduction in strength of 37% from the development stage to the fully benched stage.

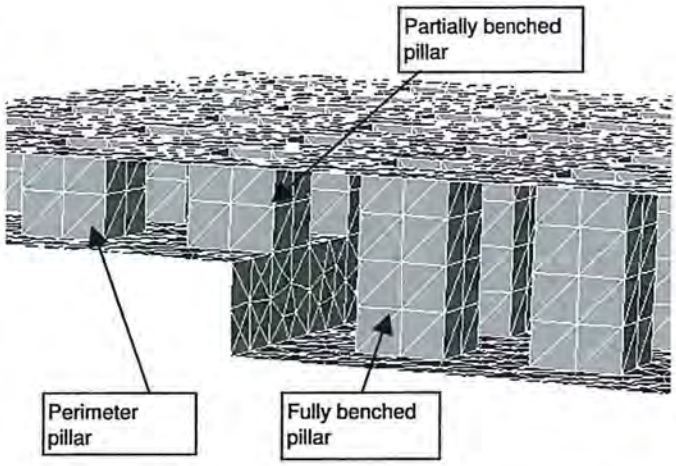
Figure 5. Cutaway view of Examine 3D model showing development and benched pillars.

limestone. Figure 5 shows a cut-away view of the model in which the initial developed pillars, the perimeter pillars and the benched pillars can be seen.

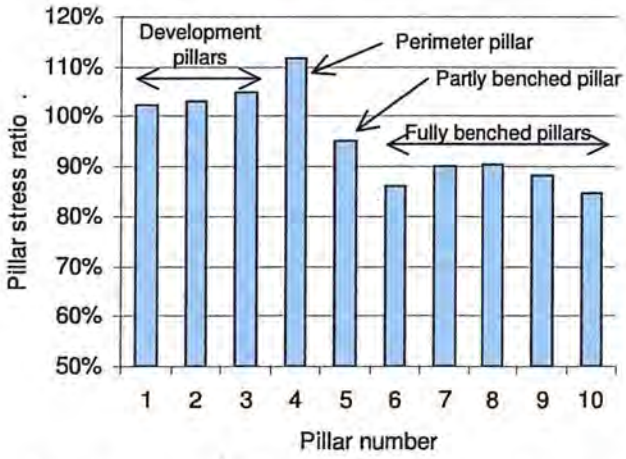
Figure 6 shows the average stress in the pillars obtained from a model in which half of the pillars have been benched. The results show that the development pillars at the edge of the benched area are subjected an increase of about 12% in their average stress. The results further show that the stress in the partly benched pillar is lower than the stress in the adjacent pillar that has not been benched yet, indicated as "perimeter pillar" in Figures 5 and 6. The lower stress in the partly benched pillar can be explained by the fact that its stiffness is reduced by the increase in height of one of the sides of the pillar, causing the load to be transferred to the stiffer development pillars. It can clearly be seen that the fully benched pillars are at a reduced stress level, owing to their relatively low stiffness. As benching continues, the stress in the fully benched pillars is expected to gradually

Figure 6. Results of Examine 3D model showing the average pillar stress during bench mining as a ratio of the average pillar stress prior to bench mining.

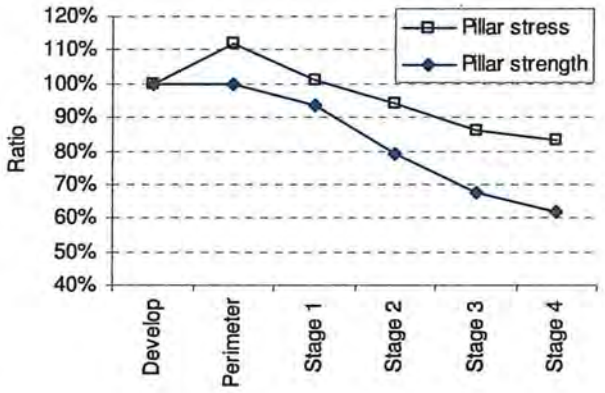
Further results, showing the changes in the average vertical stress in a pillar at the various stages of bench mining are presented in Figure 7. The figure also shows the associated changes in the pillar strength for a pillar with W:H=1.5, as previously presented in Figure 4. It can be seen that the pillar stress is a maximum just before benching starts around the pillar. As soon as one side of the pillar has been benched, the average pillar stress decreases, owing to the increased height and reduced stiffness. The average pillar stress continues to decrease as benching progresses, until the pillar is fully benched. The stress in the fully benched pillars will gradually rise as the benching face moves away. Full tributary loading can re-establish in the benched pillars if the mined area is sufficiently large.

Figure 7. Change in the average vertical pillar stress and strength during various stages of bench mining, for a pillar with W:H=1.5 based on FLAC3D and Examine3D results.

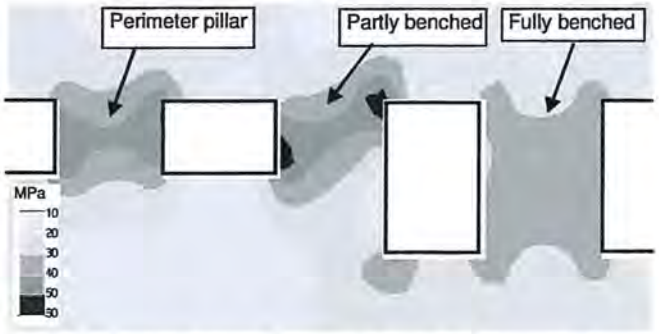
The numerical models confirm that elevated stresses can occur in pillars around the perimeter of a benched area. However, the existence of reduced stresses in the partially benched pillars seems to be in conflict with the field observations, which indicate that elevated stresses exist in the partially benched pillars. Nearer inspection of the model results show that stresses are not symmetrically distributed within pillars at the edge of a benched area, shown in Figure 8. It can be seen that zones of high stress exist within the partially benched pillar that are absent in the perimeter pillar, although the average vertical stress in the two pillars may be similar. The elevated local stresses are likely to

Figure 8. Section through the central part of an Examine 3D model showing maximum principal stress contours in and around pillars at the edge of bench mining. Contours in MPa.

contribute to the failure observed in the partially benched pillars in operating mines.

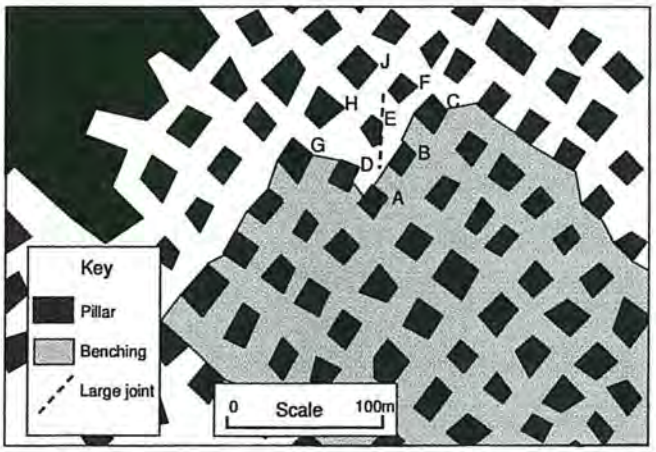
Pillar instability was observed adjacent to an area of bench mining at a mine that is extracting a near horizontal limestone bed. Spalling of the pillar ribs, resulting in hourglass formation, was observed. In the area of concern, the pillars were square with side dimensions varying between about 12.2 and 15.2 m and were initially benched to 15.8 m high. Further benching was carried out, which increased the pillar height to 27 m. The room width was measured to be about 16.4 m, and the depth of cover is 140 m. The average pillar stress is about 15 MPa, based on the tributary area method. However, the irregular pillar shapes and effects of benching resulted in variable stresses in the pillars. The width to height ratio of the benched pillars was as low as 0.44 in the 27 m high area. Figure 9 shows a plan of the mine

Figure 9. Plan view showing layout of pillars and bench mining at case study mine as modeled using the Examine 3D software.

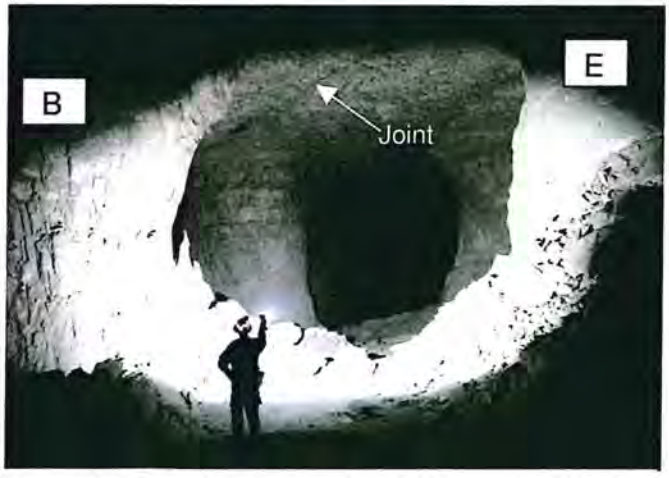
The initial development mining was carried out about 15 years ago, but the final benching stage was carried out less than 5 years ago. A number of pillars were reported to be progressively spalling to the current hourglass shape at the perimeter of the benched area. Figure 10 shows the conditions of pillars B and E. Evidence of fracture through intact rock and slab formation was seen. Pillars A, B, D and E showed open vertical fractures and there were large slabs lying on the mine floor around the pillars. Pillar E was considerably reduced in size, owing to the presence of the large joint that intersected one of its corners and caused the corner to slough. The remaining part of the pillar was in a poor condition, containing many stress related fractures and slabs. Pillars C, F, H and J were in a relatively good condition and did not show any signs of stress damage.

Figure 10. View of pillars showing slabbing and rubble from rib failure, Pillar B on left and Pillar E on right in photograph.

The pillars labeled A, B, D and E in Figure 10 are clearly exposed to elevated loading. Spalling to an hourglass shape, open fractures and slab formation are all well known manifestations of pillar overload. A 3D model of the area was set up using the Examine 3D software. The model simulated an area of about 300x300m with the pillars in question located near the center of the model. Two stages were modeled. The first stage simulated a condition prior to bench mining and the second simulated the benched configuration shown in Figure 9. The results showed that prior to bench mining, pillars D, E and F were slightly more stressed than the surrounding pillars owing to their smaller size. The stress distribution in the pillars after benching is shown in Figure 11. It can be seen that pillars D, E and F contain the highest stresses and A, B and C have already been partly relieved of stress by the bench mining. Pillar E carries the highest stress, because it is smaller than the other pillars, and is stiffer than the partially benched pillars. The relatively lower stresses in pillars A, B and C is expected, since their height has been increased by benching, and they have shed stress. However, as benching approached these pillars, the stresses will have been elevated and is likely to have caused the observed damage. The benching configuration, which forms a protruding right-angle, also contributes to the elevated stresses on these pillars.

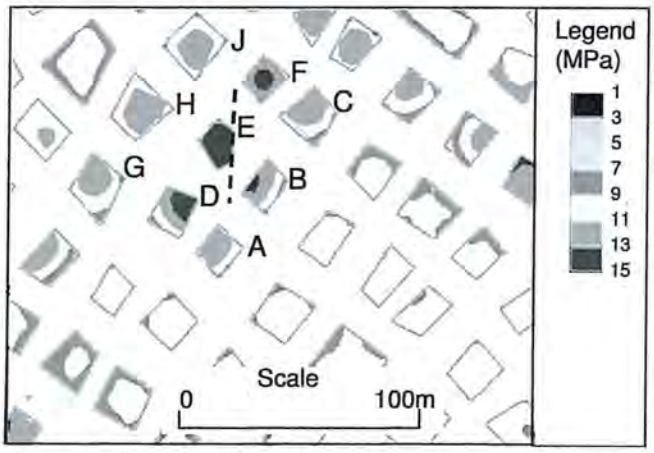
Figure 11. Examine 3D results showing contours of maximum principal stress in the pillars.
