Using Major Hazard Risk Assessment to Appraise and Manage Escapeway Instability Issues: A Case Study

Anthony T. Iannacchione, Principal Research Engineer
Gabriel S. Esterhuizen**,** Sr. Research Fellow
Stephen C. Tadolini, Principal Research Engineer
NIOSH-Pittsburgh Research Laboratory
Pittsburgh, PA

Proceedings
26th International Conference on Ground Control in Mining

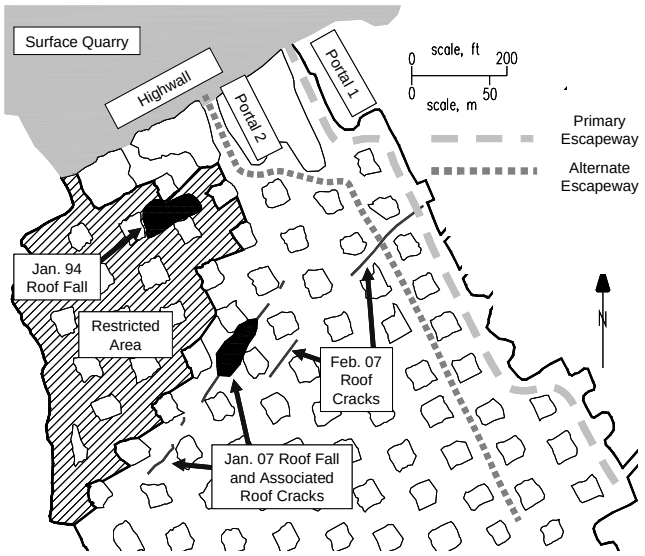
Figure 1. Escapeways, roof falls and recent roof cracks found at the mine.

Recently, roof conditions in the escapeways showed signs of deterioration. Of particular concern are the January, 2007 roof fall and the January/February, 2007 appearance of intermittent, en echelon roof cracks (figure 1). One of these roof cracks is especially troublesome because it extends across the Alternate Escapeway and into the Primary Escapeway, signaling an elevated risk.

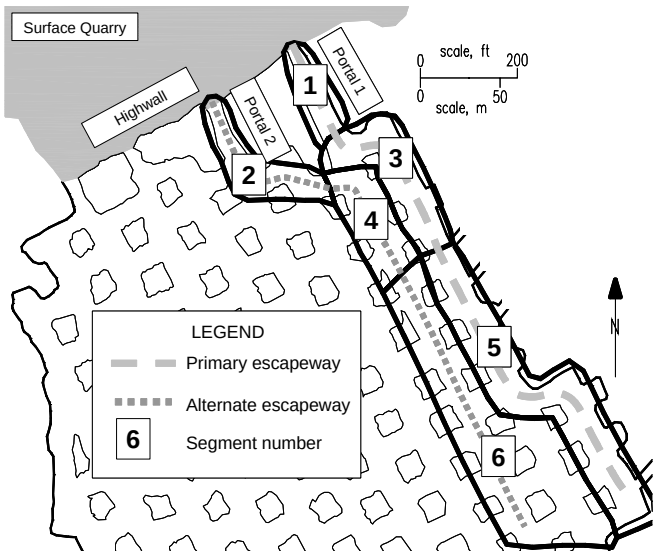
Segments of the Escapeway System: For the purposes of this analysis, the description of a metal/nonmetal escapeway follows from the definitions cited in the Code of Federal Regulations, Part 30, Section 57.11050 (CFR, 2005). The escapeway system at the study mine are subdivided into six segments (figure 2).

Figure 2. Six segments of the mine's escapeway system.

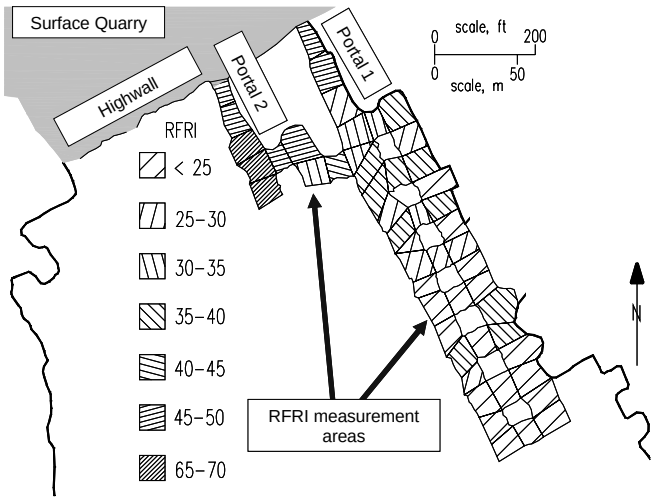
A NIOSH developed tool, called the Roof Fall Risk Index (RFRI), was used to systematically identify roof fall hazards in the escapeways. The RFRI is a hazard assessment technique that maps the spatial distribution of stability conditions. The RFRI focuses on the character and intensity of defects associated with specific roof conditions (Iannacchione et al., 2006; Iannacchione, et al., 2007). Ideally, values approaching 0 represent safer roof conditions, while an RFRI approaching 100 represents a serious roof fall hazard. The RFRI values for the mine's escapeway system are shown in figure 3. Higher values indicate increasing risk of roof collapse in the absence of additional roof stabilization efforts. For example, the relative roof fall risk in Segment 1 of the Primary Escapeway is potentially lower than Section 2 because this section contains roof bolts, wire mesh and narrower entry spans.

Figure 3. Roof fall risk index (RFRI) measured in the mine's escapeways.
