RI 9660

Evaluation of Systems to Monitor Blind Areas Behind Trucks Used in Road Construction and Maintenance: Phase 1

Todd M. Ruff

February 2003

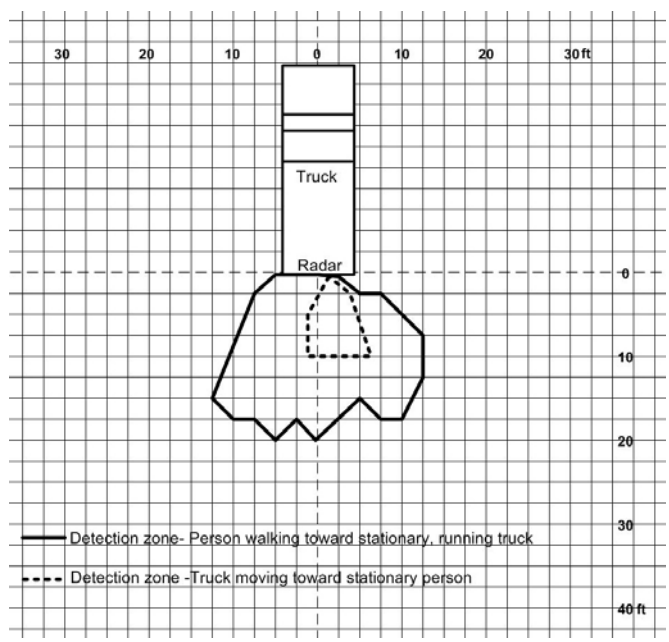
Significant differences in the detection zone were seen when tests were conducted with the truck moving in reverse. The dashed line of figure 5 shows the detection zone for a person standing still and facing the radar while the truck moved slowly (3-5 km/hr [2-3 mile/hr]) in reverse. The range of the system decreased to approximately 3 m (10 ft), and the width no longer covered the width of the truck. An exact reason for this decrease in the detection zone was not found, but the manufacturer suggested the cause could be vibration or moving at a speed too slow for reliable detection (Guardian Alert, 2000). However, tests conducted by moving at the same reverse speed toward other objects, such as a building or vehicle, did not show the same decrease in detection. It is suspected that a combination of slow reverse speeds and the smaller radar cross section of a person contributed to the decrease in the detection zone.

Figure 5.—Detection zones for person and Guardian Alert radar system.

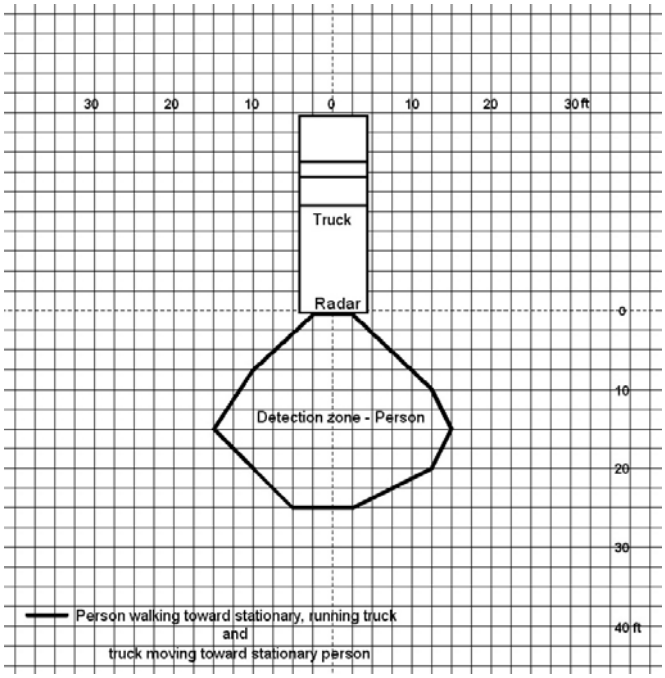
To determine the detection zone for a person, the test subject walked toward the rear of the sanding truck and recorded where reliable detection occurred (figure 8). The test subject then remained stationary while the truck was moved slowly (3-5 km/hr [2-3 mile/hr]) in reverse. No significant changes were seen in the detection zone. The range for both scenarios was 7.6 m (25 ft), and the width of the detection zone was adequate to detect a person standing 30 to 60 cm (1 to 2 ft) away from the outer edge of the rear tires. However, at this mounting height, a crouching person might not be detected immediately next to the tires, and the tilt of the radar would need to be increased if possible.

Figure 8.—Detection zone for person and Preview radar system.

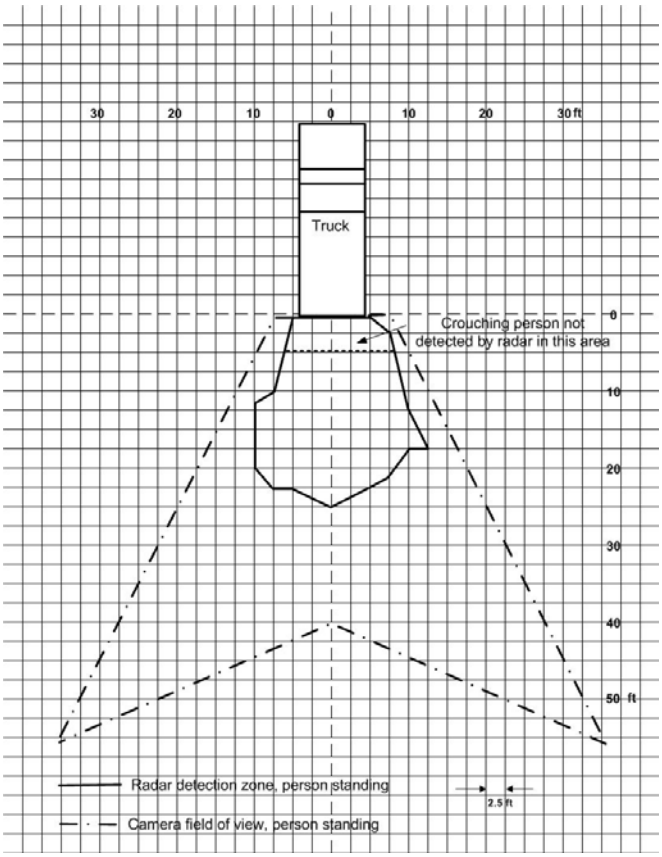
After mounting the systems, the final radar detection zone and the FOV for the camera were recorded as shown in figure 11. The radar's detection zone for a person standing behind the truck (inner solid line) adequately covered the width of the truck and extended 7.6 m (25 ft) from the back. However, the system did not detect a person crouching or

Figure 11.—Detection zone for Preview radar system and field of view for Clarion camera on a sanding truck.

kneeling immediately behind the truck. The downward tilt of the radar system was increased to improve detection of a crouching person, but the system began to sense the truck itself, which caused false alarms. The tilt angle was reset to 20°.

After mounting the system, the FOV for the camera was recorded as shown by the outer dashed line in figure 11. The FOV was adequate to show a person standing or crouching immediately behind the truck. This view extended to 12 m (40 ft) from the center of the hitch plate. The fisheye effects of the wide-angle lens account for the odd shape of the FOV.

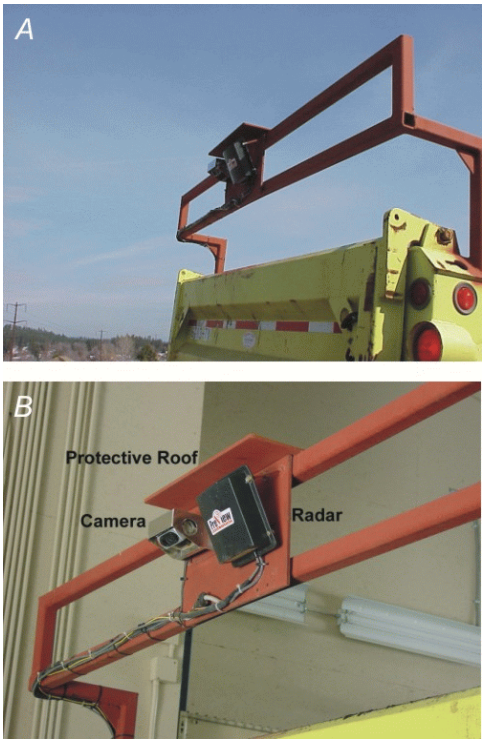
NIOSH and WSDOT personnel designed the mounting bridge shown in figure 14. The size of material to be hauled, such as boulders, must be considered when determining the height of this bridge so that the bridge will not obstruct dumping. However, if the bridge is too high, it can be easily struck by a loader bucket or, as discussed later, it may not fit under some material loading bins.

Figure 14.—*A*, Mounting bridge; *B*, radar and camera mounting.

- The radar system was useful in that it prompted the driver to check the camera system's video monitor, but most often the alarms were caused by items that posed no danger, e.g., sand piles or other equipment of which the driver was already aware.
- Very few false alarms were heard, i.e., alarms generated for no apparent reason.
- The radar system was reliable in detecting and displaying an approximate distance to the sand pile when backing to the dump point.
- The mounting bridge caused the loader operator to slow down to avoid hitting the bridge during loading.

- The mounting bridge was too high and would not pass under the asphalt loading bin in later tests. This truck could not be used for paving projects.

While the radar system operated well on this truck, the fact that it must be mounted high in order to avoid tailgate mounting is a major drawback. As designed, the mounting bridge interfered with operations, and so other mounting positions are being investigated. Based on the above observations and the fact that this truck could not be used for paving projects, it was decided to pursue other sensor systems that could be mounted on the truck's rear bumper, hitch plate, or on the side of the dump box near the taillights.

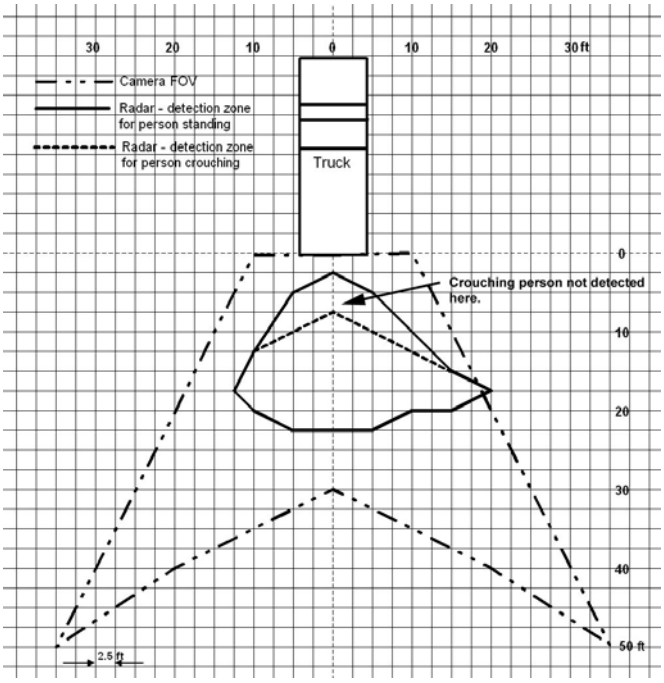
After the system was mounted, the final radar detection zone and FOV for the camera were recorded as shown in figure 15. Because of the mounting height of the radar, a person was not detected immediately behind the truck. This was because a person could walk underneath the radar beam at close distances.

Figure 15.—Detection zone for Preview radar system and field of view for Clarion camera on dump truck.

The mounting height also resulted in poor detection of a crouching person when close to the truck, as indicated by the dashed line inside the solid line of figure 15. A standing person was detected at distances between 0.76 and 6.9 m (2.5 and 22.5 ft) from the back of the truck, while a crouching person was detected at distances between 2.3 and 6.9 m (7.5 and 22.5 ft). The radar system was mounted several feet above the manufacturer's suggested mounting height, which caused the detection zone to be inadequate for this truck. Tests continued, however, because the addition of the camera system provided redundancy.

After mounting the systems, the final radar detection zone and the FOV for the camera were recorded as shown in figure 15. The FOV for the camera (outer dashed line) was able to show a person standing or crouching immediately behind the truck. This view extended to 9.1 m (30 ft) from the rear of the truck.

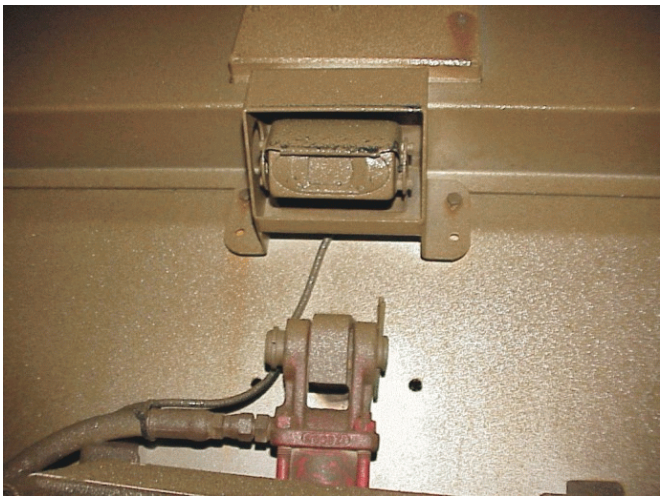
The camera system had similar problems as the radar when driving on the road during the winter months. Ice, snow, and mud build-up on the camera caused several problems. Initially, the motorized lens shield on the camera was left in the open position for forward and reverse gears. This was requested so the driver could monitor vehicles behind the truck during sanding and plowing operations. After the first few days of operation, it was necessary to change this configuration so the lens shield closed when the truck was in forward gear, allowing the camera view to be activated only in reverse. This was because (1) mud and snow build-up on the lens occurred

because (1) mud and snow build-up on the lens occurred quickly in forward gear (figure 18), obstructing the camera view, and (2) glare from headlights distracted the driver during night operations. After this change was made, the camera system operated reliably on warmer days. However, in snowy conditions, ice and snow quickly covered the camera when traveling forward. This caused the lens shield to become frozen in the closed position, making the camera unusable even in reverse. After a few days of operating under these conditions, the lens shield mechanism failed and was stuck in the closed position even after snow and ice were cleared from the camera. A heated camera enclosure or some other method to keep snow and ice from building up on the camera would be required before using this system on a sanding truck.

The camera system was removed from the truck and inspected after 2 months of use. In addition to the broken lens shield mechanism, the glass window protecting the camera lens was cracked. The monitor and cables appeared in good shape.

Figure 18.—Mud build-up on Clarion camera.

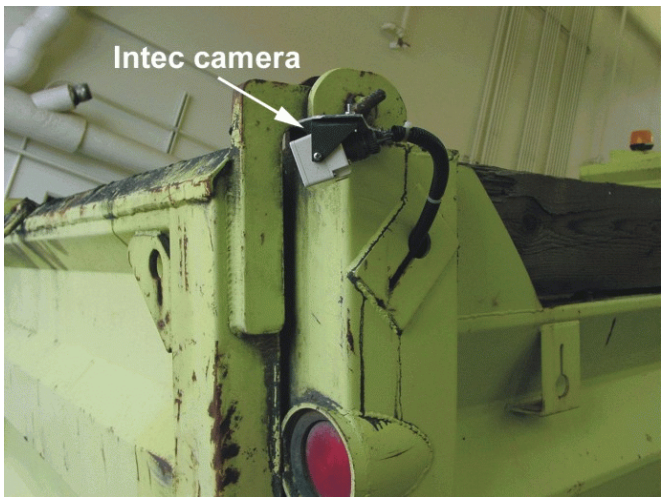
The camera was temporarily mounted in various positions on the bed of a dump truck. The goal was to find a position on the side of the box near the taillights that would be high enough to achieve an adequate FOV, but where the camera would not protrude too far from the side of the truck. The final position selected was near the top of the dump box, just above the taillights (figure 19).

Figure 19.—Intec camera mounted for short-term test.

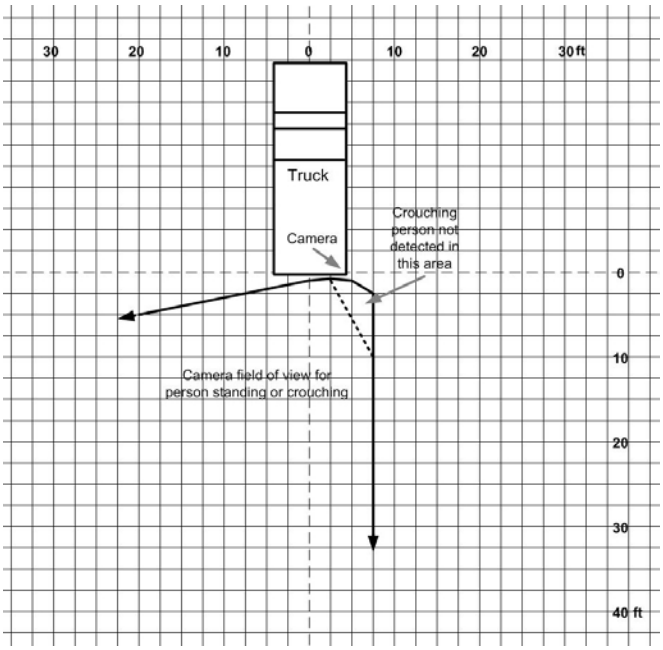
The monitor was temporarily mounted in the cab of the truck between the two seats. The FOV for the camera was tested by recording where a person could be seen behind the truck in both a standing and a crouching position. As seen in the graph in figure 20, the FOV for a person in a standing position extended from the back of the truck out to the horizon. The right side of the FOV was blocked by the camera enclosure. The area between the dotted line and the truck represents the area where a crouching person could not be seen in the video monitor because the person was beneath the camera's FOV. Full coverage of a crouching person behind the truck could be achieved by tilting the camera further downward, but there is a tradeoff between close coverage and the distance that the FOV extends on the left side of the truck. Results of this initial test showed that the camera system could be useful, so long-term tests on a dump truck were conducted during the summer months.

Figure 20.—Field of view for a person and Intec camera system.

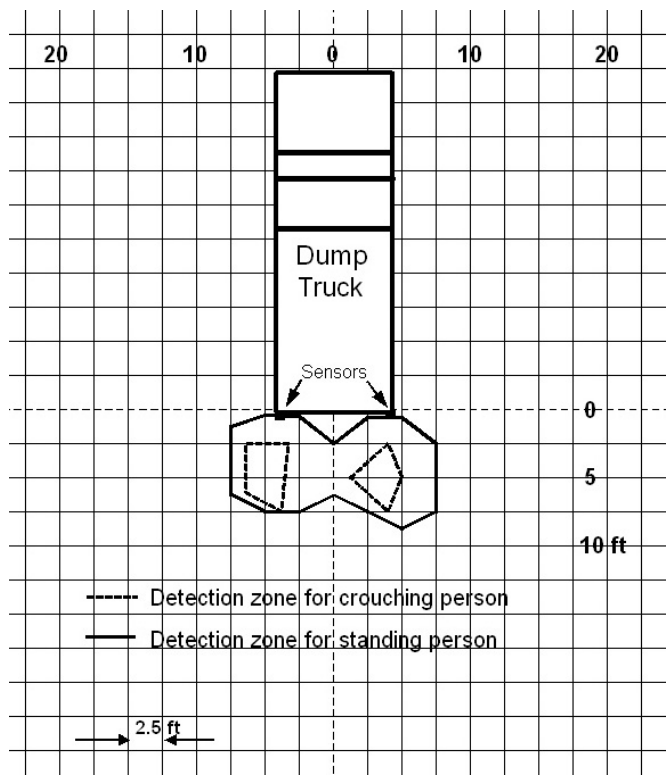
As suggested by the manufacturer, the two sensors were temporarily mounted on the lower corners of the dump truck's box (just below the tailgate hinge points) as shown in figure 23. The alarm was situated at the rear of the truck for easy viewing for these initial tests. Several problems were seen with this mounting configuration, including the potential for damage to the sensors when material flowed through the tailgate and the lack of continuous detection of a crouching person behind the truck, as shown by the dashed lines in figure 24.

Figure 24.—Detection zone for person and Hindsight sensors mounted on dump box corners.

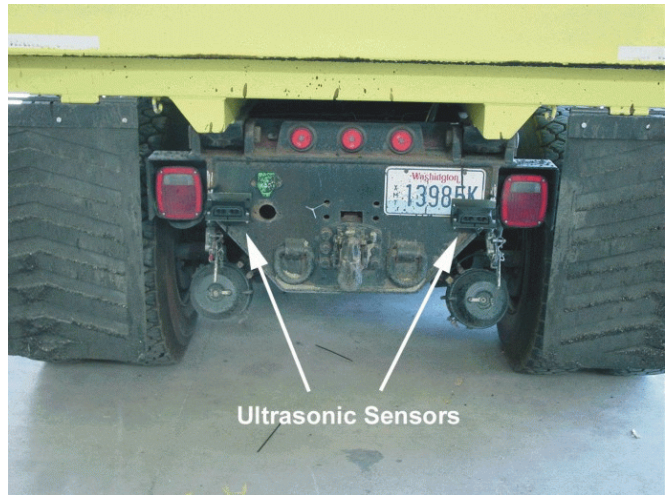
An additional short-term test was conducted on a sanding truck. The same positions on the hitch plate were used for sensor mounting (figure 25). Frequent false alarms were produced, but the source of the alarms was not obvious. It was suspected that the slightly different configuration of the mud flaps was causing the flaps to be detected. No long-term tests were planned on the sanding truck because it was obvious that the sensors would be covered with snow and mud during winter operations.

The final mounting position for the sensors on a dump truck was near the taillights, as shown in figure 25. The sensors were mounted at a height of 76 cm (30 in) with 81 cm (32 in) spacing. The alarm was mounted on the dashboard. The detection zones for a standing and crouching person were the same as in the short-term results (figure 26). The system was tested during the summer months on road-patching and materials-hauling jobs. No evaluation forms were turned in, but comments from drivers were received through interviews and are summarized below.

Sensing dust was a problem with this sonar system according to the drivers, which brought up concerns about false alarms in snow and rain. The manufacturer did acknowledge the possibility of false alarms in heavy snow. Additional tests are needed to determine what precipitation rates would cause an alarm, if any. Concerns were also raised regarding the short detection range of the system. A person immediately behind a very slow-moving truck might be detected in time for the driver to react. However, in fast-moving situations, 2.4 m (8 ft) of detection does not give adequate time to respond (Society of Automotive Engineers, 1999).

At the end of the summer, the system was removed and inspected. All components were in good working order.

Figure 25.—Final mounting position of Hindsight sensors.

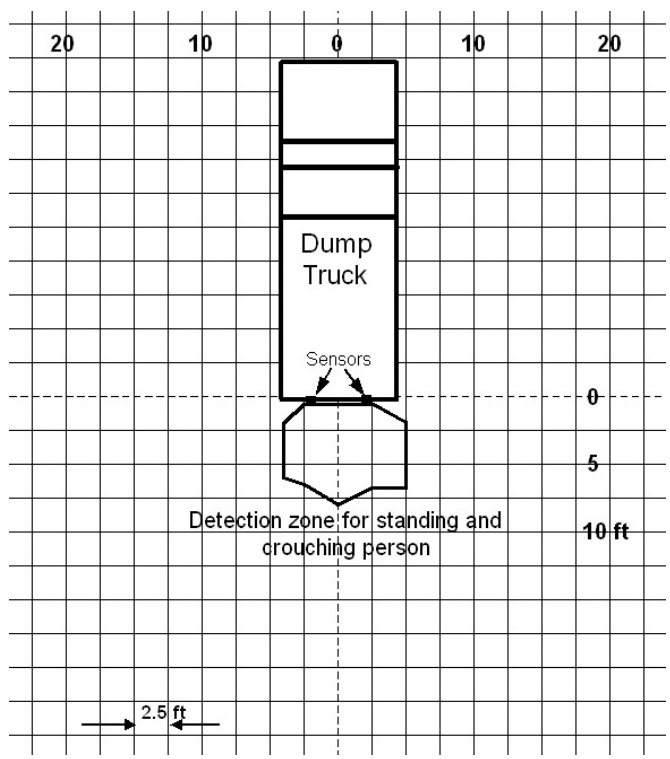
An alternative mounting position for the sensors was tested (figure 25). This placed the sensors on the hitch plate and closer together, which resulted in a more continuous detection zone for a person, as seen in figure 26. The total range of the system was 2.4 m (8 ft), and detection covered most of the width of the truck except the corners of the dump box. The system did not generate false alarms in a clear area on asphalt, and the mud flaps were not detected. Despite the short detection range, long-term tests on a dump truck were conducted.

Figure 26.—Detection zone for person and Hindsight sensors mounted on hitch plate.
