Rock Bursting and Seismicity During Ramp Development, Lucky Friday Mine, Mullan, Idaho

J. K. Whyatt, Mining Engineer
B. G. White, Geologist

National Institute for Occupational Safety and Health
Spokane Research Laboratory
Spokane, WA

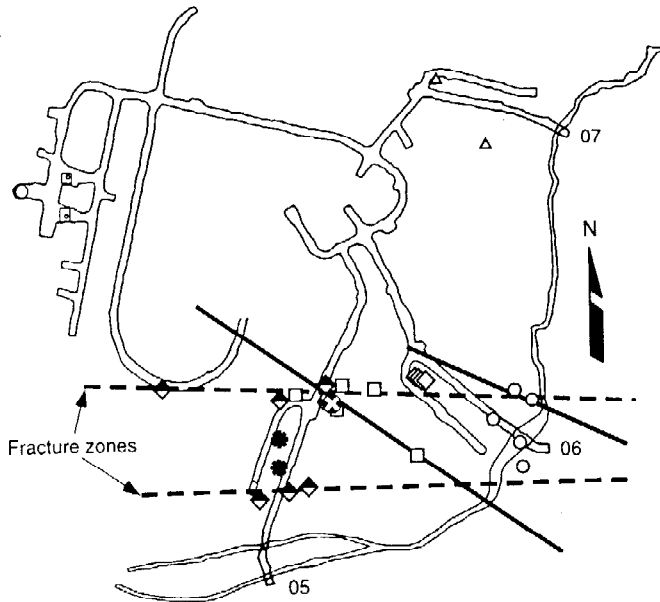
Twenty-nine large events were sorted into a number of groups with common characteristics, including location, activated geologic feature, and failure mechanism (figure 3). Damage to mine workings was reported for only six of these events, but for three of the six, the relationship proved to be only coincidental. Overall, these events accounted for surprisingly little damage and appear to be part of the rock mass response to mining rather than to development.

Figure 3.—Locations of large events assigned to various groups.

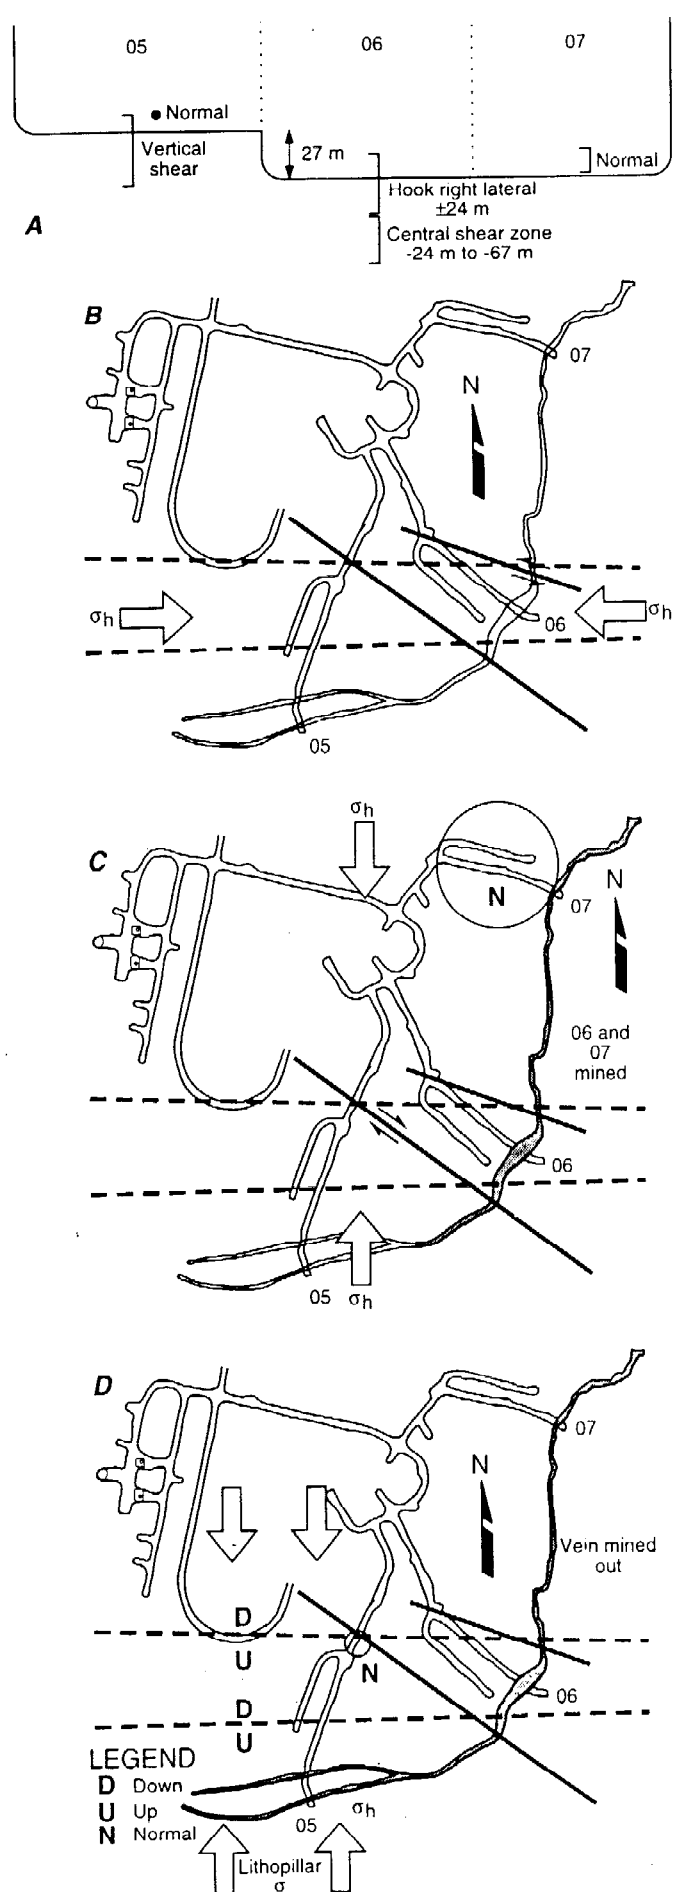
The relationship between large seismic events and mining can be examined by plotting the location of these events relative to the mining front (figure 4A). Each type of event appears to maintain a fairly constant position with respect to the mining front, and the first-motion patterns reported for these sets of events are consistent with the influence of mining-induced stresses (figure 4B-D). The deepest events were located at the southern end of the central shear zone, and relieved concentrated horizontal stresses below the 06 stope. The next major set of events, right-lateral events along the Hook Fault, was driven by relief of east-west horizontal stresses by mining in the 06 and 07 stopes and concentration of north-south stresses under the lagging 05 stope. Concentration of stress in the dipping beds was relieved through vertical shearing (figure 5), and vertical stress on bedding planes above the stope floor was relieved by normal movement toward the stope.

Figure 4.—Location of major groups of large events relative to mining face. *A*, Longitudinal section; *B*, deep events responding to east-west abutment stress; *C*, intermediate events responding to leading 06 and 07 stopes; *D*, uppermost events relieving stress in beds through vertical shear and vertical stresses by normal slip.

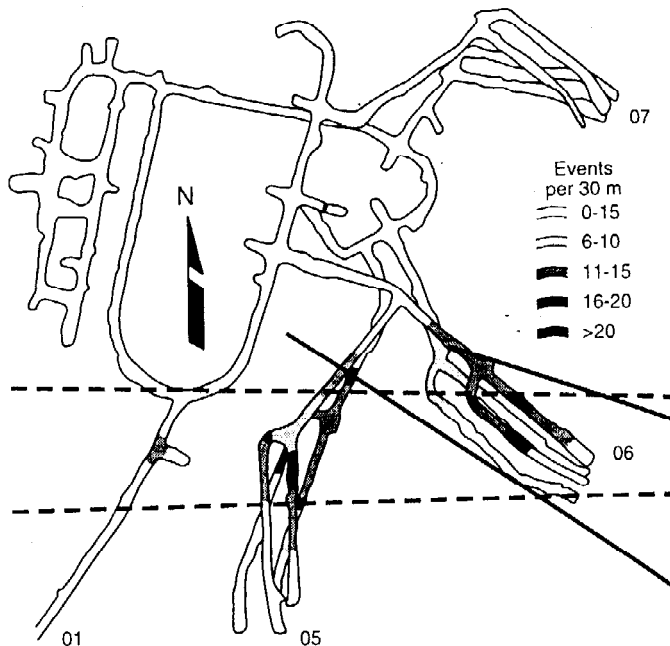
An eyewitness account of a small-magnitude rock burst in the 01 ramp on May 20, 1993, illustrates this mechanism. The burst occurred as two miners were drilling bolt holes in the rib to install bolts and chain-link fencing. One miner reported that his jackleg drill seemed to leap toward the rib, as if the drill steel had broken (it had not). In the next instant, the rib burst almost from floor to back along a 5-m (15-ft) section of the ramp to a depth of about 1 m (3 ft). A miner was bruised but not seriously injured, being protected somewhat by the fencing hanging between them and the burst.

An examination of the rib at the ends of the burst cavity revealed many closely spaced, joint-like fractures at a slight angle to the surface of the rib. These fractures had not been recorded during mapping of the rib several days earlier. Whether or not they were preexisting structures, their prominence after the burst suggests they at least opened as the burst occurred. The miner's perception that his drill leaped toward the rib suggests that quasi-static dilation of the rib occurred as a prelude to the burst. The movement was likely caused by fracturing and bending of rock layers defined by fractures prior to buckling of these slabs into the ramp.

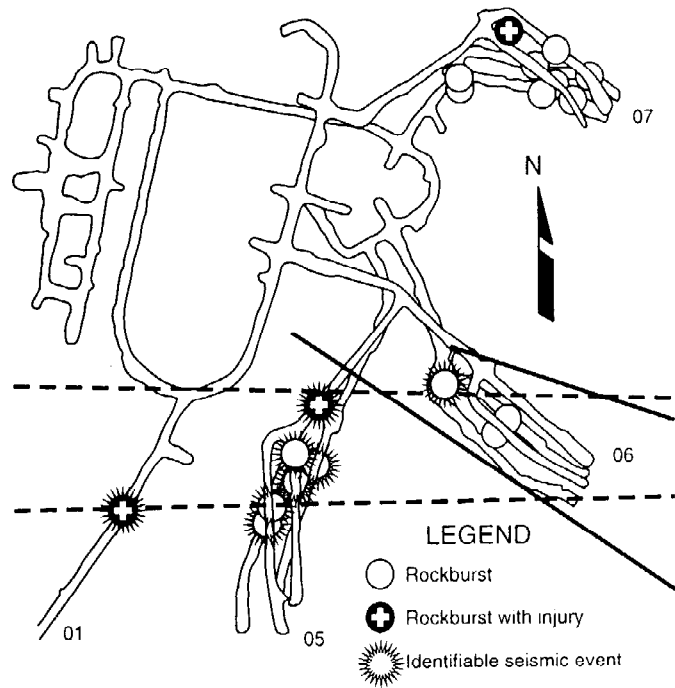
Rock bursts, like events in the first two sets, occurred in a few clusters involving only a small portion of the ramp system. Figure 7 illustrates the locations of these clusters and locations where these bursts resulted in injuries. The location of injuries within the clusters of rock bursts suggest that the level of hazard was influenced by sudden onsets of rock bursting that may have surprised miners. Adding destress holes to the round and adjusting support measures were probably responsible for the lack of subsequent injuries in these clusters, but detailed records of these measures were not obtained.

Figure 7 also indicates which rock bursts could be linked to records of a particular seismic event. This link could not be forged for a majority of reported rock bursts, including all bursts reported in the 07 ramp, and 3 of the 4 reported in the 06 ramp. Establishing a link between damage and a seismic event can be difficult, particularly when the event has little seismic energy or occurs with blasting. The time at which the ramp is damaged can be difficult to ascertain if a section of ramp is idle when the damage occurs and the seismic event is not unusually energetic. Finally, it is also possible that some of these rock bursts, particular those with minor amounts of reported damage, might have occurred independently of a seismic events and, thus, be more appropriately described as falls of ground. However, there was no correlation between amount of damage and seismic magnitude within this data set. In fact, many of the most damaging bursts could not be linked with a seismic event while while one of the least damaging bursts was included in the set of large seismic events.

Figure 7.—Locations of rock bursts and rock burst injuries.
