RI 9478

REPORT OF INVESTIGATIONS/1993

Evaluation of Catalyzed Diesel Particulate Filters Used in an Underground Metal Mine

By John J. Baz-Dresch, Kenneth L. Bickel, and Winthrop F. Watts, Jr.

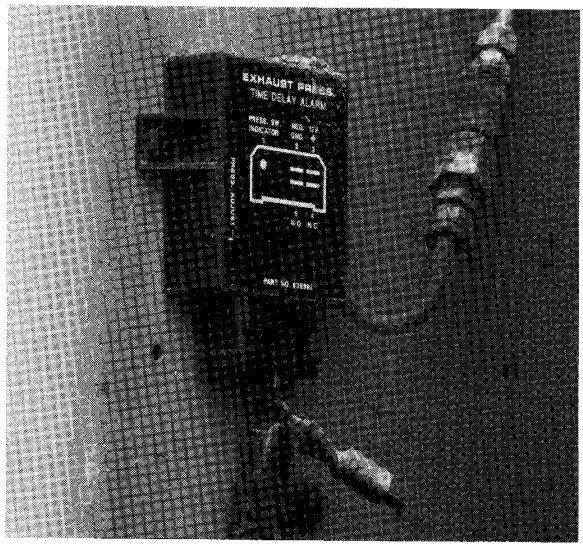
Figure 3.—Mounted backpressure alarm.

The backpressure alarms installed on Asamera's equipment consist of a "black box" with a red light that is mounted in the engine compartment. The unit (fig. 3) is connected to the inlet of the CDPF with a metal tube. A red light is also installed on the dashboard in the operator's compartment that glows when the backpressure exceeds a preset value, indicating the CDPF requires regeneration.

Only 2 of the original 12 backpressure alarms are currently operational. Production equipment is not removed from service to repair a backpressure alarm, and frequently pressure tubes and wires are not reattached after engine repairs are completed. Production and maintenance personnel, both staff and hourly, must be aware of the purpose of these alarms and trained to maintain them. Operators must ensure that regeneration occurs frequently to avoid damage to the CDPF, in order to protect the mine's large investment in CDPF's.

Fatigue-induced breaks and leaks in the metal tube and fittings of the backpressure alarm are reported by Asamera's maintenance personnel to be at least partly responsible for backpressure alarm failure. These leaks are caused by engine vibration and stresses developed from operating a machine in a harsh mine environment.

New backpressure alarms, which take advantage of improved technology to improve durability and performance, need to be developed. One such system combines sensors to monitor backpressure with thermocouples to monitor exhaust temperature on the inlet and exit of the CDPF. Digital readouts in the operator's cab display current conditions, and indicator lights flash when the exhaust temperature and/or backpressure exceeds acceptable limits. This type of monitoring system is advantageous because it provides information when the CDPF is undergoing regeneration, but it is more costly. The monitoring system must be made to withstand the mine environment and be simple to maintain.

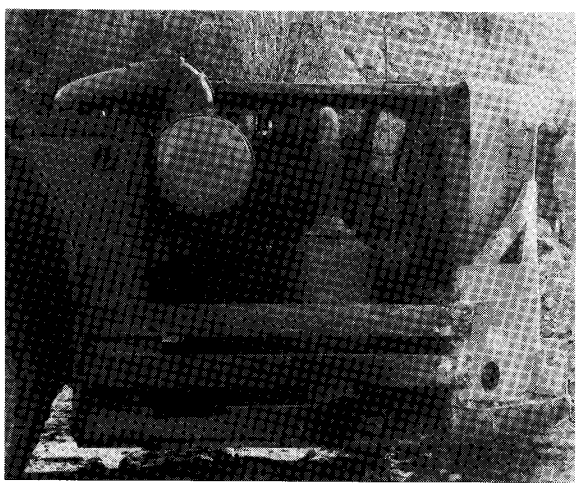
Figure 4.—Load-haul-dump, 6.1 m^3 (8 yd^3).

The CDPF immediately improved mine air quality by reducing the black smoke emitted from the tailpipe. However, the ceramic substrate of the CDPF broke apart after 2,960 h of use and the CDPF was replaced. The replacement CDPF now has 3,483 h of use. The total time that this LHD has been equipped with a CDPF providing exhaust filtration is 6,443 h as of June 30, 1992.

Black smoke is now being emitted from the tailpipe, indicating that the replacement CDPF has reduced

filtration efficiency. Both CDPF's were removed and cleaned on several occasions, because the filters were plugged because of incomplete regeneration. The backpressure alarm is no longer operational on this LHD.

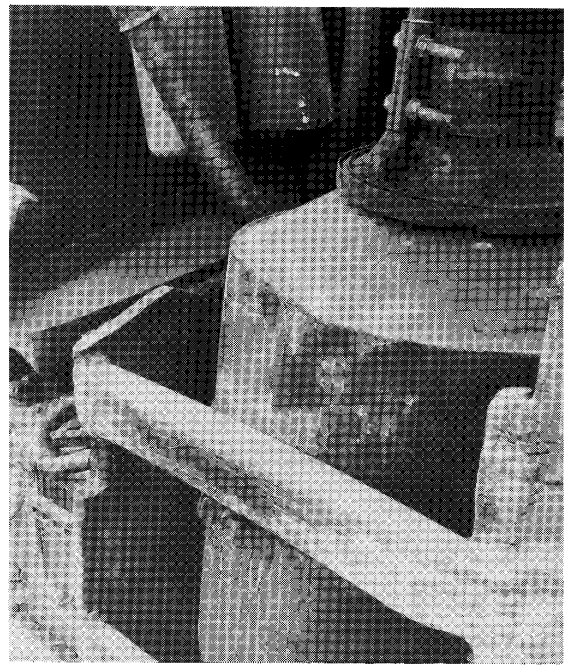
Regeneration problems and/or ceramic substrate damage are strongly suspected. Black exhaust smoke is frequently observed, the CDPF's have required pressure washing, and none of the backpressure alarms are functional. The CDPF's installed in these trucks are prone to damage due to impact against the mine rib. When a CDPF is hit, the substrate is frequently crushed at the point of impact, which affects filtration efficiency. Figures 5 through 7 show the damage sustained by a CDPF in use on a 23.6-mt (26-t) truck and by a CDPF that was removed from service.

Figure 5.—Truck, 23.6 mt (26 t), with dent in CDPF.

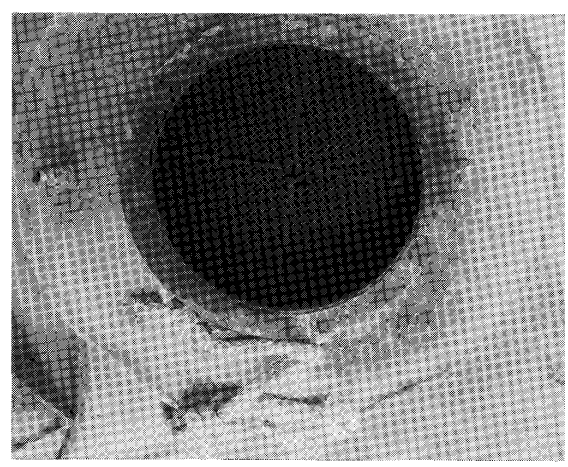
Figure 6.—CDPF with damage to inlet end.

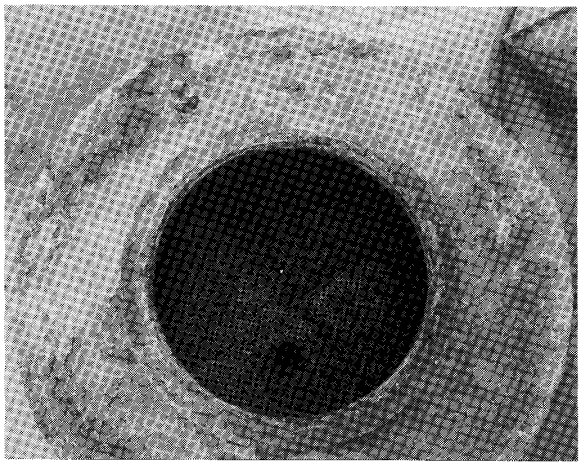
This CDPF showed a gradual decline in filtration efficiency, as increasing amounts of black smoke were observed in the exhaust stream. Several times the CDPF was removed from the road grader and pressure washed with water to remove some portion of the collected DPM and to reduce backpressure. After cleaning, visual observations suggested that the CDPF appeared to trap more of the DPM, but eventually the backpressure built up to unacceptable levels and further cleaning was required. At the time of the last cleaning, light could be seen through the CDPF and it was considered to have failed.

Figure 7.—CDPF with damage to exhaust end.

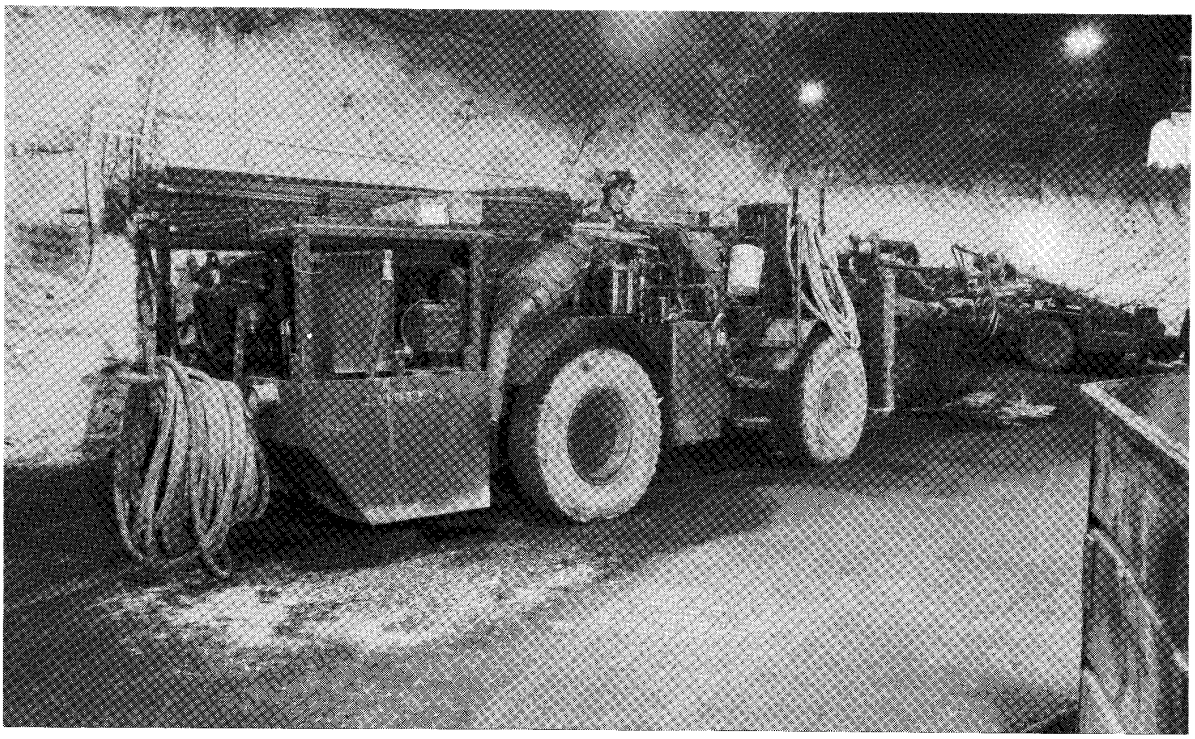
Figure 9.—Roof-bolting jumbo with CDPF.

A diesel-hydraulic roof-bolting jumbo (fig. 9) powered by a 61-kW (82-hp) Deutz F6L912W engine was equipped with a CDPF in October 1988. The unit's diesel engine provides power both to move the unit from location to location and to operate the hydraulic systems that power the drilling and bolting functions. The jumbo installs roof bolts throughout the mine, but stays in a given location for anywhere from a few hours to several days, with the diesel engine running under heavy load for a large portion of the shift. This duty cycle is ideal for a CDPF, because the high exhaust temperatures promote regeneration and mechanical stresses are limited when the jumbo is not moving.
