Preprint 01-113

"ADVANCE AND RELIEVE" MINING, A METHOD TO MITIGATE THE AFFECTS OF HIGH HORIZONTAL STRESS ON THE MINE ROOF

D. R. Dolinar, T. P. Mucho, and D. C. Oyler
Natl Inst for Occuptnl Sfty and Health
Pittsburgh, PA, USA

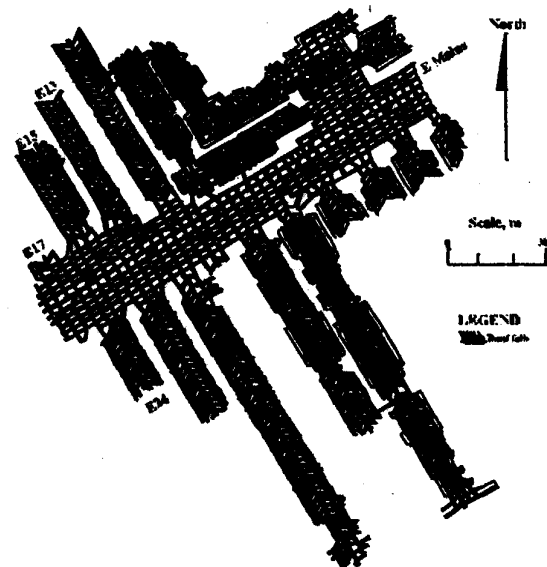
Figure 1. Plan view of E mains and panels showing long falls

In the E mains and panels, the mine has experienced directional roof control problems that are related to horizontal stress. The stress damage includes long running roof falls and cutters. Roof falls as long as 610 m and up to 9.1 to 10.7 m high have occurred generally in the northwest or southeast direction (figure 1). About 95% of the fallen roof is in the N 30° W orientation. Figure 3 shows the amount of fallen roof normalized by the drivage in a given direction. In the N 30° W direction (150° azimuth), over 5% of the drivage has failed while sightly over 2% of the drivage has fallen in the N 40° W direction (140° azimuth). In the other mining directions, less than 1% of the roof has fallen. These roof falls have occurred on both development and during retreat mining where falls occur just outby the cave. When the roof falls occurred during retreat mining the panels or portions of the panels would often be abandoned.

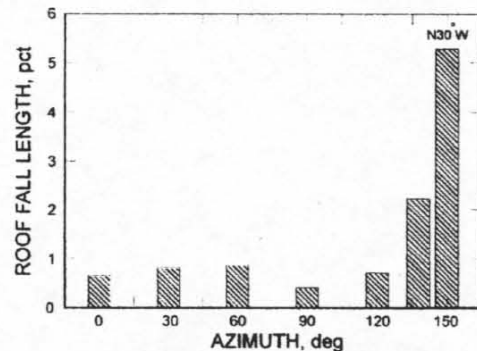
Mapping of the stress damage also indicates the directional nature of the roof problem by documenting more subtle roof damage in addition to roof falls (Mucho and Mark, 1994). This stress damage is in the form of cutters or gutters (figure 4). In the panels, most of the stress damage again occurred in the N 30° W entries. In panel E13 about 23% of the drivage had stress damage in the form of cutters or guttering. Ninety-five percent of this damage was in the N 30° W entries with 45% of the drivage in this direction suffering stress damage.

Figure 3. Direction of failed roof normalized by drivage in a given direction

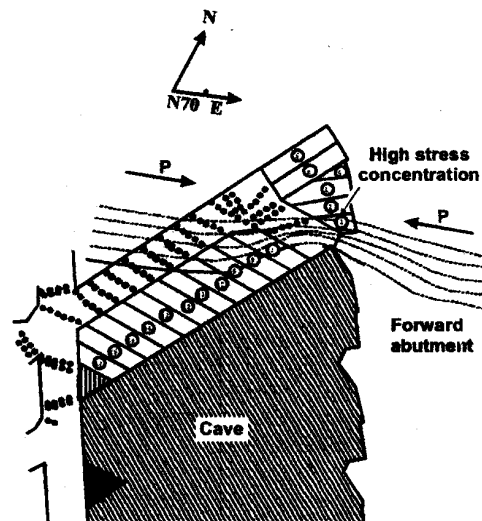
R1 entry next to the cave. With this system, a cave quickly developed that was about 30 to 37 m wide and that extended from the pillar remnant to the barrier. At several intersections the cave did extend into the R1 entry. However, with this plan, the cut back entry was very difficult to mine because the entry was subjected to severe roof damage from the horizontal stress concentration. Figure 8 shows the stress concentration that developed around the cut back entry. After 6 pillars were mined using the first plan, a second pillaring plan was developed to address this issue.

Figure 8. Forward stress abutment and concentration with respect to original pillaring plan

The second pillar plan eliminated the cut back entry, substituting a notch cut into the pillar parallel to the R1 entry from the outby room prior to the pillar extraction (figure 9). This notch allowed for a cut through of the pillar during the early stages of pillaring for ventilation and allowed for the full pillar width to be mined. Normally, the notch would be bolted with only 2 rows of bolts inby the rib line. With this second pillaring plan, the horizontal stress appeared to be concentrated near the notch and on the inby half of the crosscut where stress damage in the form of cutters still occurred (figure 10). However, the intervening coal pillar between the notch and the crosscut reduced the combined affects of the two openings on the stress concentration. During pillar extraction, the cuts that mined into the notch, cuts 4 and 5 resulted in the roof caving from the notch inby to the barrier. After this cave, there were few problems encountered with the extraction of the remainder of the pillar.

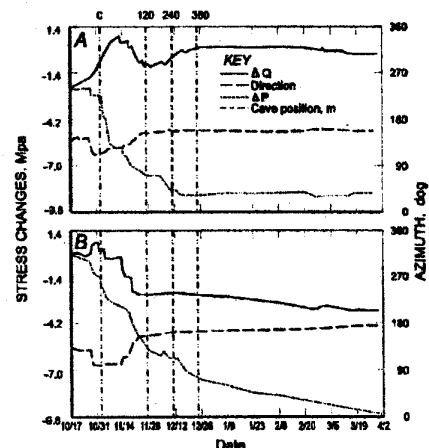
Figure 15. Horizontal stress changes measured at the test site. (A) 0.6 m depth and (b) 0.3 m depth. The azimuth direction is to ΔQ.

This forward horizontal stress abutment was seen by the increase in stresses as the cave front approached and passed the test site. At 37 m from the cave, stress increases ranged from 1.4 to 5.5 MPa. This stress increase began when the cave was 60 m outby the test site. At the 0.6 m level, the roof conditions did not allow this added stress to be sustained which quickly dropped to show a stress reduction. At other depths, the stress concentration just sub parallel to the cave remained higher than the original levels.

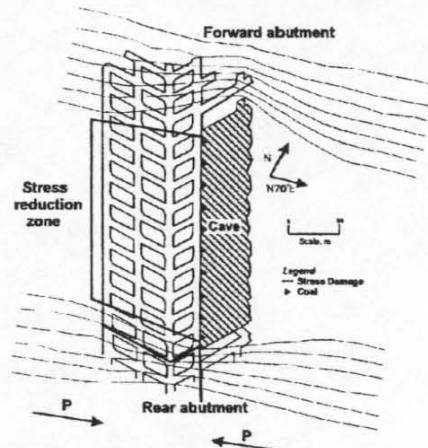
Roof damage in the entries and crosscuts in the panels just outby the cave was probably caused by the rear horizontal stress abutment (figure 16). This abutment did not advance with the mining, but remained stationary. In E15, the damage consisted of cutters that developed in the R1 entry from the cave outby for a distance of approximately 60 m. This stress damage was parallel to the length of the cave. Stress damage also occurred in the crosscut just outby the cave. A cutter ran across the belt entry then into the crosscut from the belt entry to the L1 and L2 entries. This was a narrow zone about 3 m to 5 m wide of fairly severe roof damage that crossed the entire panel at a right angle (figure 17). Because the rear abutment was stationary, the damage from this abutment appeared to be more severe than that resulting from the forward abutment. The damage parallel to the cave in the R1 entry was probably caused by the concentration of the maximum horizontal stress. However, the stress damage across the panel may have in part been caused by the minimum horizontal stress.

Figure 16. "Advance and relieve" panel with cave showing the forward and rear abutments and stress reduction zone

To rehabilitate the damaged roof, cribs, posts and cable bolts were used as supplemental support in the R1 entry and across the panel along the narrow zone of damage. Similar, though not as severe damage was seen outby the cave in E17. Again supplemental support was used to control the stress damage. In E17 the damage approached but did not reach the mains.
