Reinforcing Coal Mine Roof with Polyurethane Injection: 4 Case Studies

Gregory Molinda

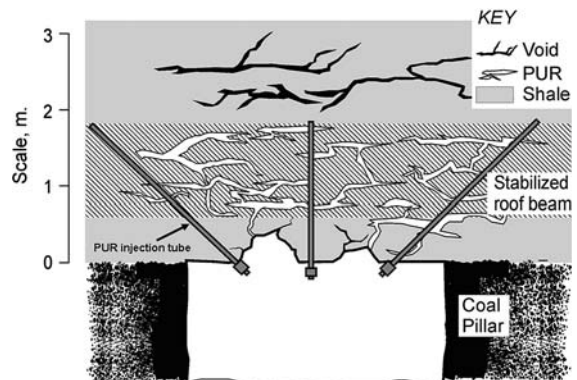
Fig. 1 Idealized PUR injection design

5. Injection arrays—These pumping patterns can have a number of configurations. A typical injection pattern for an intersection will have injection holes angled over the rib on 3 m (10 ft.) centers spanning each crosscut in the intersection (Fig. 1). PUR may be injected over the rib on each side of the intersection. These injection holes will be packed off to the destabilized zone, and then PUR is injected to erect a “grout curtain” which will act as a barrier and permit infilling of the intersection. The holes are either pumped to a predetermined volume or pressure or injected to refusal. Then holes will be drilled and pumped in the center of the intersection to complete infilling of the pattern. The exact specifications of the design are often determined by the experience of the contractor.

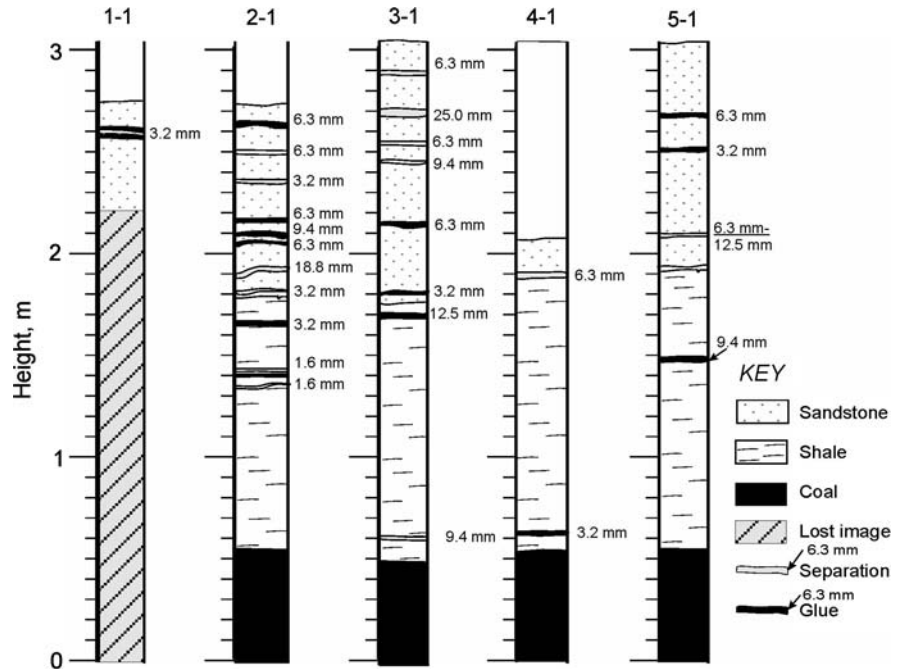
Fig. 9 Post-injection monitoring holes in the intersection

Figure 9 shows the logs of test holes drilled after PUR injection. Approximately 50% of the total

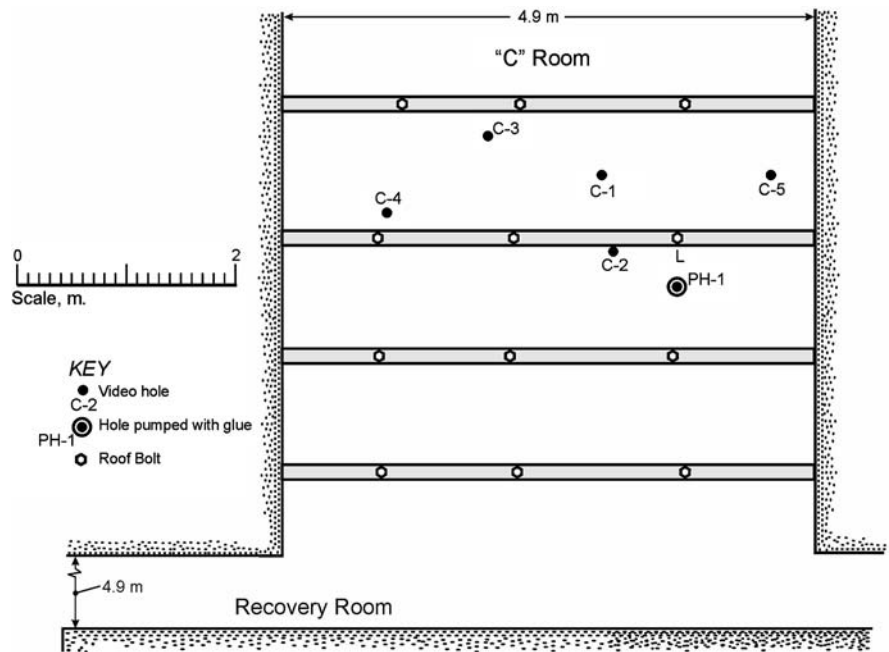
Fig. 15 First recovery chute with PUR injection and monitoring holes

could not migrate over the solid panel as originally planned, but hydrofractured a weak bedding plane and followed the path of least resistance back into the entry. Two adjacent recovery chutes off of the recovery room were also selected for a test of the injection of PUR into unfractured, but undermined, roof rock. Chutes C and D were injected with PUR and the results monitored via videoscope (Figs. 15, 16). Figure 17 shows the lithology and final location of the PUR in the immediate roof after the injection in room C. No open separations occurred in the immediate 3.0 m (10 ft.) of roof rock prior to the injection. In room C one hole (PH-1) was drilled to 2.4 m (8 ft.), packed at 1.5 m (5 ft.), and injected with 4.0 l (15 gal) of PUR (Fig. 15). Then the hole was re-packed at 0.6 m (2 ft.) and injected with another 4.0 l (15 gal) of PUR. A number of cable and combination bolt holes experienced leaks as the PUR migrated through the entry roof. Five monitor holes were videoscoped after the PUR injection (Fig. 17). The first PUR injection zone was isolated at 1.5–2.1 m (5–7 ft.). This was the contact between the sandstone and the underlying shale. This was done to see if the PUR could hydrofracture the coarse sandstone with coal spars. No PUR was observed in the sandstone in any of the monitoring holes (Fig. 17). It appears that the bedding in the sandstone was too strong to be hydrofractured and the PUR must have found some other conduit for relief. The other injection zone was isolated at 0.6 m (2 ft.) (PH-1). PUR was injected from 0.6–1.5 m (2–5 ft.). A thin 0.08–0.64 cm (0.03–0.25 in.) PUR wafer was observed at 42.7–57.9 cm
