Bureau of Mines Report of Investigations/1987

# Analysis of Cutter Roof Failure Induced by Clastic Dikes in an Underground Coal Mine

By Eric R. Bauer and John L. Hill III

**Report of Investigations 9117**

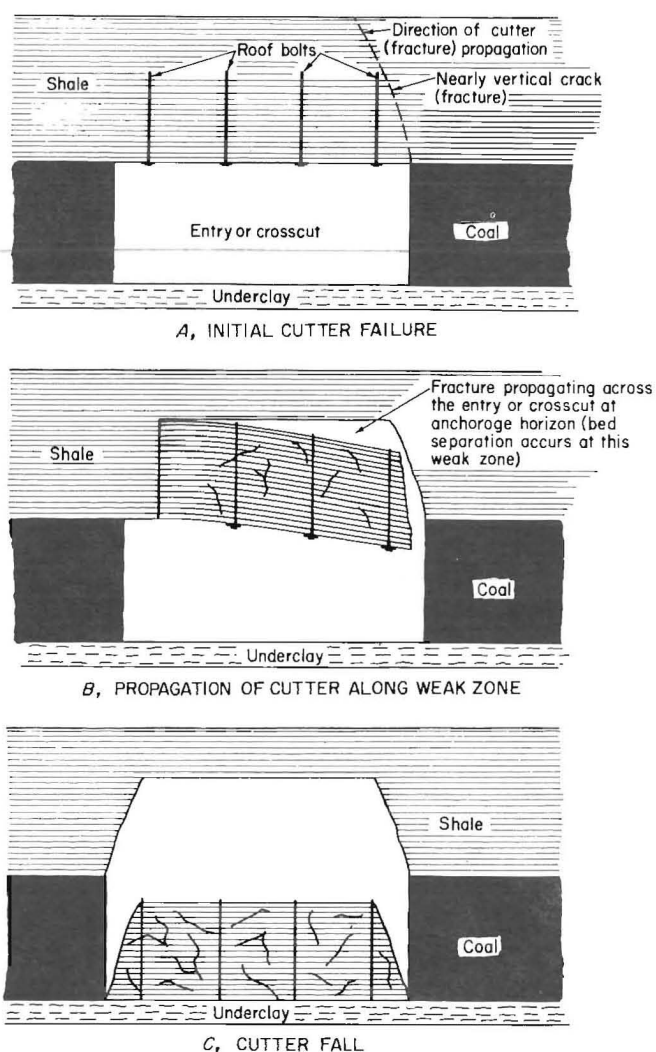
Cutter roof failure begins as a fracture along one or both roof-rib lines of an entry or crosscut and propagates nearly vertically into the roof (fig. 1). When the fracture extends above the anchor horizon of the roof bolts, or deflects along a weak bedding plane, massive roof failure may occur. Figure 2 is an example of initial cutter failure, and figure 3 illustrates the end result of such cutter development.

FIGURE 1.—Schematic of cutter roof failure sequence (8).  
Not to scale.

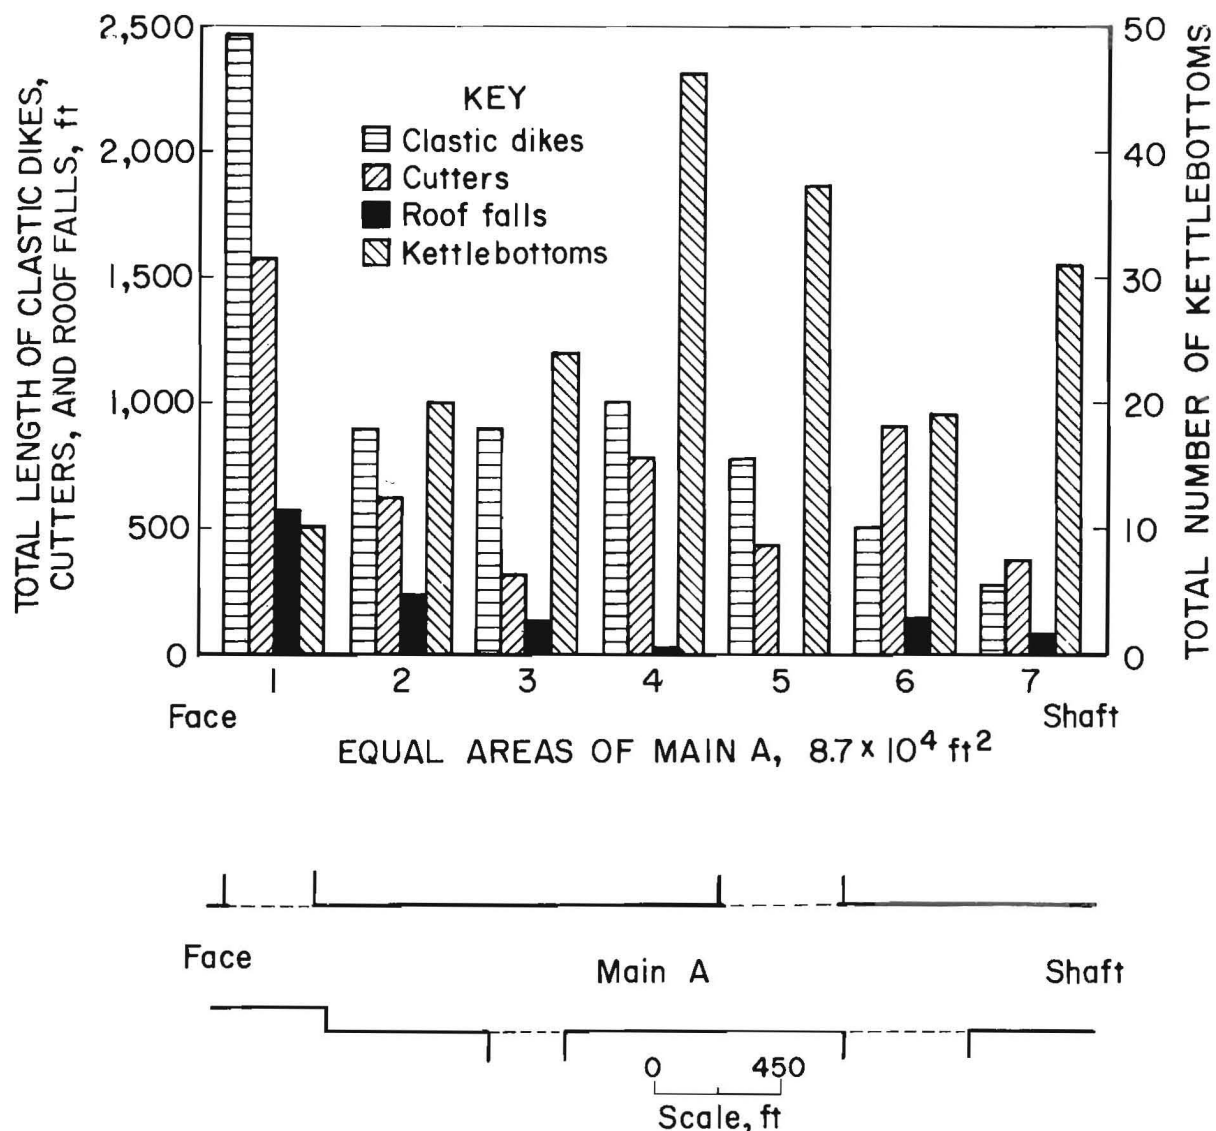
Figure 9 shows that the frequencies of clastic dikes and cutters were much greater near the face of Main A than near the shaft area. Main A was divided into seven equal areas of 87,000 ft<sup>2</sup> from the face to the shaft. The total lengths of clastic dikes, cutters, and roof falls in each area were calculated, then plotted on a histogram (fig. 10). This histogram shows that there was a gradual increase of both clastic dikes and cutters from the shaft to the face. Along with the increase in dikes and cutters is a corresponding increase in roof falls, a normally occurring and predictable trend. Also plotted on figure 10 is the total number of kettlebottoms found in each area. Kettlebottoms were found in all areas of the Main A headings, indicating that generally similar environmental conditions were present during coal formation of the entire area. The entirety of the mapping suggests that the stresses were greater in the area of the present mining face at some point in time, possibly due to the formation of the syncline causing more fissures and eventually, through infilling, more clastic dikes.

FIGURE 10.—Histogram of the geologic and deformational features in the Main A headings from the shaft to the face.

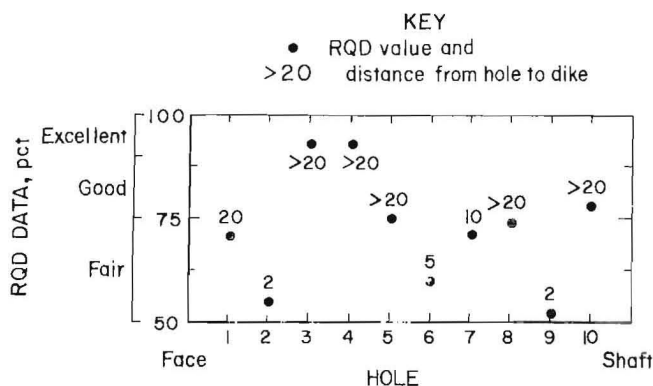
Two distinct correlations were found between RQD and roof conditions. First, when the overall RQD values for each hole were compared with mapped geologic and deformational features around the hole, a relation was seen between holes with low RQD values and the proximity to a clastic dike or cutter failure (figs. 6 and 11). Second, a relation was seen between low RQD values in areas of each corehole and the presence of a carbonaceous sandy shale which was consistently present in each hole approximately 5 ft above the coalbed. By combining these two correlations, the data suggest that roof bolts longer than 5 ft should be used, to ensure a solid anchor above the fractured zone. Based upon the Kalia system, maximum support should be employed when clastic dikes are present or where cutter failure has occurred, since the data also show low RQD values for these areas.

FIGURE 11.—RQD data accompanied by a number indicating the distance from the cored hole to a clastic dike or cutter failure in feet (9).

Otherwise, the roof is stable according to the Kalia system and should require only normal patterned bolting. The mapping of clastic dikes and cutter failure throughout the Main A headings supports these recommendations.

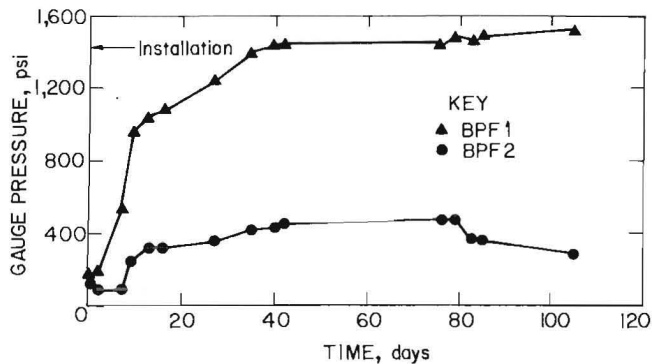
began, as mining exposed a clastic dike just inby the BPF's. BPF 1 measured pressure changes perpendicular to the heading of the entry. Six days later, both BPF's showed signs of increased loading as a cutter began to develop adjacent to the clastic dike just inby the BPF's (fig. 16). As the cutter progressed to the next outby clastic dike, the loading on BPF 1 continued to increase. By day 10, posts were installed for additional support. However, loading continued to increase on both BPF's, and roof conditions continued to deteriorate. On day 30, the entire entry had to be cribbed to control the roof. Loading eventually leveled off as the cribs took

FIGURE 16.—Pressure monitoring behavior of BPF's 1 and 2 (8).

the load, and the entry finally stabilized. Both BPF's responded as if the roof was acting as a cantilever beam with support on the southern pillar and the cutter along the northern pillar allowing the beam of the roof to bend. The cantilever beam effect is explained in detail in the "Roof Failure Analysis" section of this report.

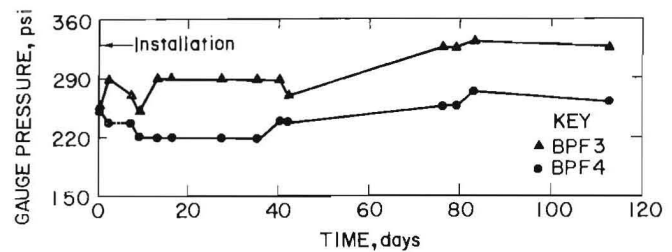
Loading of U-cell 1 and BPF 3 occurred as soon as the next 20-ft cut into the face was taken from the crosscut, exposing the two clastic dikes. BPF 3 detected pressure changes perpendicular to the entry and showed a total increase of approximately 35 psig in the first day, while BPF 4 bled off (fig. 17). Some natural bleedoff is expected as the hole deforms if there is no movement in the roof to apply pressure to the BPF or if extension occurs in the beam of the roof. By the second day, U-cell 1 (closest to the inby rib) showed an increase in load of nearly 290 psig as a cutter began to develop along the inby rib between the

FIGURE 17.—Pressure monitoring behavior of BPF's 3 and 4 (8).

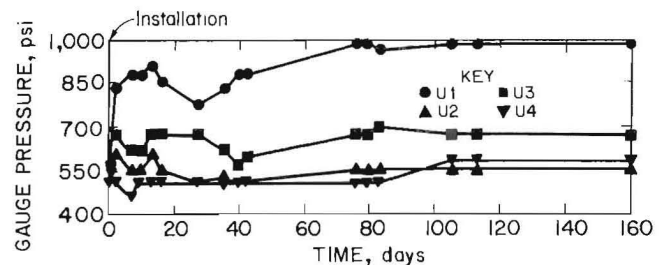
FIGURE 18.—Bolt load monitoring behavior of U-cells 1-4 (8).

clastic dikes intersecting the rib (fig. 18). From past experience with cutters developing this quickly, it was suggested that supplemental support be installed immediately. Trusses were installed between the rows of bolts (day 3), resulting in an immediate decrease in the rate of loading (fig. 19). The addition of trusses effectively reunited the natural beam of the roof and prevented the roof from deteriorating further. Finally, loading leveled off and the cutter did not become any more severe. Figure 20 summarizes the maximum load seen by each U-cell in the crosscut. Once again, the loading roughly paralleled that which would occur from a cantilever beam.

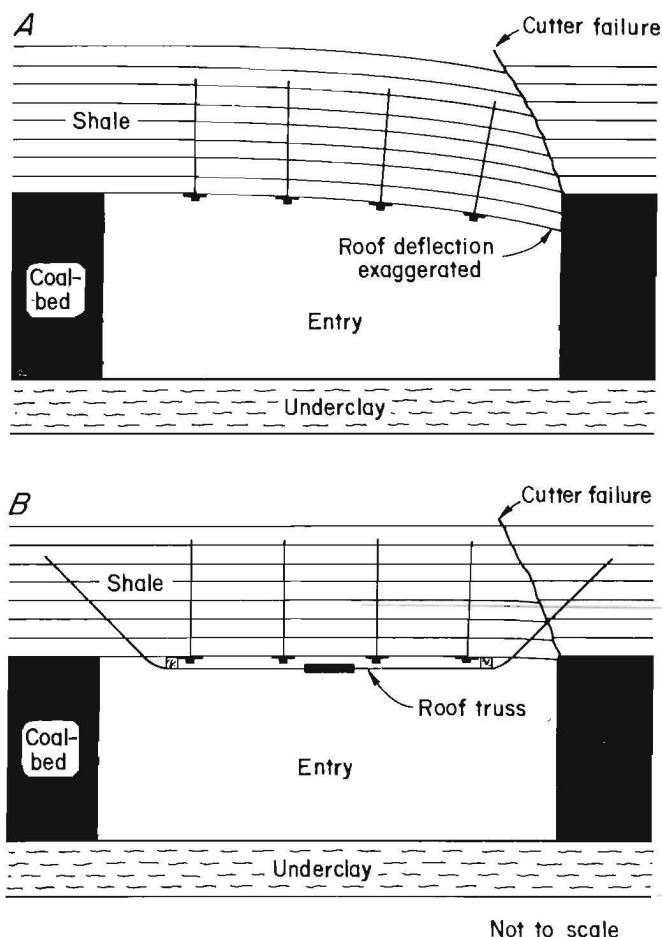
FIGURE 22.—Schematic of roof movement (cantilever beam) before and after installation of roof trusses.

Very little loading occurred on U-cells 6 and 8, while U-cells 5 and 7 actually bled off. Bleedoff of loading on bolts is natural if there is no new inducement of load (17). Figure 22 depicts what is suspected to be happening prior to and after roof truss installation. Just after mining and exposure of a clastic dike, the roof begins to sag, loose roof rock falls, and cutter failure initiates (fig. 22A). After the trusses are installed, the clastic dike, cutter, and

roof fractures are partially closed by the upward thrust and compressive forces transmitted to the strata by the trusses (18) (fig. 22B). Further roof movement and cutter formation are deterred by the introduction of shear strength across the plane of fracture, as witnessed by the absence of additional bolt loading.

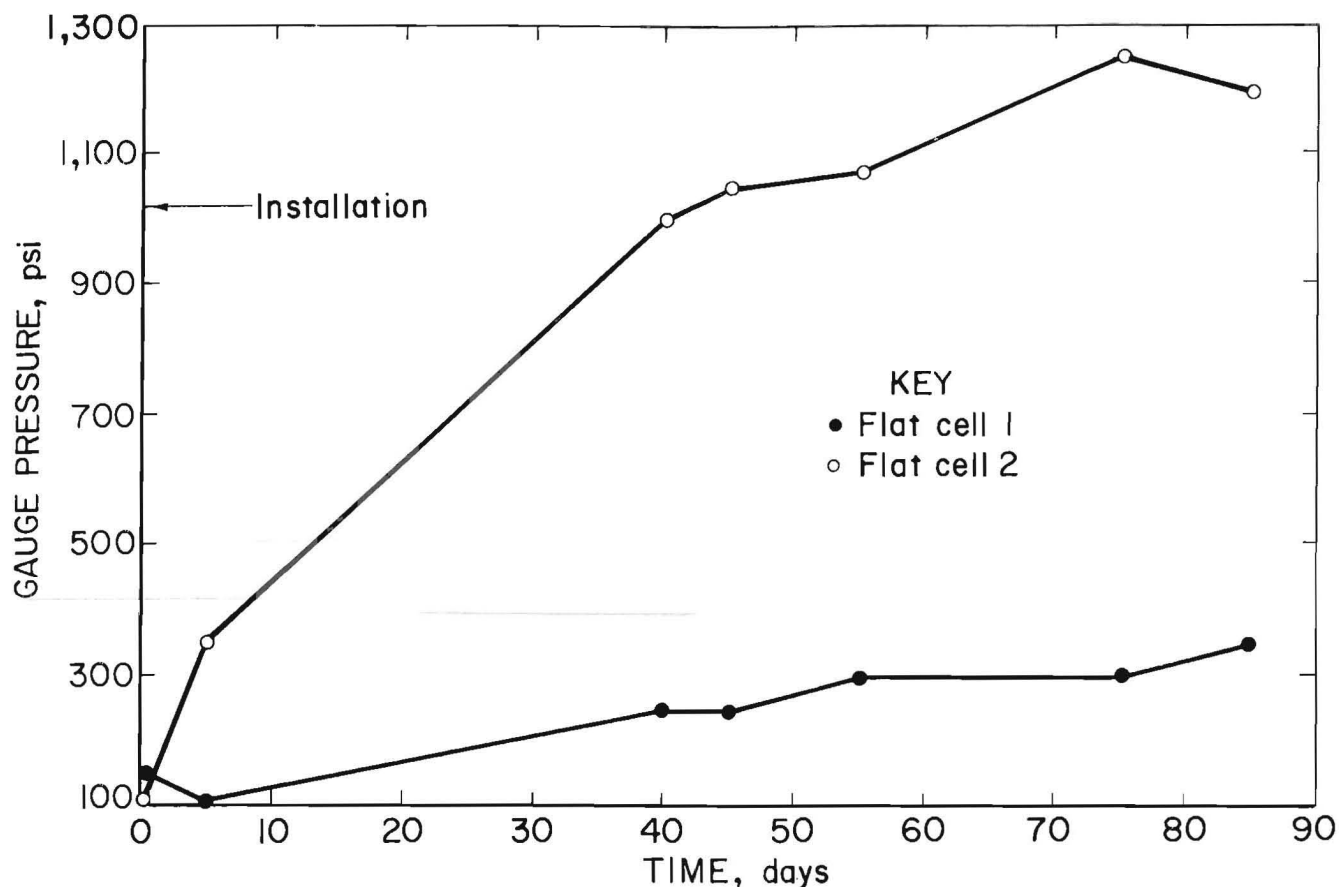
Steel-fiber-reinforced concrete cribs were monitored using flat hydraulic cells as shown in figure 23. Figure 24 shows the crib loading detected by two flat cells for approximately 3 months. Flat cell 2 was installed on a crib that eventually was overridden by a cutter. The large increase in load it measured resulted from the cantilever beam effect (roof deflection) as the cutter developed.

FIGURE 24.—Crib load monitoring behavior of flat cells 1 and 2.

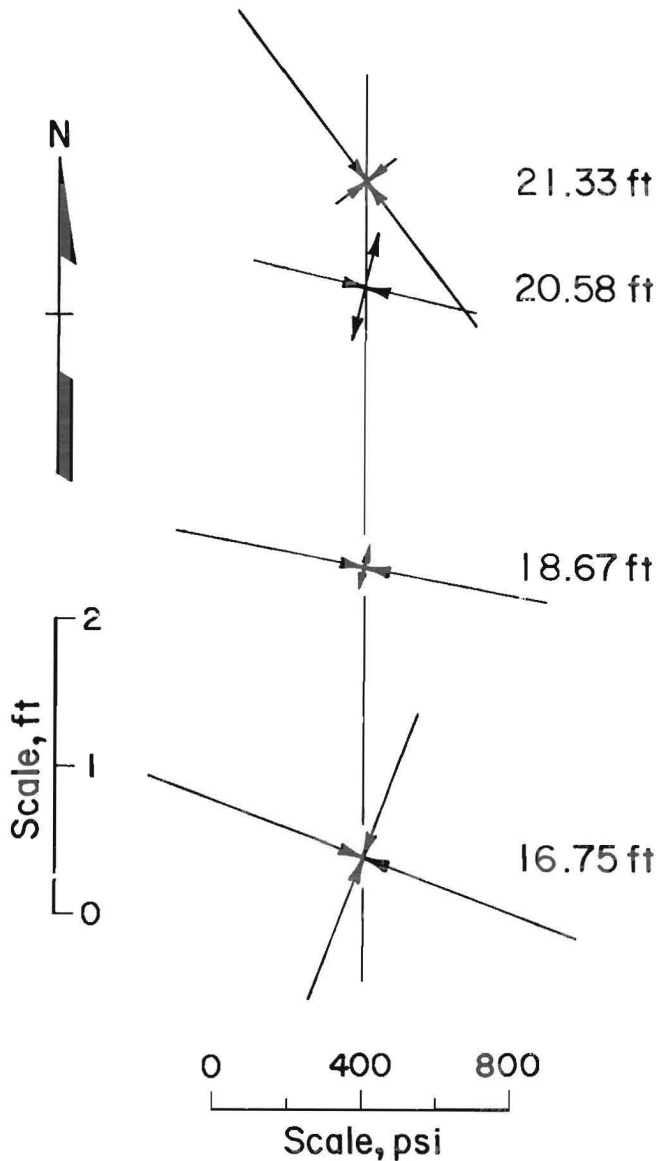
The site, adjacent to corehole 2, was selected because of its proximity to the mine areas experiencing the most cutter failure (fig. 6). Four complete measurements were made at depths from 16.75 to 21.33 ft into the mine roof. The results are summarized in table 3 and figure 25.

In general, the measured stresses appear insufficient to initiate cutter failure on their own. They have, however, influenced the angle of fracture propagation into the roof. The ratio of horizontal stress to vertical stress will dictate the inclination of the plane of

FIGURE 25.—Vector plot in situ horizontal roof stress measurements. Feet is depth into the mine roof. North arrow for reference to orientation of stress measurements.

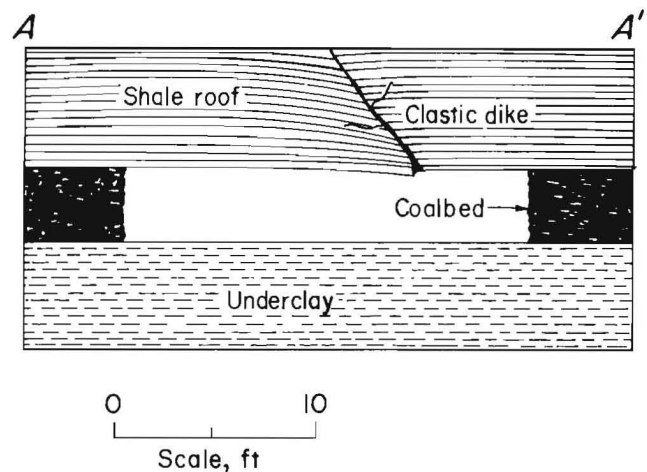
Observations made during mapping revealed that cutters mainly formed adjacent to clastic dikes shortly after mining. This suggested that the disruption of roof integrity, due to the presence of clastic dikes, contributed to the propagation of cutters. The natural beam of the roof rock, spanning from pillar to pillar, is severed when a clastic dike is present, causing the roof to behave as a cantilever beam (fig. 27). In most cases, the cutters formed at the obtuse angle of the clastic dike-rib intersection, propagating inby or outby depending on the situation. They initiate at this location because it is where the maximum load on the beam occurs and thus is the most susceptible failure point.

FIGURE 27.—Schematic of cantilever beam effect that occurs during cutter roof failure (8).

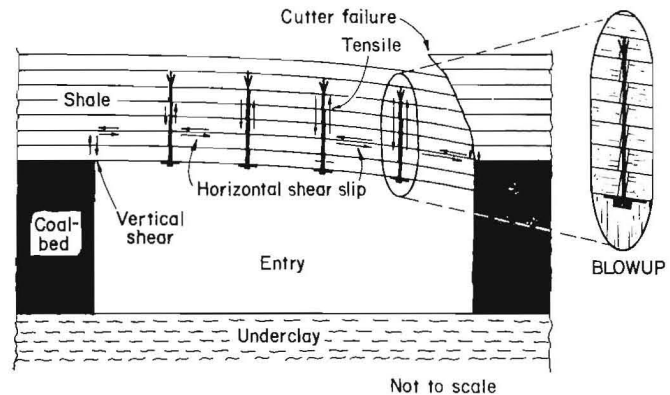
horizontal shear slip at the free end of the beam (fig. 29) (21-22). An increase in bolt loading (tension) will be induced by the shear slip only, because the bolts do not extend through the beam and into the solid roof above.

FIGURE 29.—Schematic of forces in roof strata subject to cantilever beam failure.

This cantilever beam scenario was evident in the results of the rock pressure monitoring. Increased bolt loading was measured as cutter failure progressed, with the maximum increase found next to the cutter (the free end of the beam where the shear slip was greatest). Decreased loading was detected after trusses were installed, a result of reducing the shear slip by eliminating some of the downward deflection of the cantilever beam. Additionally, the pressure increases in the roof strata measured by BPF's were indicative of a cantilever beam. The BPF's were detecting the shear slip along the bedding planes parallel to the beam. Thus all measurements and observations support the contention that the roof is failing as a cantilever beam.
