REPORT OF INVESTIGATIONS/1989

Effects of Structural Faults on Ground Control in Selected Coal Mines in Southwestern Virginia

By Gregory M. Molinda and David K. Ingram

BUREAU OF MINES

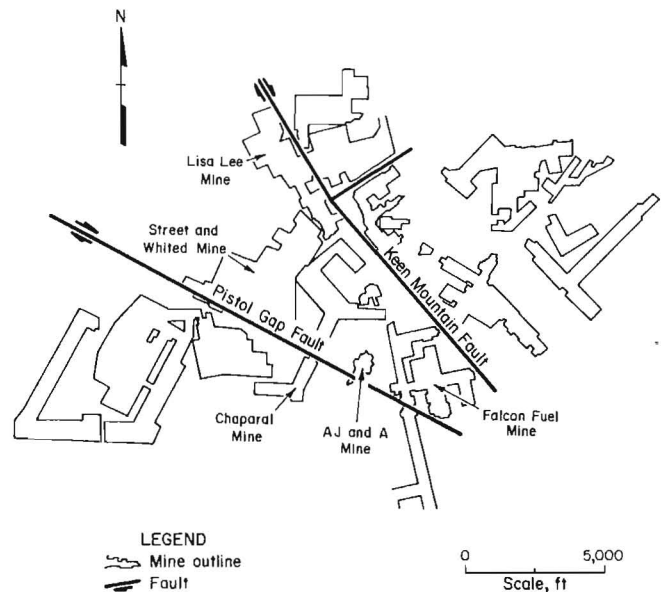
The Falcon Fuel Mine, a contract mine to United Co., has been severely affected by the Keen Mountain and Pistol Gap Faults (fig. 4). This mine works the Jawbone Coalbed.

Figure 4.—Mines in study area affected by Keen Mountain and Pistol Gap Faults.

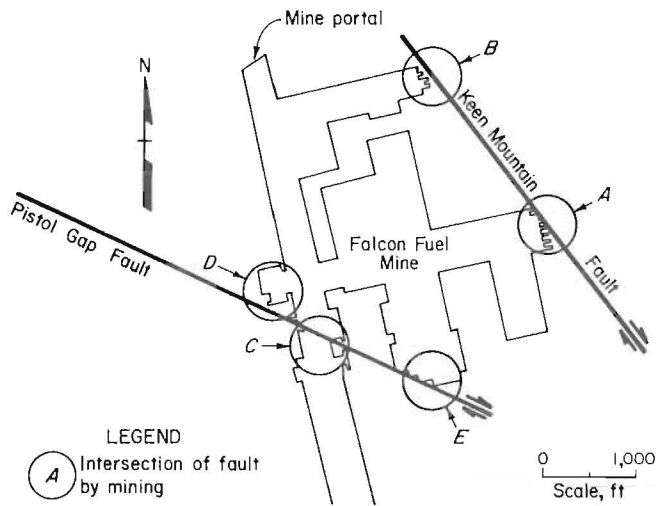
The Falcon Fuel Mine is truncated to the northeast by the Keen Mountain Fault. At location A, a seven-entry section was terminated by the truncation of the coalbed against the fault (fig. 5). Poor roof conditions and lack of coal are reported by the operator to be the causes of termination. The other development that intersected the fault is at location B (fig. 5). This five-entry section stopped against the fault trace. Exact conditions of disruption are unknown because all of the eastern developments are sealed to entry and are inaccessible for observation.

Figure 5.—Falcon Fuel Mine with developments affected by Keen Mountain and Pistol Gap Faults (circled).

At approximately 2,800 ft in by the portal, the mine first encountered the Pistol Gap Fault (figure 5, location C). The operators withdrew because of adverse roof conditions and began driving a four-entry development to the southwest (figure 5, location D). After approximately 400 ft, the development was halted as the mine again intersected the Pistol Gap Fault zone. The operators did not know at the time that the two discontinuities were the same fault zone. The southwestern development was discontinued and developments were begun to the east.

The Falcon Fuel Mine intersects the Pistol Gap Fault in several other locations (fig. 5). At location E, an 11-entry section intersected the fault, which trends N. 36° W. Roof conditions were too poor to continue and the section was stopped.

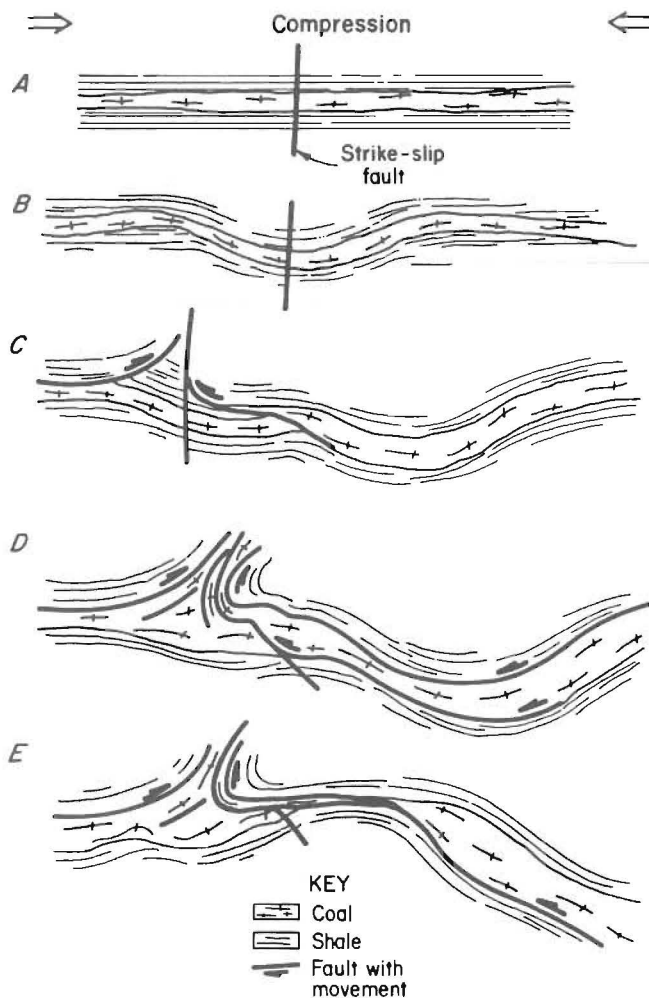
Figure 11.—Interpretation of events in formation of bedding plane faults due to lateral compression. Section A is the coalbed with the strike-slip fault; sections B-D are subject to increasing lateral compression until complete failure in section E.

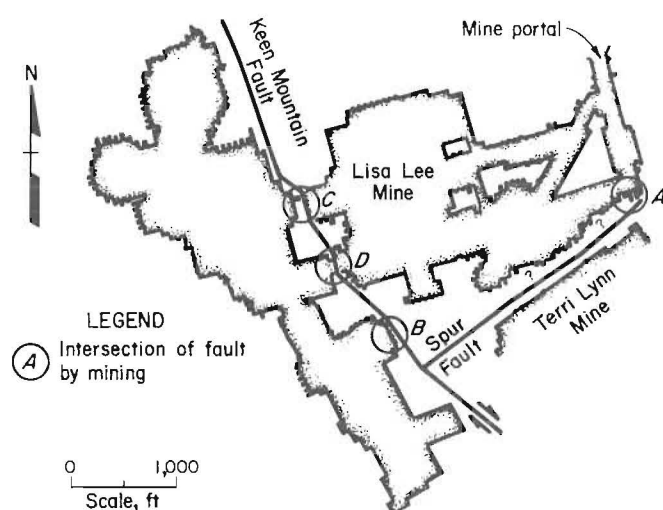
Figure 19.—Lisa Lee Mine outline and areas (circled) affected by Keen Mountain Fault.

The Keen Mountain Fault is intersected by the Lisa Lee Mine in four places. The northeastern driving section at location B was completely stopped when it intersected the fault (fig. 19). The coalbed "ran out," and no attempt was made to drive through the zone and relocate the coal. At location C, a six-entry development was narrowed to one entry in crossing the fault. This single entry causes a severe restriction to ventilation. In addition, poor roof conditions occur at this fault intersection. The Keen Mountain Fault continues northwest through location C but is not again exposed because the Jawbone Coalbed splits are too thin to mine.

At location D (fig. 19), the Keen Mountain Fault intersects mains, which provide access to the western side of the mine. Here, an eight-entry development was necked down to three entries to cross the fault zone. The effects of the fault were mapped in detail at this crossing. Figure 20 shows part of the fault zone in cross section at location D. The zone is approximately 200 ft wide and consists of a bedding plane thrust fault and numerous roof fractures, which do not offset the coalbed, and a large coalbed swag. The main coalbed offset is 48 to 51 in, and the bed is downbuckled to the northeast. The main fault runs along bedding on the northeastern side of the offset for an

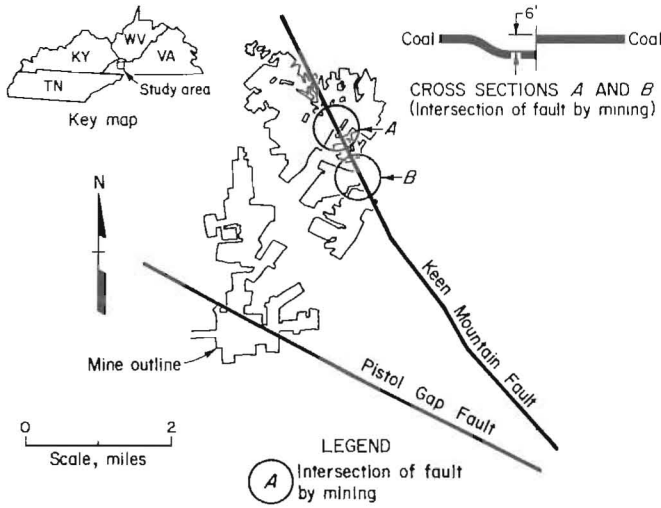
Seven coalbeds in the study area have been heavily mined and are affected by the Keen Mountain and Pistol Gap Faults. All coalbeds are above drainage and are worked mainly by small operations (5- to 20-person). Mining in the Kennedy Coalbed is shown in figure 22. At location A, the Keen Mountain Fault offsets the coalbed by 6 ft (8). The affected zone is 200 ft wide and shows the characteristic swag on the southwestern side. At location B, the same feature truncates another mine. The swag is also on the southwestern side of the fault.

Figure 22.—Extensively mined Kennedy Coalbed affected by Pistol Gap and Keen Mountain Faults.

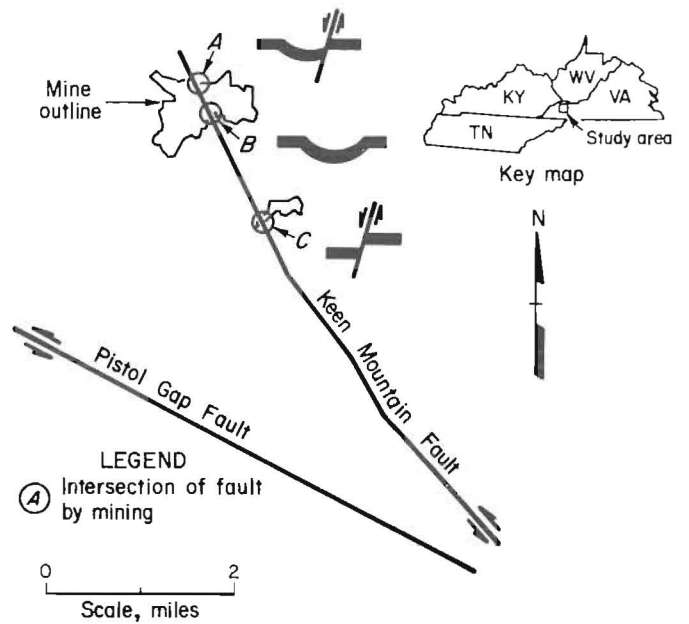
The Splashdam Coalbed is stratigraphically the highest coalbed being mined in the study area. In several instances, the Keen Mountain Fault has affected mining in this coalbed (fig. 23). In addition, the type of displacement varies between tensional, compressional, and shear movement. At location A, the coalbed is displaced 3 ft with a swag on the southwestern side. The offset is a normal tensional break with the southwestern side downdropped. At location B, the fault does not offset the coalbed but occurs as a swag, approximately 200 ft wide. The coalbed has not failed here but has only been downbuckled. This indicates not only the intensity but that the type of movement on the fault has changed in slightly over 1,000 ft. At location C, the fault was exposed in a strip mine highwall. This offset was a normal tensional break with about 3 ft of offset (figure 23, western side down-dropped). The fault was actually a zone about 200 ft wide with zones of vertical fractures spaced every 20 ft. There is another highwall exposure of the fault shown in figure 24. Here, the offset is a normal tensional offset of about 18 in.

Figure 23.—Exposures of Pistol Gap and Keen Mountain Faults in mined-out Splashdam Coalbed.

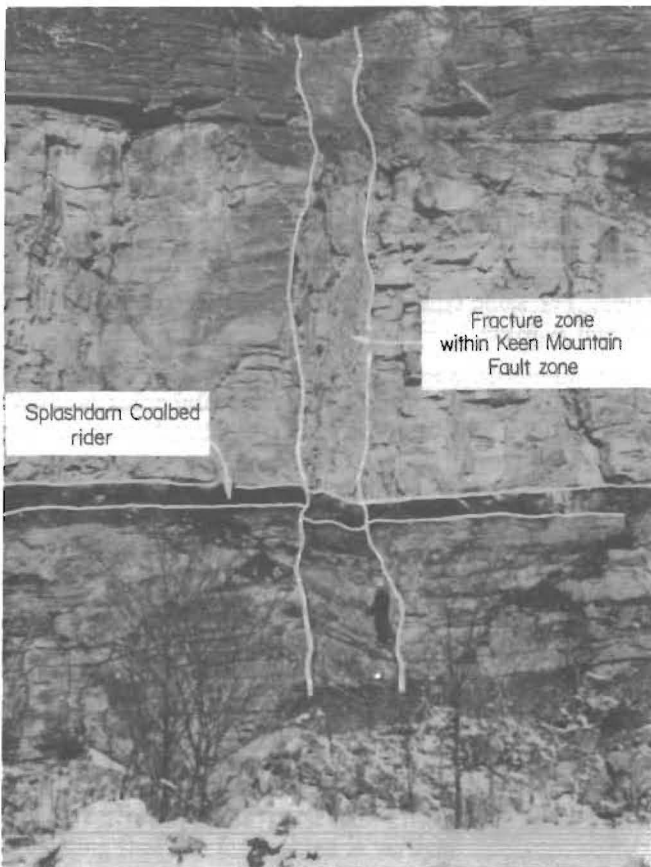
Figure 24.—Keen Mountain Fault zone exposed in highwall of surface mines.

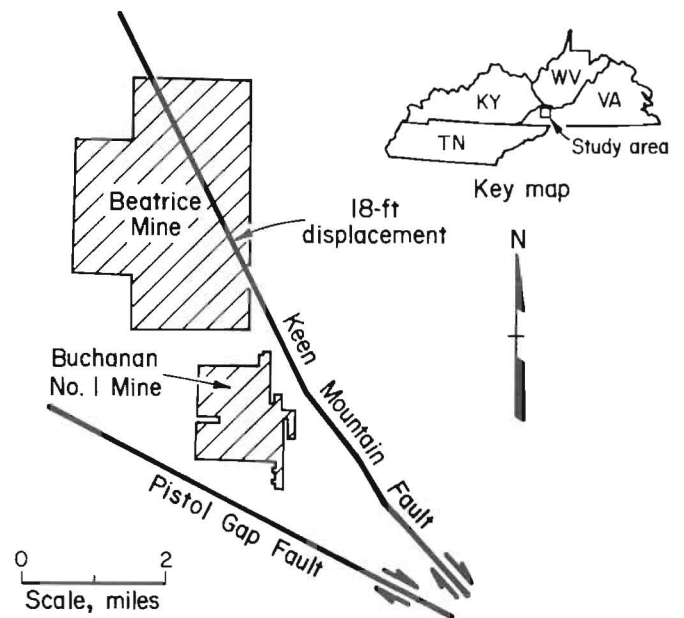
The Keen Mountain Fault appears to have a much larger displacement at greater depth from the surface (>1,500 ft deep). The Pocahontas #3 Coalbed at Island Creek Coal Co.'s Beatrice Mine (now closed) had been displaced up to 18 ft by the fault (5) (fig. 25). Preliminary seismic information from above Consolidation Coal Co.'s Buchanan No. 1 Mine, also in the Pocahontas #3 Coalbed, indicates up to 20 ft of displacement (9). At all exposures, strike-slip movement is indicated by slickensides and fault gouge.

Figure 25.—Shaft mines in Pocahontas #3 Coalbed (deepest mined) affected by Keen Mountain Fault.

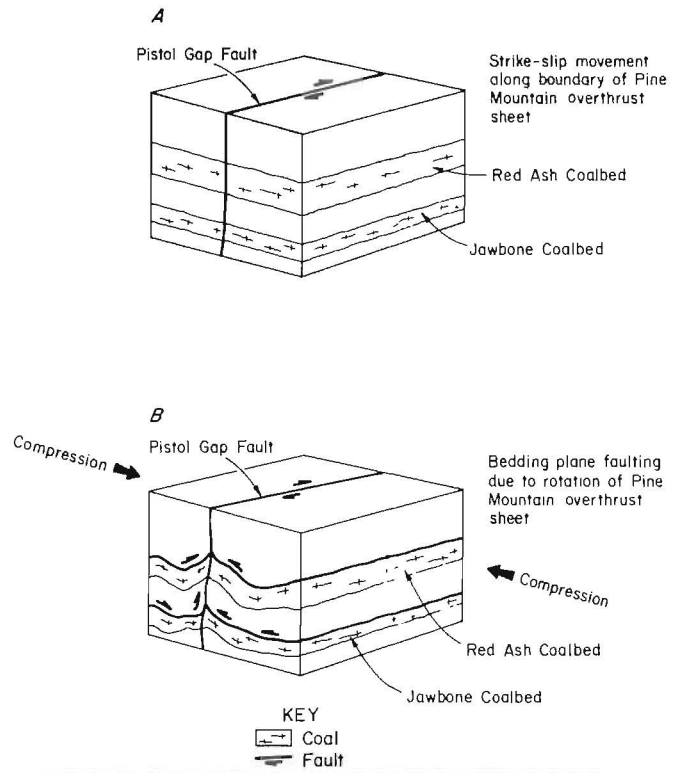
Figure 26 is an interpretation of the two stages of faulting believed to have occurred on the Pistol Gap and Keen Mountain Faults. Figure 26A shows simple strike-slip movement as a result of northwestern-southeastern compression. Figure 26B shows later bedding plane faults and deformation as a result of compression due to rotation of the Pine Mountain sheet. A northeastern-southwestern compressional stress field caused thrust faulting to occur along weak interfaces (bedding planes and coalbeds). The Pistol Gap and Keen Mountain Faults are the points at which compressional stress was relieved by vertical coalbed

Figure 26.—Block model showing sequence of coalbeds subjected to lateral forces, causing coalbed buckling and bedding plane and vertical failure at Pistol Gap and Keen Mountain Faults.

failure, as seen in the Chaparal Mine and the Falcon Fuel Mine. The same type of failure is seen 170 ft higher in the AJ and A Mine.
