RI 9267

REPORT OF INVESTIGATIONS/1989

Hillseam Geology and Roof Instability Near Outcrop in Eastern Kentucky Drift Mines

BUREAU OF MINES

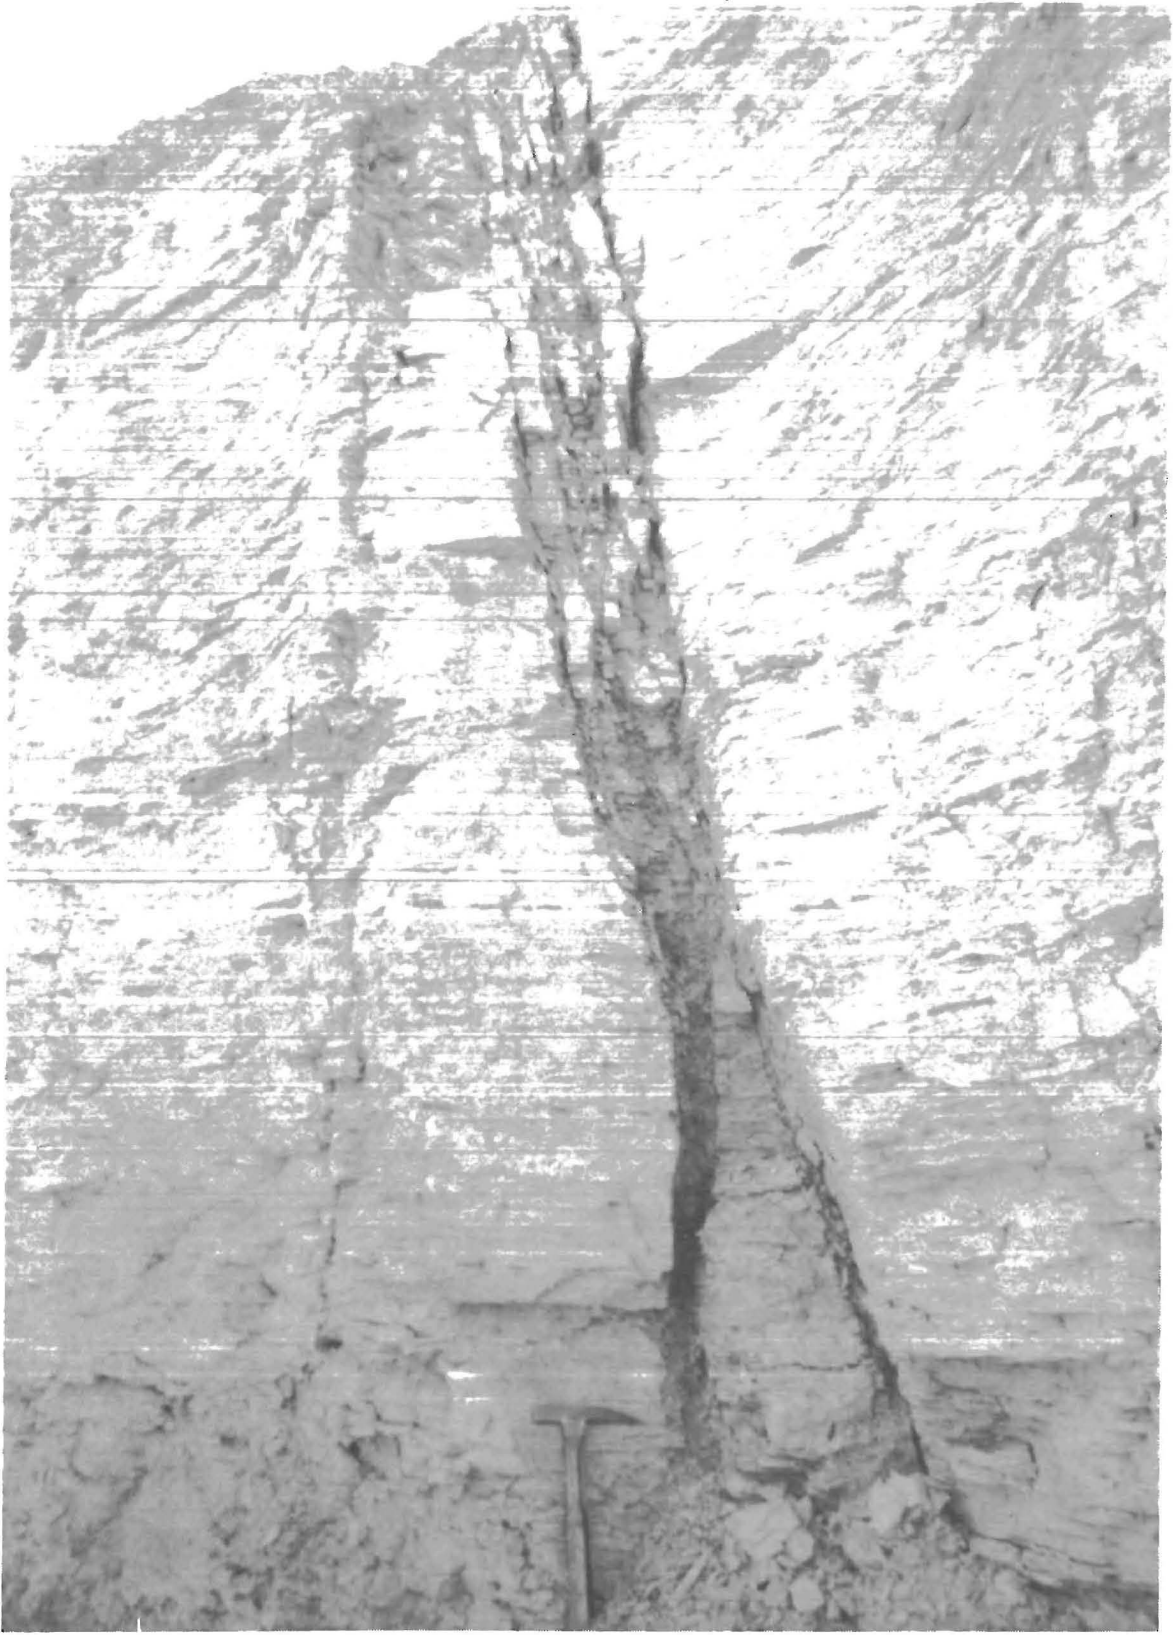
Hillseams vary widely in character. They commonly consist of a near-vertical joint or zone of closely spaced joints that are weathered, as indicated by iron oxide discoloring, mud, or softening of the adjacent rock. Figure 6 shows a common type of hillseam in outcrop. The intensity and width of weathering varies greatly with rock

Figure 6.-Parallel weathering exposed in silty shale highwall.

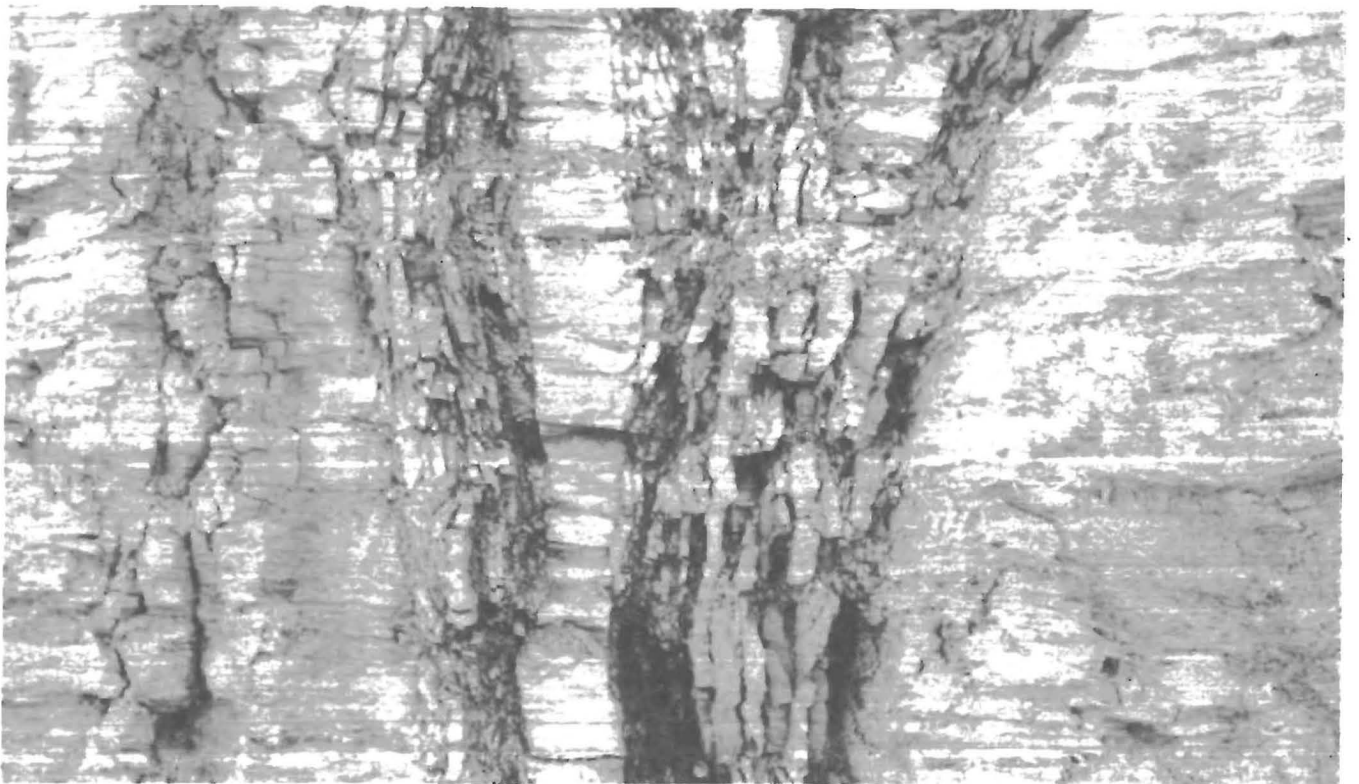
Hillseams range from little more than an iron- or mud-stained crack in the mine roof to zones 1 to 2 ft wide consisting of intensely weathered rock, or rock fragments and mud. Many hillseams appear to be narrow zones of closely spaced, weathered joints (fig. 8), but in reality, originate as a single joint. Weathering progresses irregularly into the walls of the joint, separating parallel slabs of rock in progressive stages (fig. 9).

Figure 8.—Details of hillseam structure.

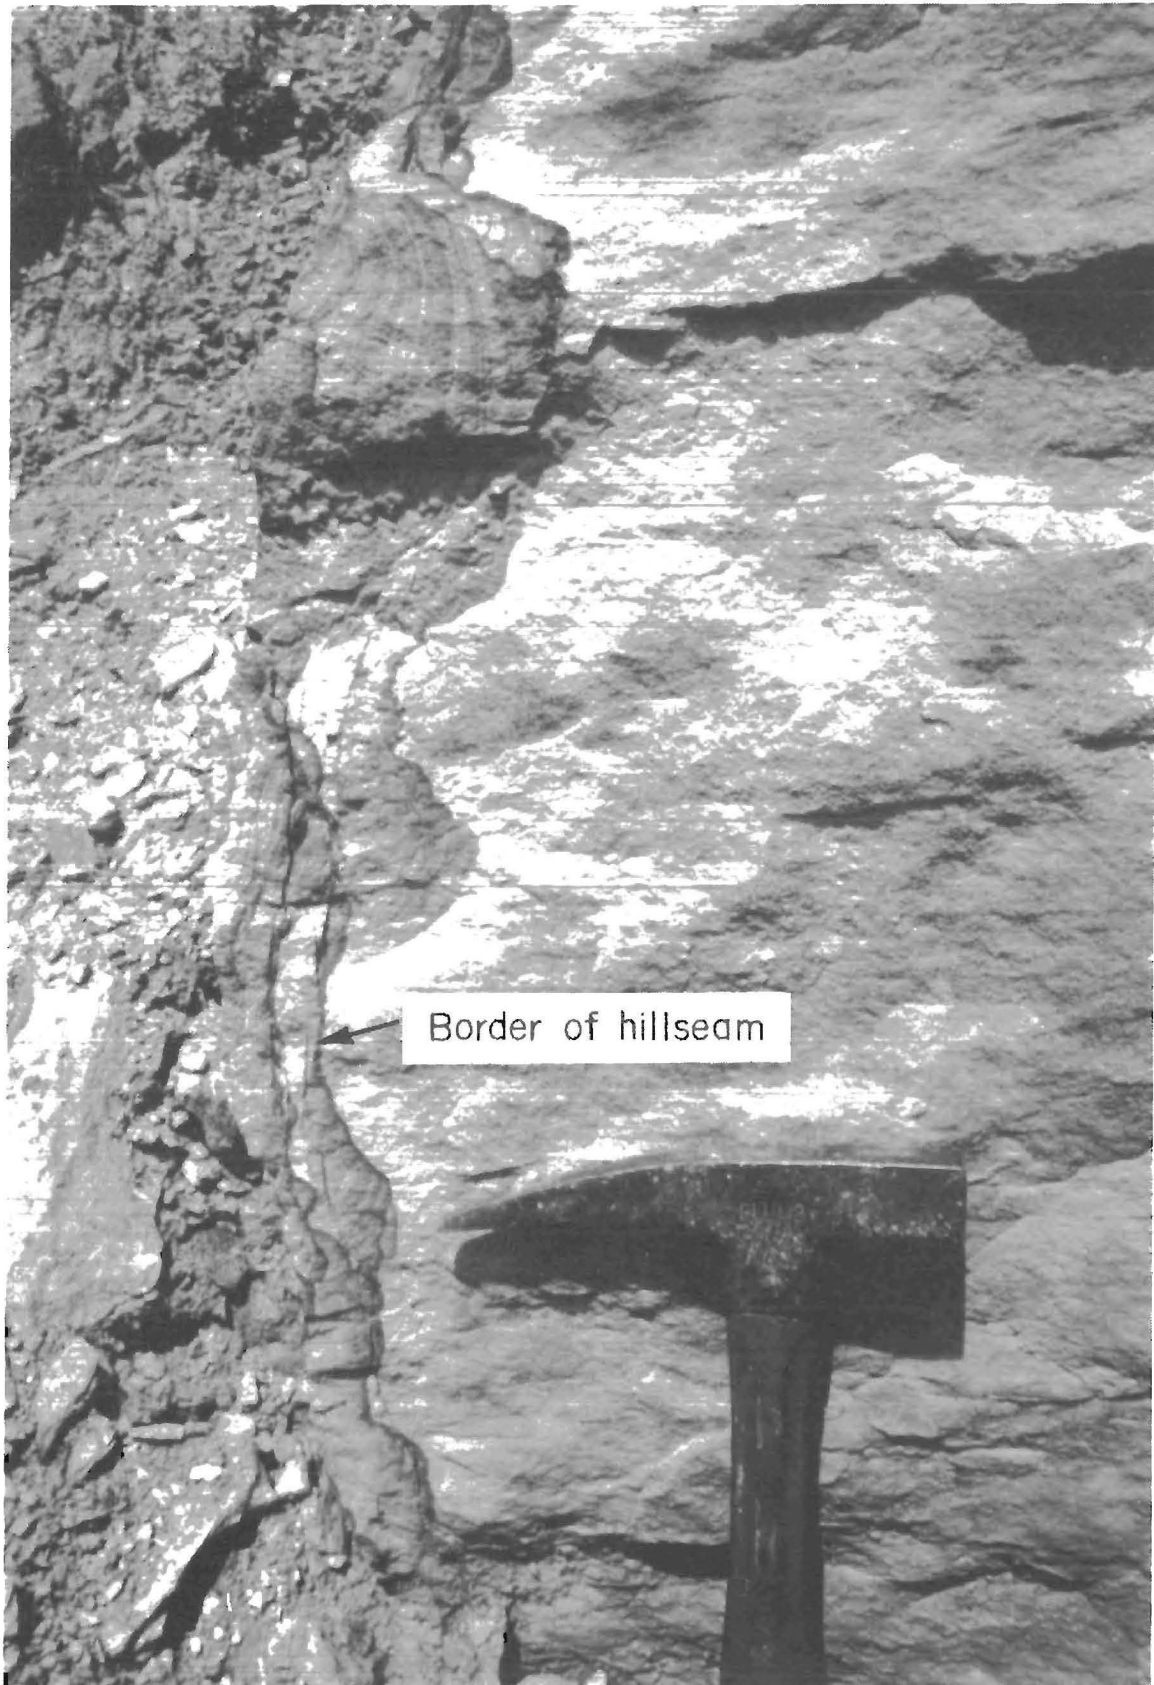
Figure 9.-Incipient parallel weathering in hillseam formation.

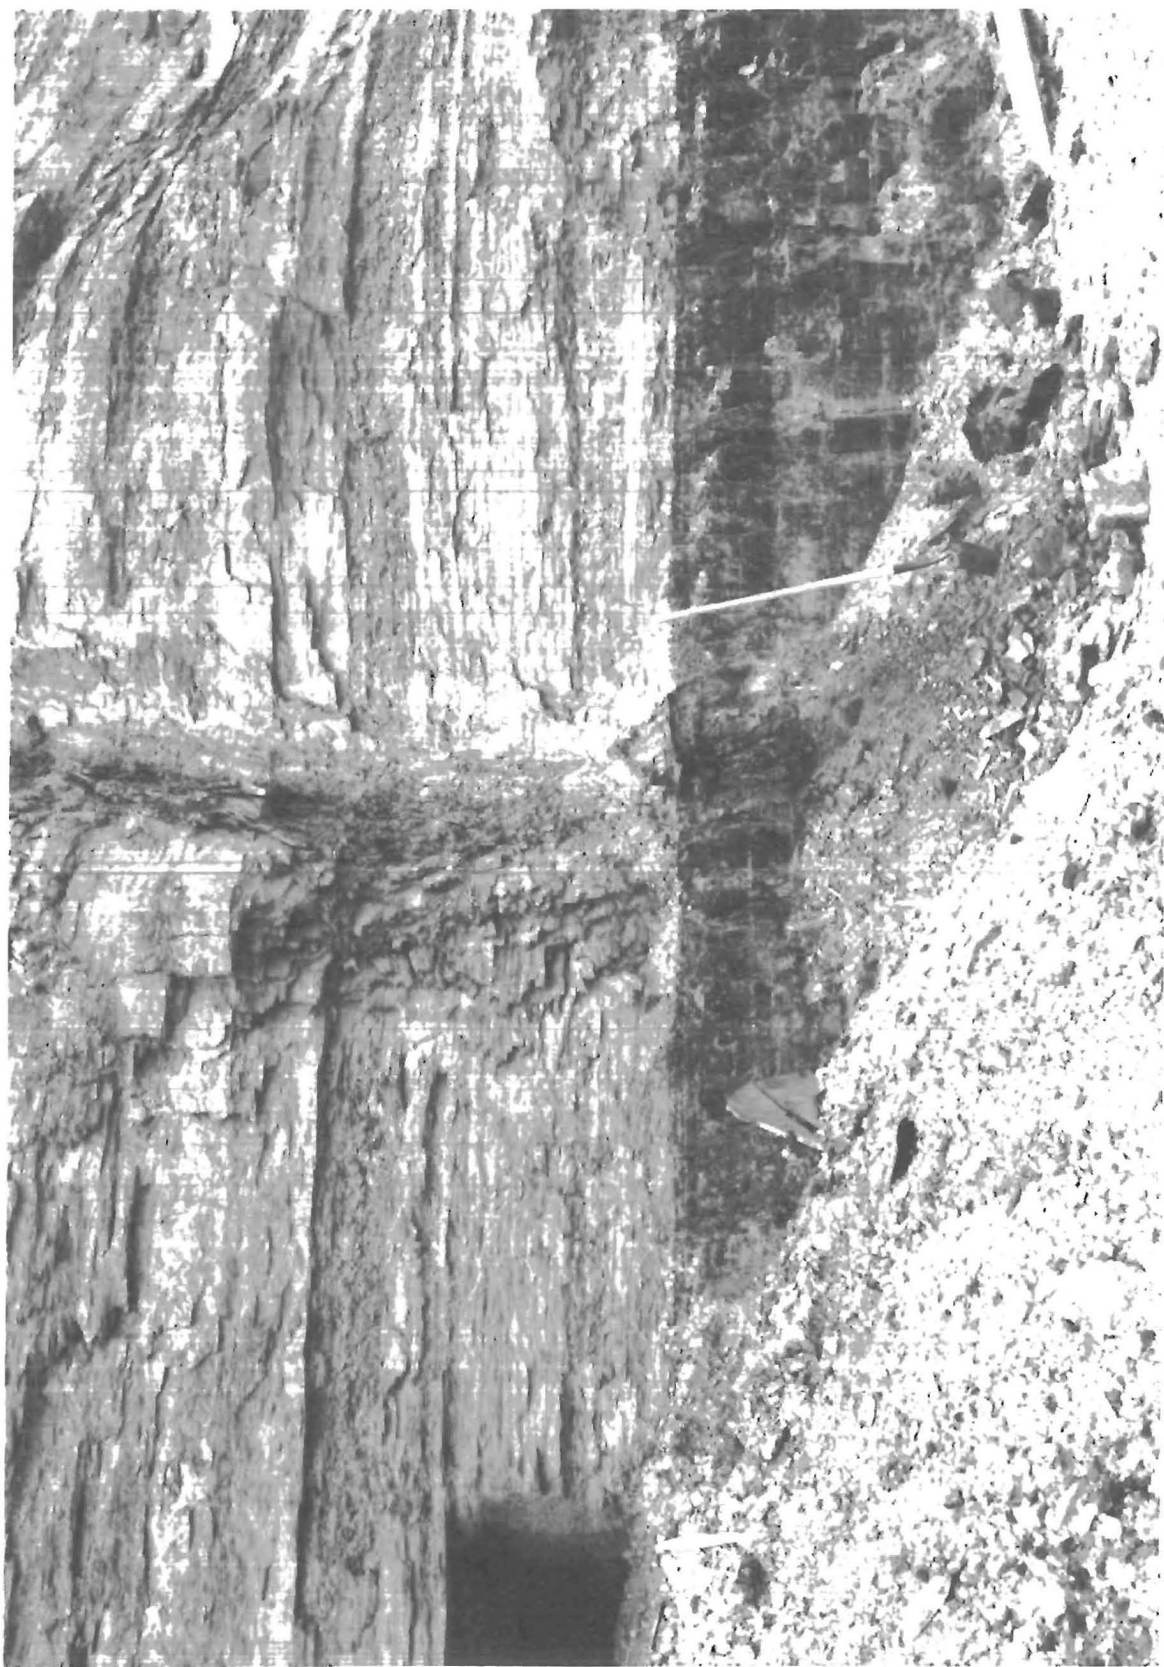
The character of a hillseam and the intensity of weathering can change abruptly along strike, or remain constant for many feet. Most hillseams are straight, but a few are curved. Some gradually diminish along strike and disappear, some are terminated by other hillseams, and others intersect (fig. 10). Hillseams almost always terminate against a coalbed, or continue through the coal as a minor fracture, and reappear in the strata below (fig. 11).

Figure 11.-Hillseams terminating at coalbed.

This is attributed to the contrast in mechanical and weathering properties between the coal and the surrounding sandstone or shale.

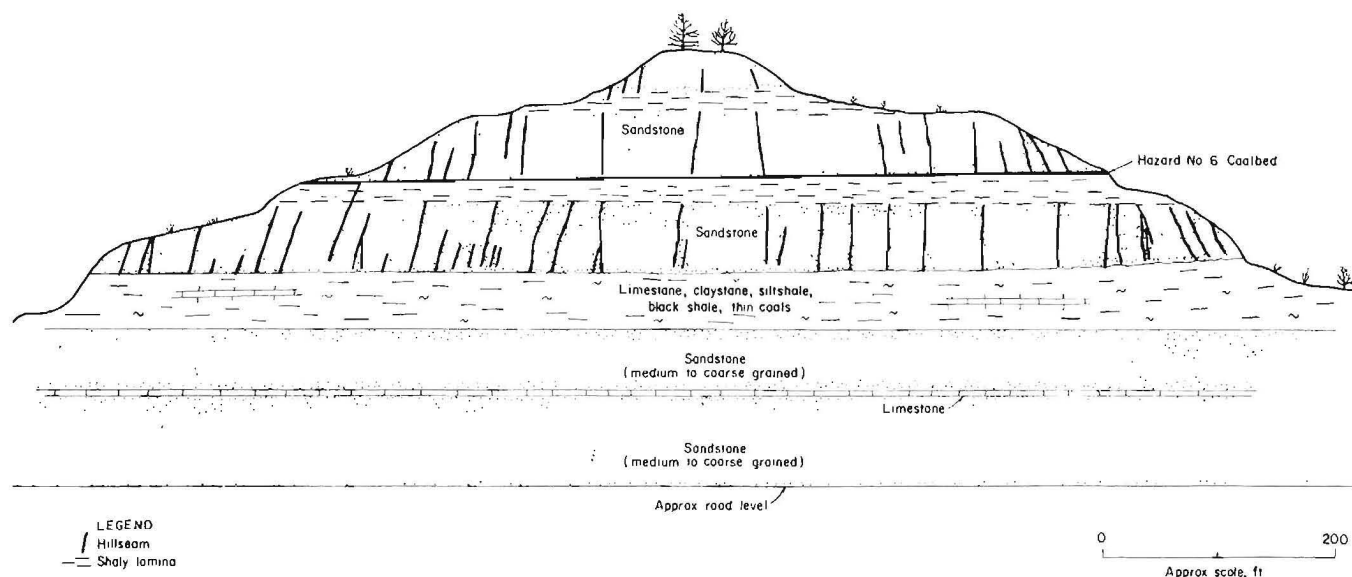
The hillseam exposures at site 3 are in a large roadcut (some 250 ft high) along Route 80 near Martin, Floyd County, in interbedded shales and sandstones (fig. 14). The trend of the roadcut, N 20° E, is generally perpendicular to the trend of the topographic ridge and

Figure 14.—Highwall exposure in Route 80 Martin roadcut.

the overall trend of the surface contours. The preferred direction of the hillseams, about E-W (fig. 12), closely parallels that of the surface contours. No common rock joints were observed and no relation to coal cleat or local structure was evident.

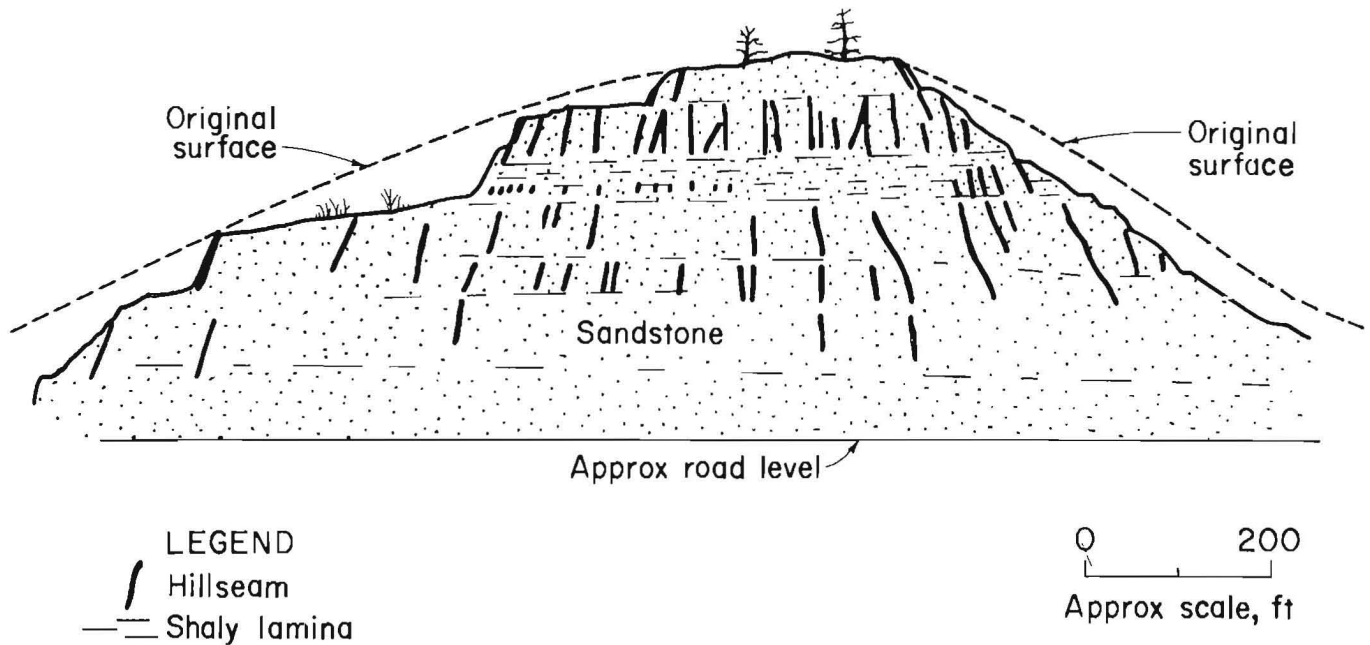
Figure 16.—Highwall exposure in Pikeville canyon roadcut.

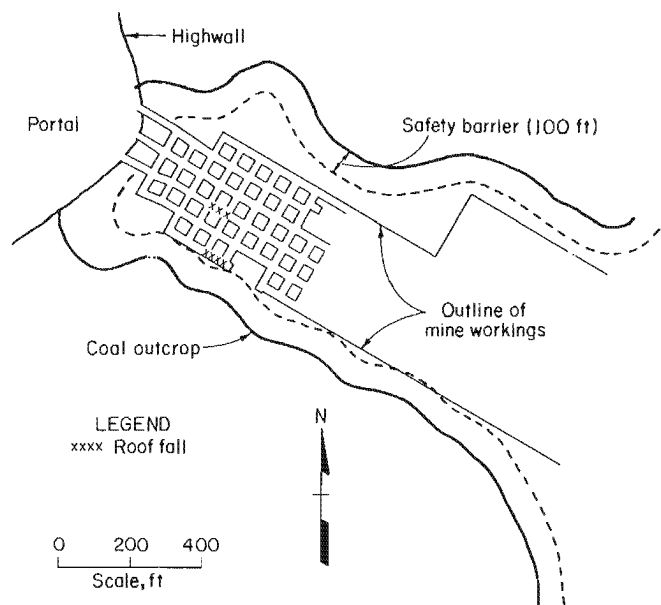
Summary: The portal of this mine was driven into the nose of a ridge and advanced for 1,500 ft parallel to the topographic contours on each side of the ridge (fig. 20). Hillseams were abundant for the first 100 ft inby the portal; however, some persisted parallel to the main entries for over 300 ft and contributed to the collapse of a large section of roof. Further inby the outcrop, the roof was largely free of hillseams because of the greater thickness of overburden.

In one area of the mine, the outer entry of the mains was adjacent to the 100-ft-wide outcrop barrier. Hairline cracks in the roof were the first indication of roof support problems. As the entry was advanced, the cracks gradually increased in width and intensity of weathering until two intersecting hillseams were exposed that followed the trend of the entry and the contour of the ridge.

Figure 20.—Map of example 1 mine workings.

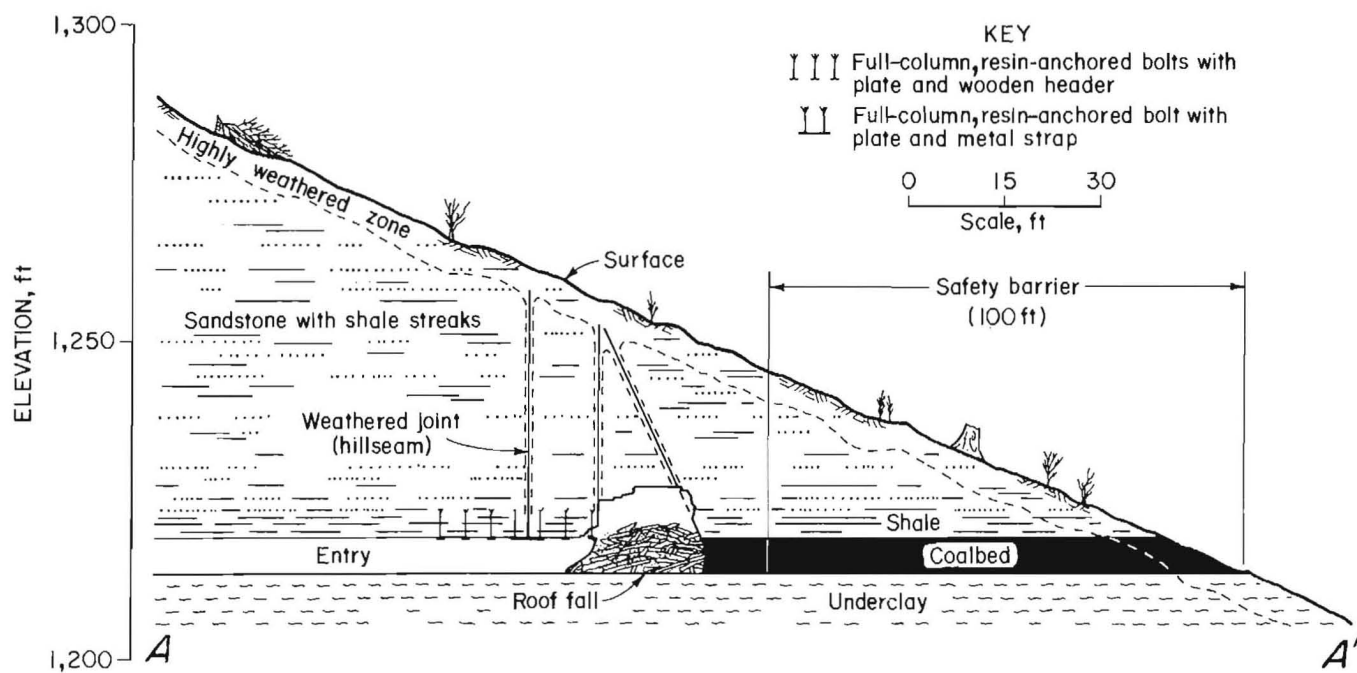
This example of hillseam related roof failure is common in situations where the entries tend to parallel the surface contours and failure occurs in long massive wedges of roof. The overburden at this roof fall site was about 40 ft (fig. 24).

Figure 24.—Overburden profile at example 1 mine.

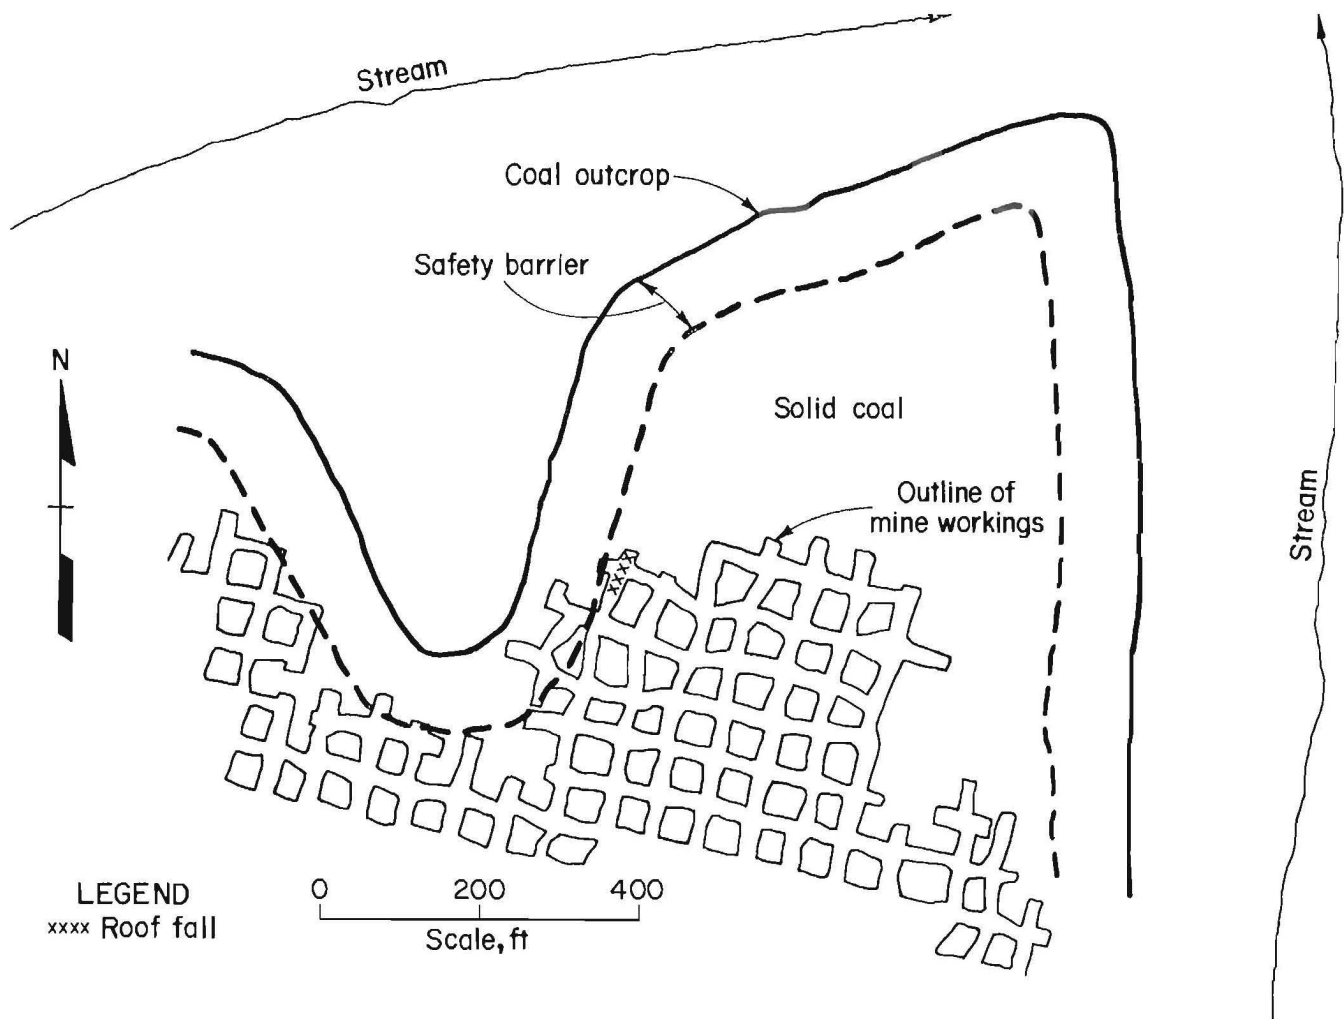
Summary: The portal of this mine was driven into a strip mine highwall 600 ft from the head of a small stream valley. The mine workings were advanced for some 1,500 ft to the safety barrier surrounding the periphery of the property (fig. 25). Hillseams were encountered in the portal area and again at two locations near the barrier 1,500 ft in by the portal. At one location, entries were stopped 70 to 100 ft short of the barrier because of hazardous roof related to hillseams. At a second location, a breakthrough was being mined when a massive block of roof collapsed into the intersection without warning, instantly killing a miner. The roof was weakened by two

Figure 25.—Map of example 2 mine workings.

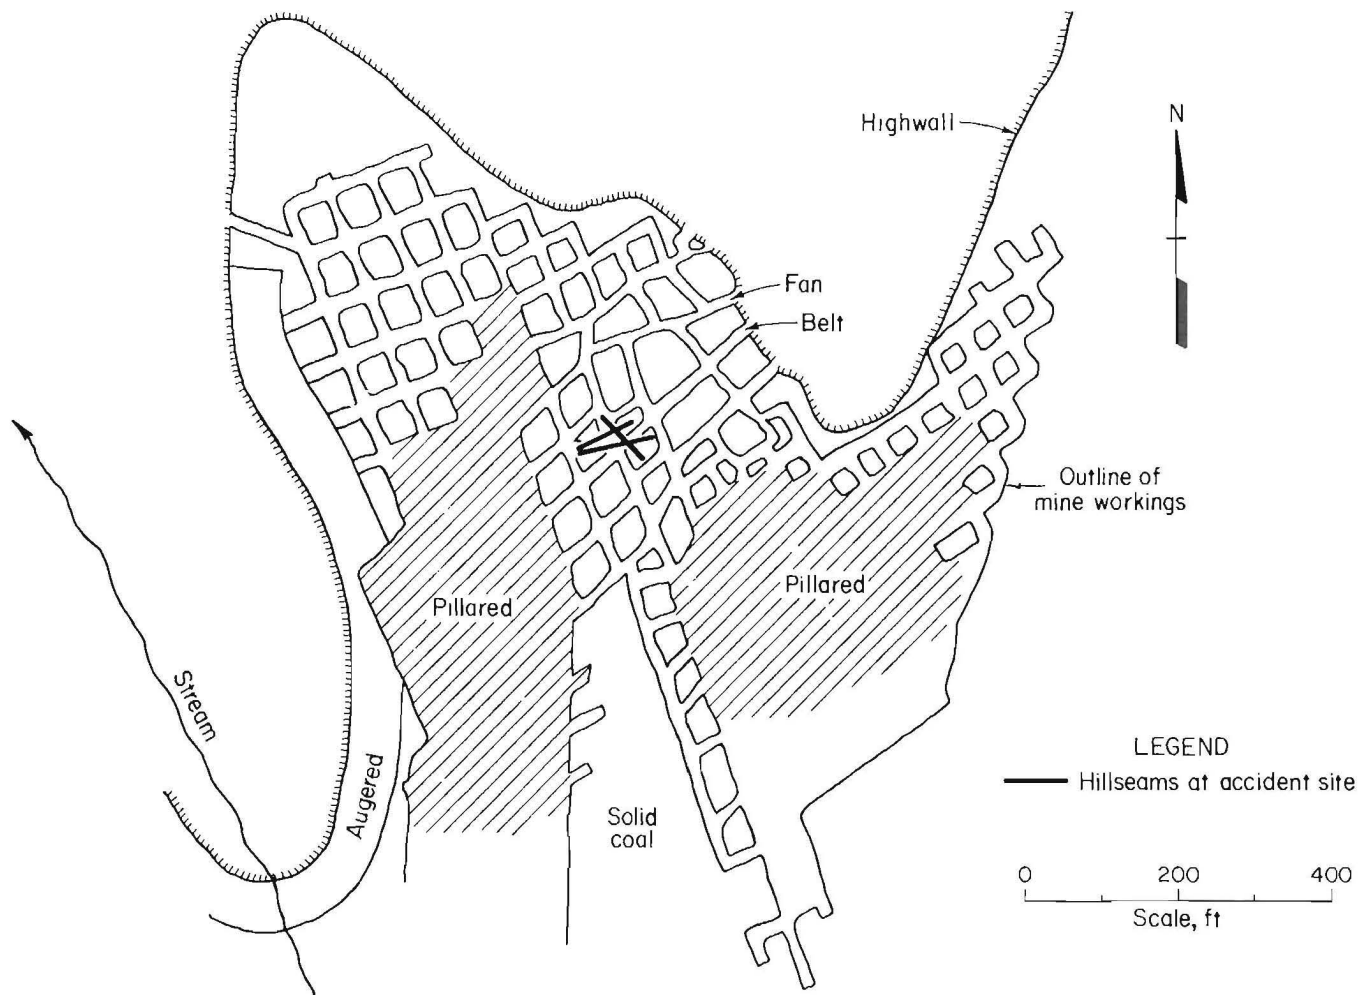
Summary: This drift mine was opened at a highwall on the side of a ridge and developed under the nose of the ridge (fig. 28). Retreat mining with full-pillar extraction was in progress using breaker posts. The scoop was removing the last remaining coal from the punchthrough of a pillar split. A hillseam along the inby (south) rib was inspected a short time before, but it showed no movement.

Small fragments of rock began to dribble from one of three hillseams located at the intersection opening into the pillar split. Immediately thereafter, the roof between the hillseams collapsed with a loud rasping noise and sparks were emitted from the ruptured metal straps that were installed across one of the hillseams.

The roof fall size was 35 by 22 by 1 to 5 ft and weighed an estimated 95 st. A scoop operator was trapped in the scoop cab by the fall for 2 h. A miner who was observing the roof while the scoop was loading coal was caught under the edge of the fall and fatally injured. The accident was attributed to the second mining being conducted under known adverse roof conditions (hillseams). The increase of load on the roof due to removal of the supporting coal dislodged the segment of roof bounded by the three hillseams.

Figure 28.—Map of example 3 mine workings.

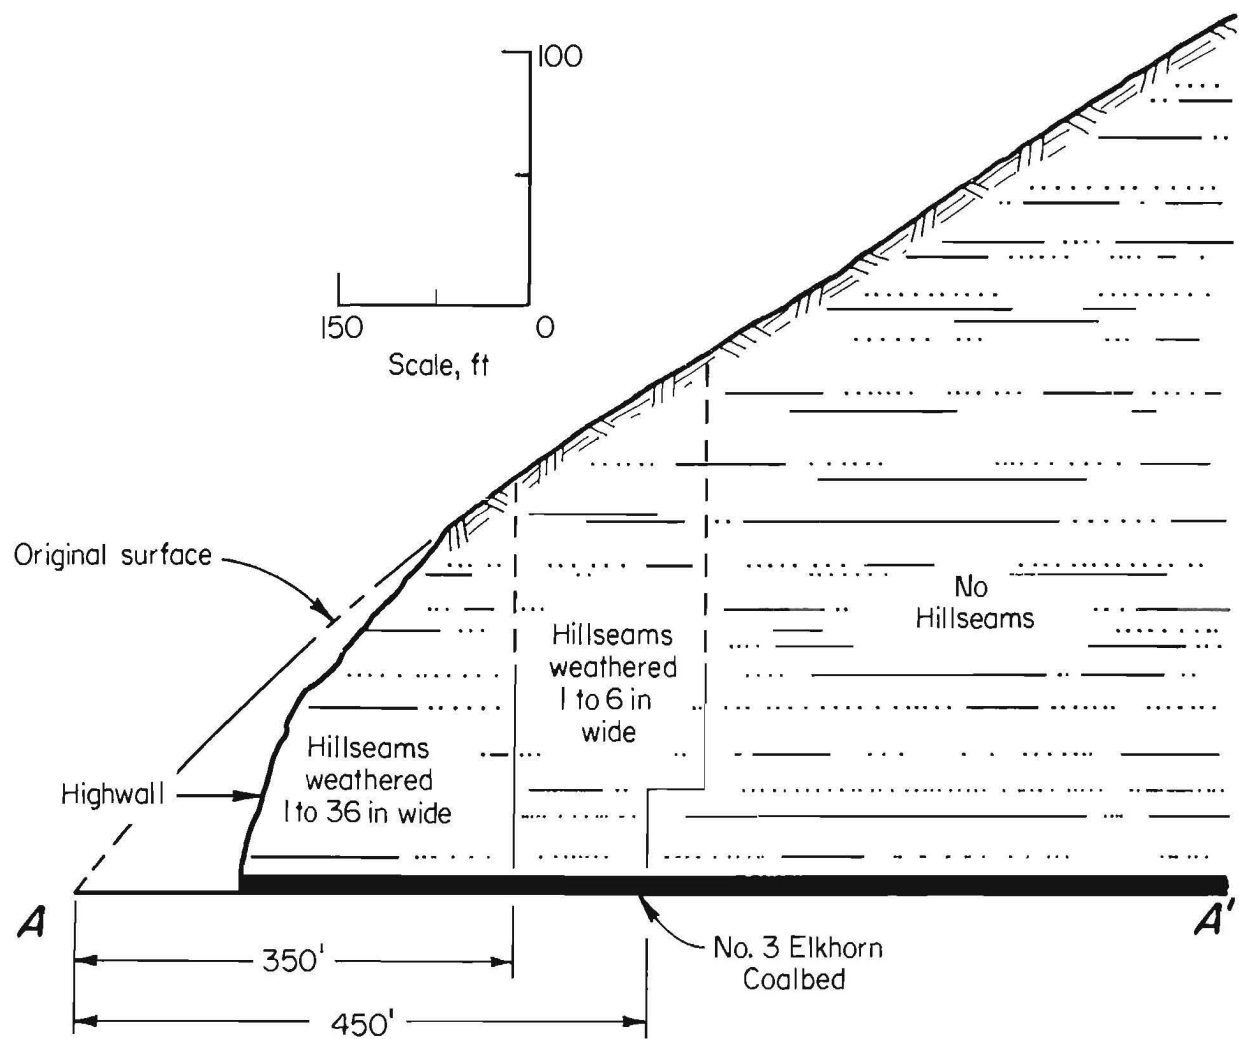
(fig. 29). The most severe roof problems occurred within 220 ft of the portals where the overburden was fractured and heavily weathered (fig. 30) and at the first crosscuts 80 to 100 ft inby the portals. Two of the crosscuts could not be completed because of the zone of hillseams and weathering. Despite attempts at supplementary support, the roof in both crosscuts collapsed. The roof for 120 ft inby the fan was supported with cribbing to prevent failure. Figures 31 and 32 illustrate roof conditions in the vicinity of some hillseams in this mine.

Figure 30.—Overburden profile at example 4 mine.
