# **Effects of Hydraulic Stimulation on Coalbeds and Associated Strata**

**Report of Investigations 8260**

**By Curtis H. Elder**

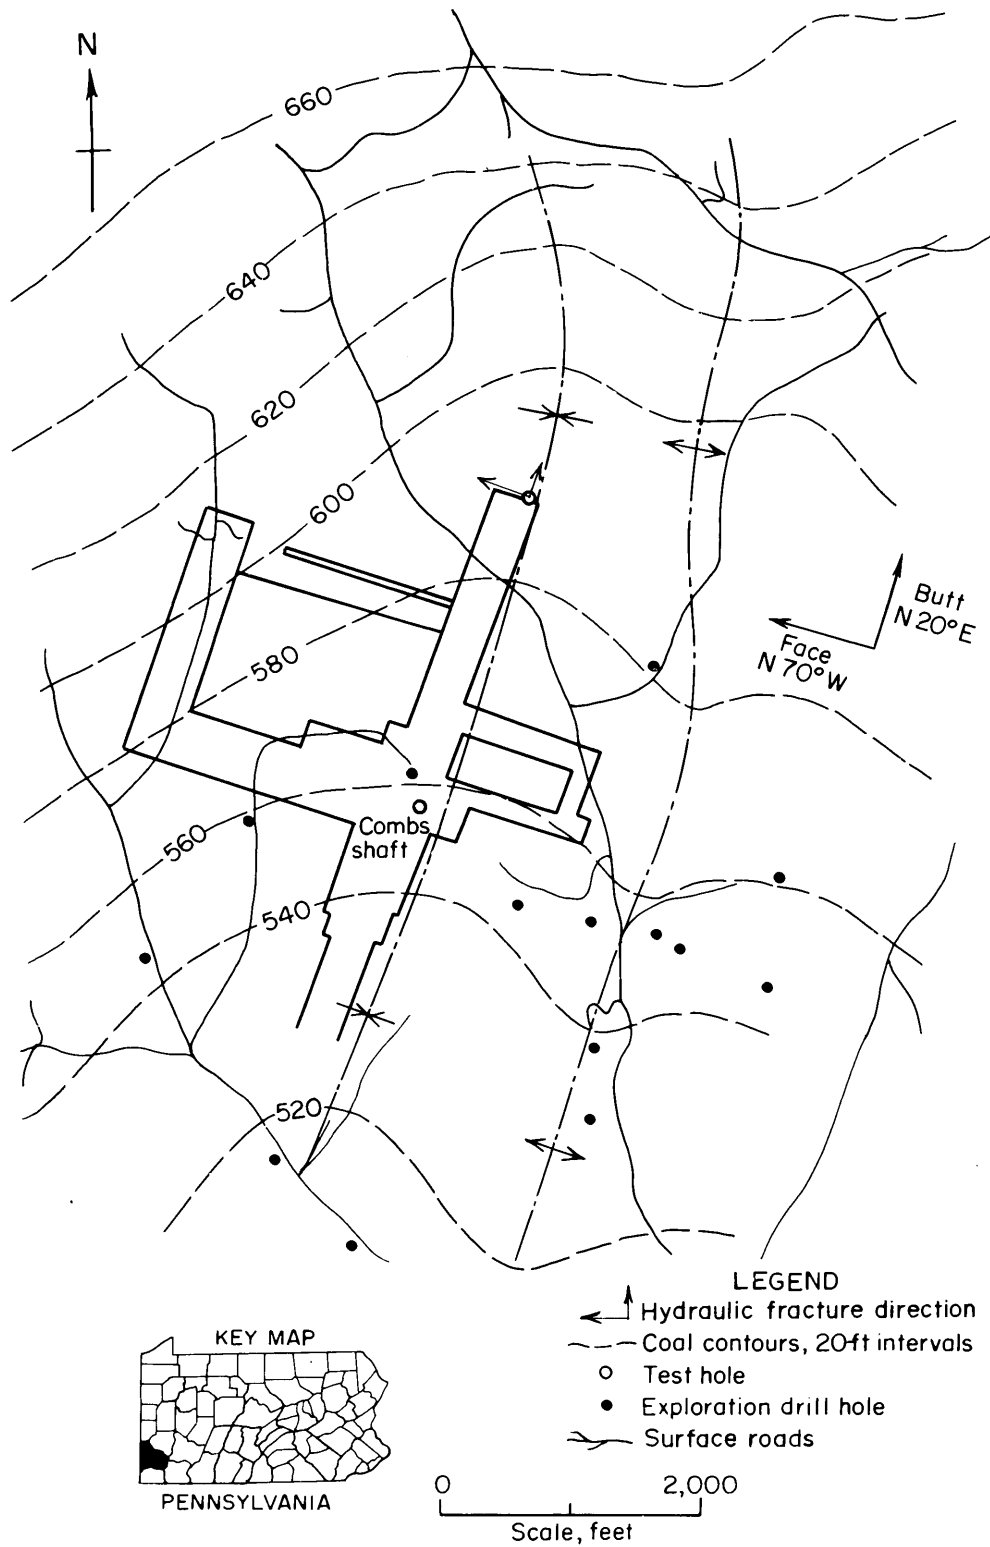
The test hole penetrated a series of interbedded shales, limestones, sandstones, and coalbeds in the Monongahela and Dunkard Group sediments of the Pennsylvanian System. The drill site lies near the axis of a small synclinal fold on the flank of the Amity anticline (fig. 2). In the vicinity of the borehole, the Pittsburgh coalbed is immediately overlain by a thin shale (draw slate) and underlain by calcareous claystone.

FIGURE 2. - Structure map contoured on Pittsburgh coalbed showing location of Vesta No. 5 mine and test hole.

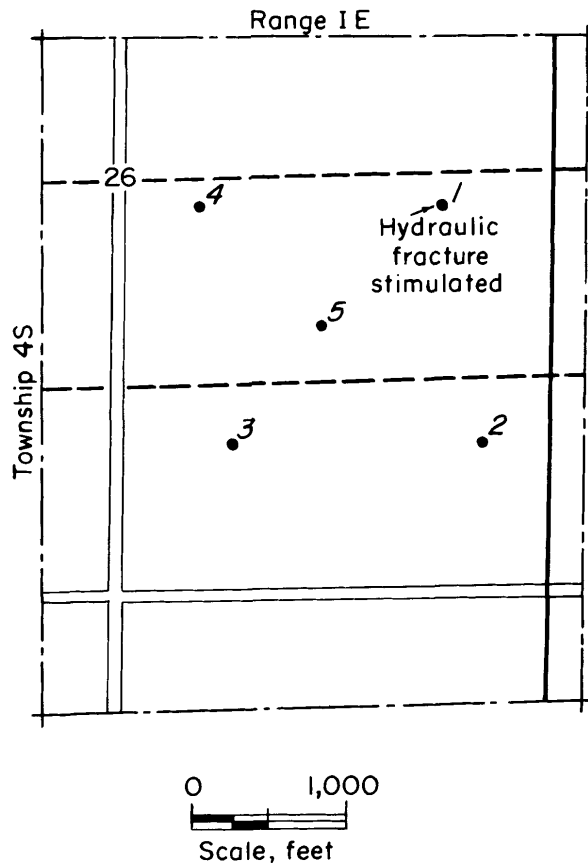
FIGURE 11. - Location of degasification borehole pattern for No. 6 coalbed, Inland mine, Jefferson County, Ill.

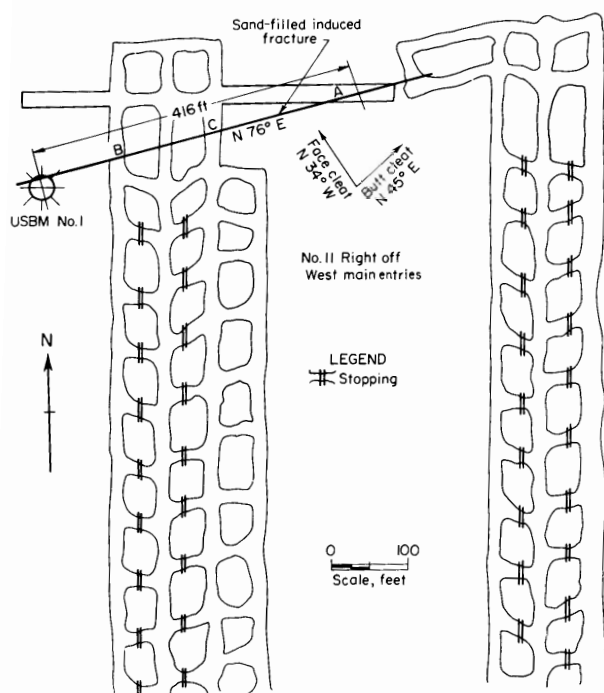
The induced vertical fracture packed with propping sand was intercepted by mining in May 1974. The induced fracture was propagated in a direction of N 76° E from the borehole. It was mapped across four entries of the No. 11 Right entries off the West main entries of the mine (fig. 13). The induced vertical fracture did not follow the directions of the face or butt cleat; it followed a path subparallel to the axis of a small anticlinal fold on the flank of the coal basin (fig. 14). The stimulation created a single vertical fracture in the coalbed. A small amount of water drainage from the fracture alerted the operator of the continuous miner that the sand-filled fracture had been mined through. The fracture was mapped for 416 feet from the borehole. The sand-propped fracture extended vertically from the roof shale to a hard shale parting approximately 2 feet from the bottom of the coalbed. The fracture was 7 feet in height. It is normal practice in this mine to leave 1 foot of roof coal during mining to protect the shale overlying the coalbed from air, moisture, and weathering.

FIGURE 13. - Induced fracture orientation as related to mine entry development at Inland mine.

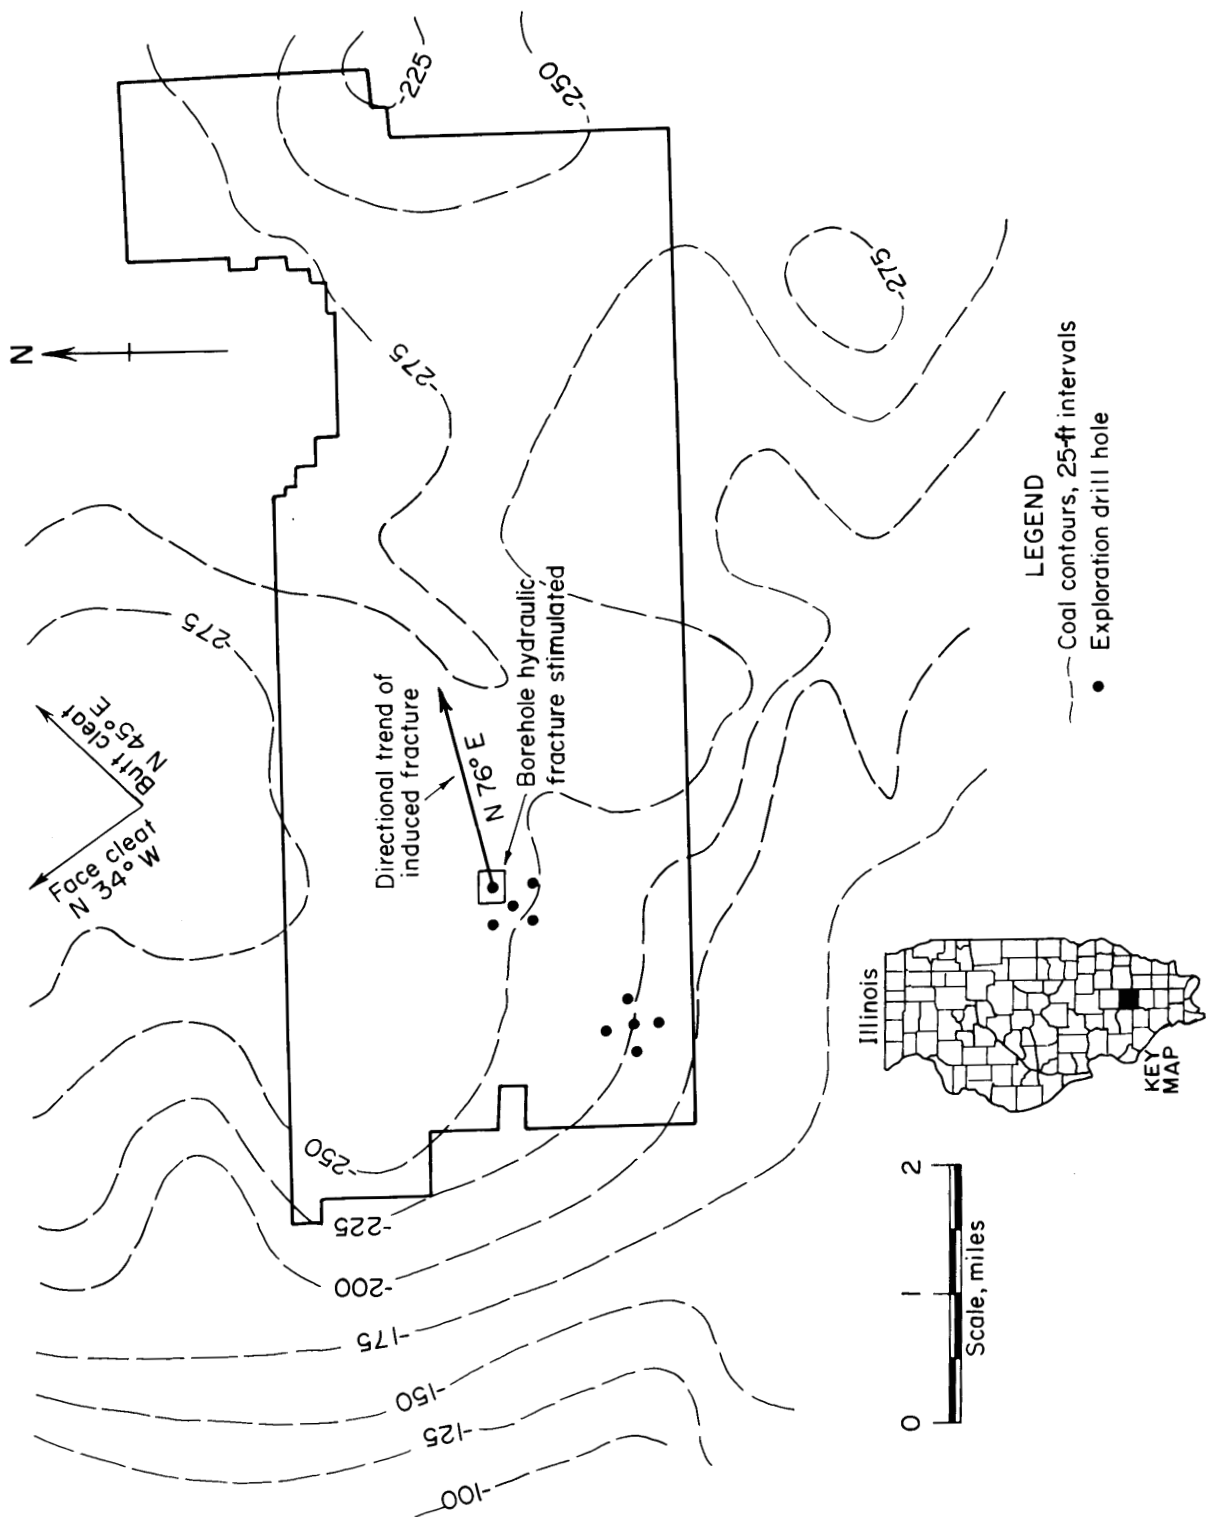
FIGURE 14. - Geologic structure map of No. 6 coalbed contoured on No. 6 coalbed, showing directional trend of induced fracture.
