**NIOSH**  
Fire Fighter Fatality Investigation  
and Prevention Program

***A summary of a NIOSH fire fighter fatality investigation***

***July 8, 2015***

## ***4 Career Fire Fighters Killed and 16 Fire Fighters Injured at Commercial Structure Fire – Texas***

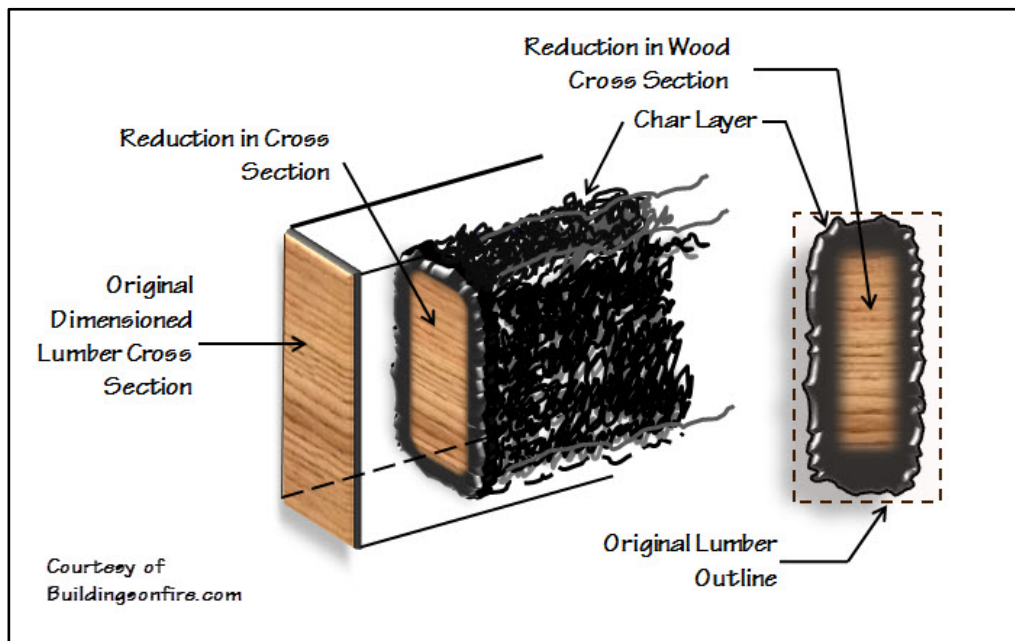
**Diagram 5. Charring Effect on Wood Component and Cross Section**  
(Diagram Courtesy of Buildingsonfire.com)

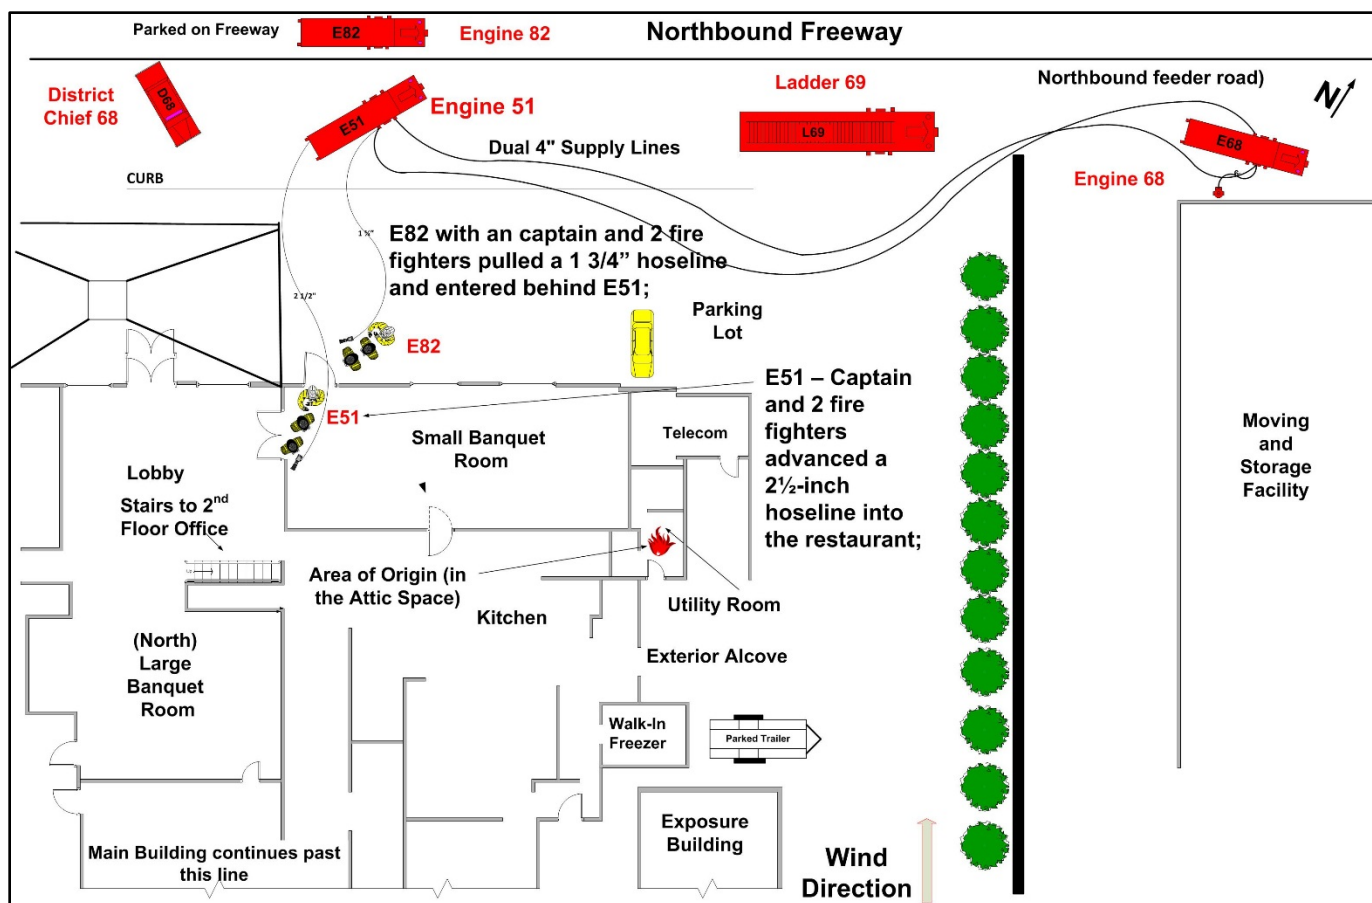
**Diagram 12. The initial fire attack by the crews of Engine 51 and Engine 82.  
The time is approximately 1215 hours.**

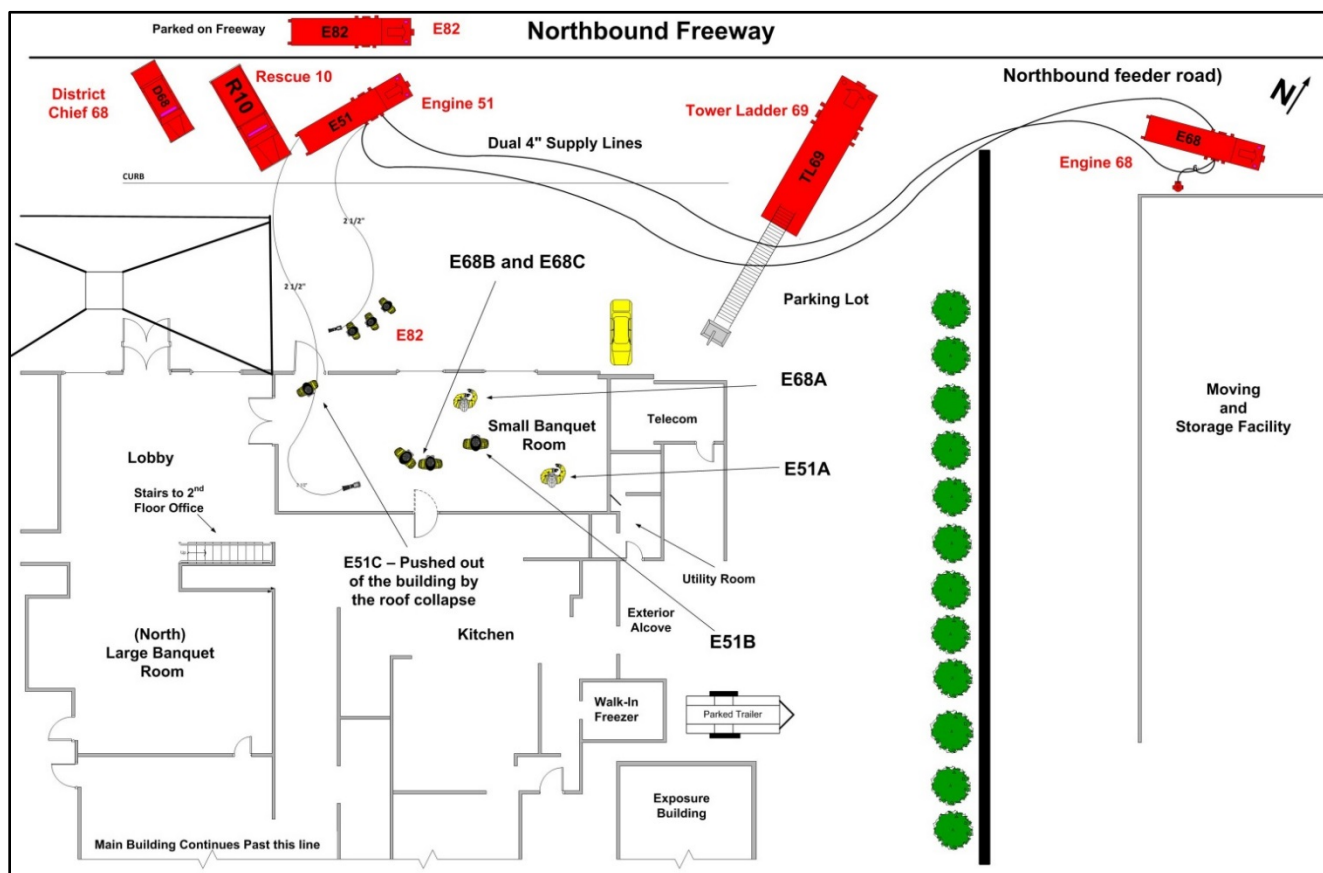
**Diagram 13. The location of the officers and fire fighters of Engine 51 and Engine 68 when the roof collapse occurred in the Small Banquet Room and Kitchen area at 12:23:24 hours.**

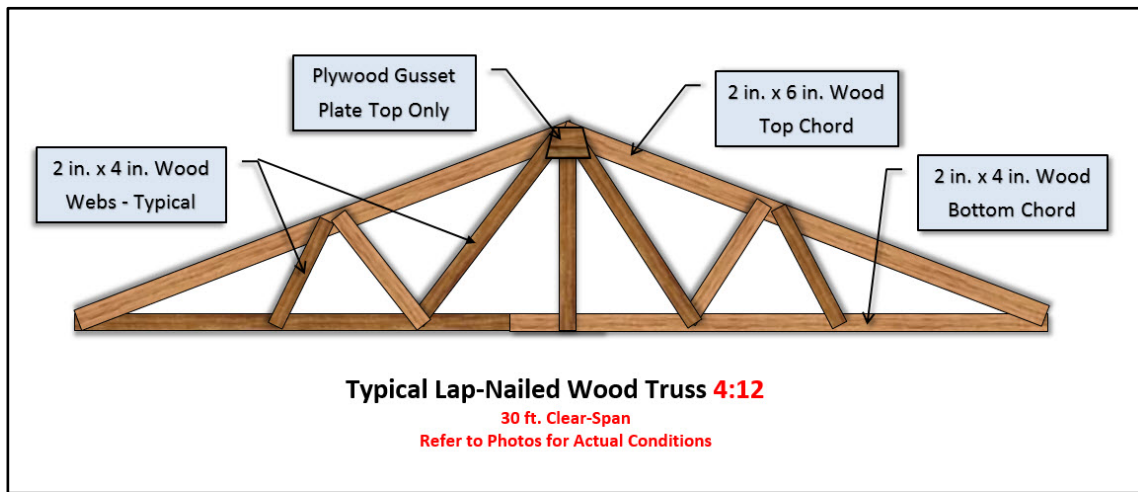
**Diagram 18. Truss Configuration**  
(Diagram Courtesy of Buildingsonfire.com)
