Structure Collapse at 140-Year Old Mill Building Kills 2 Career Fire Fighters and Injures 2 Others – Pennsylvania

Executive Summary

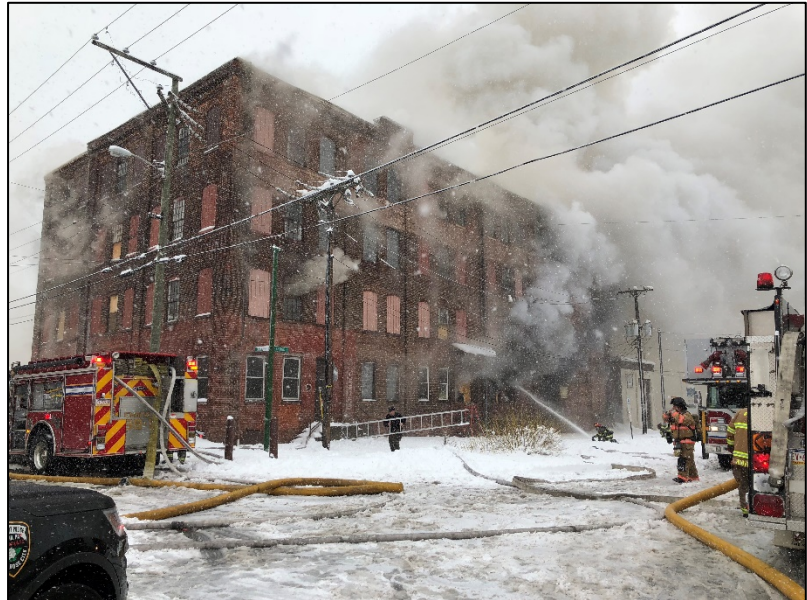
Crews work on Side Alpha on March 21, 2018 at 140-year old mill building. Time is approximately 1642 hours. Two fire fighters died following collapse on March 22, 2018.

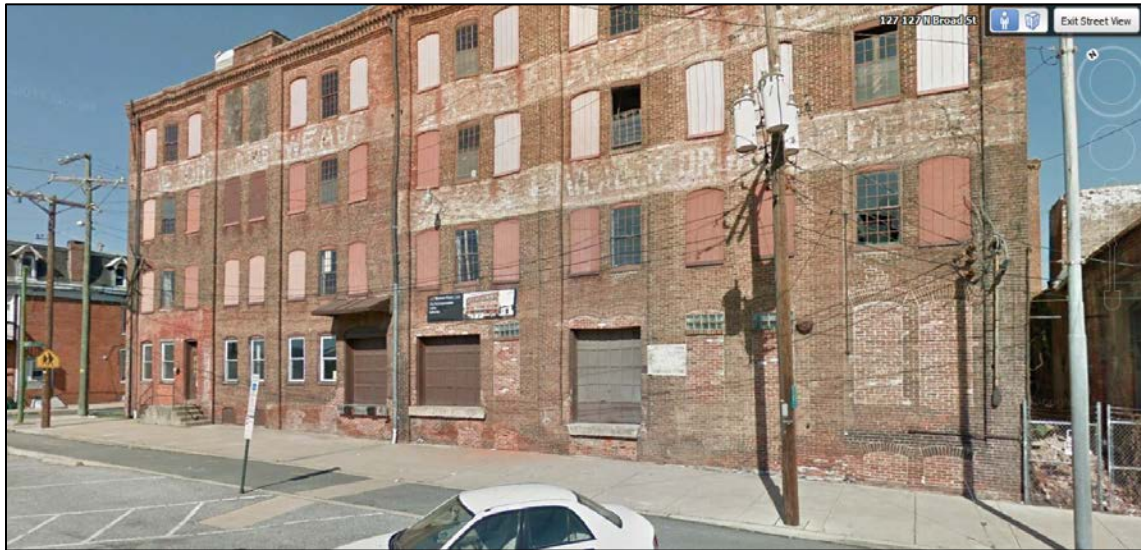
Photo 2. Side Alpha view of structure before the fire. Initial attack crews entered the structure through the man door at the Side Alpha / Bravo corner.
(Photo adapted from Google Earth street view.)

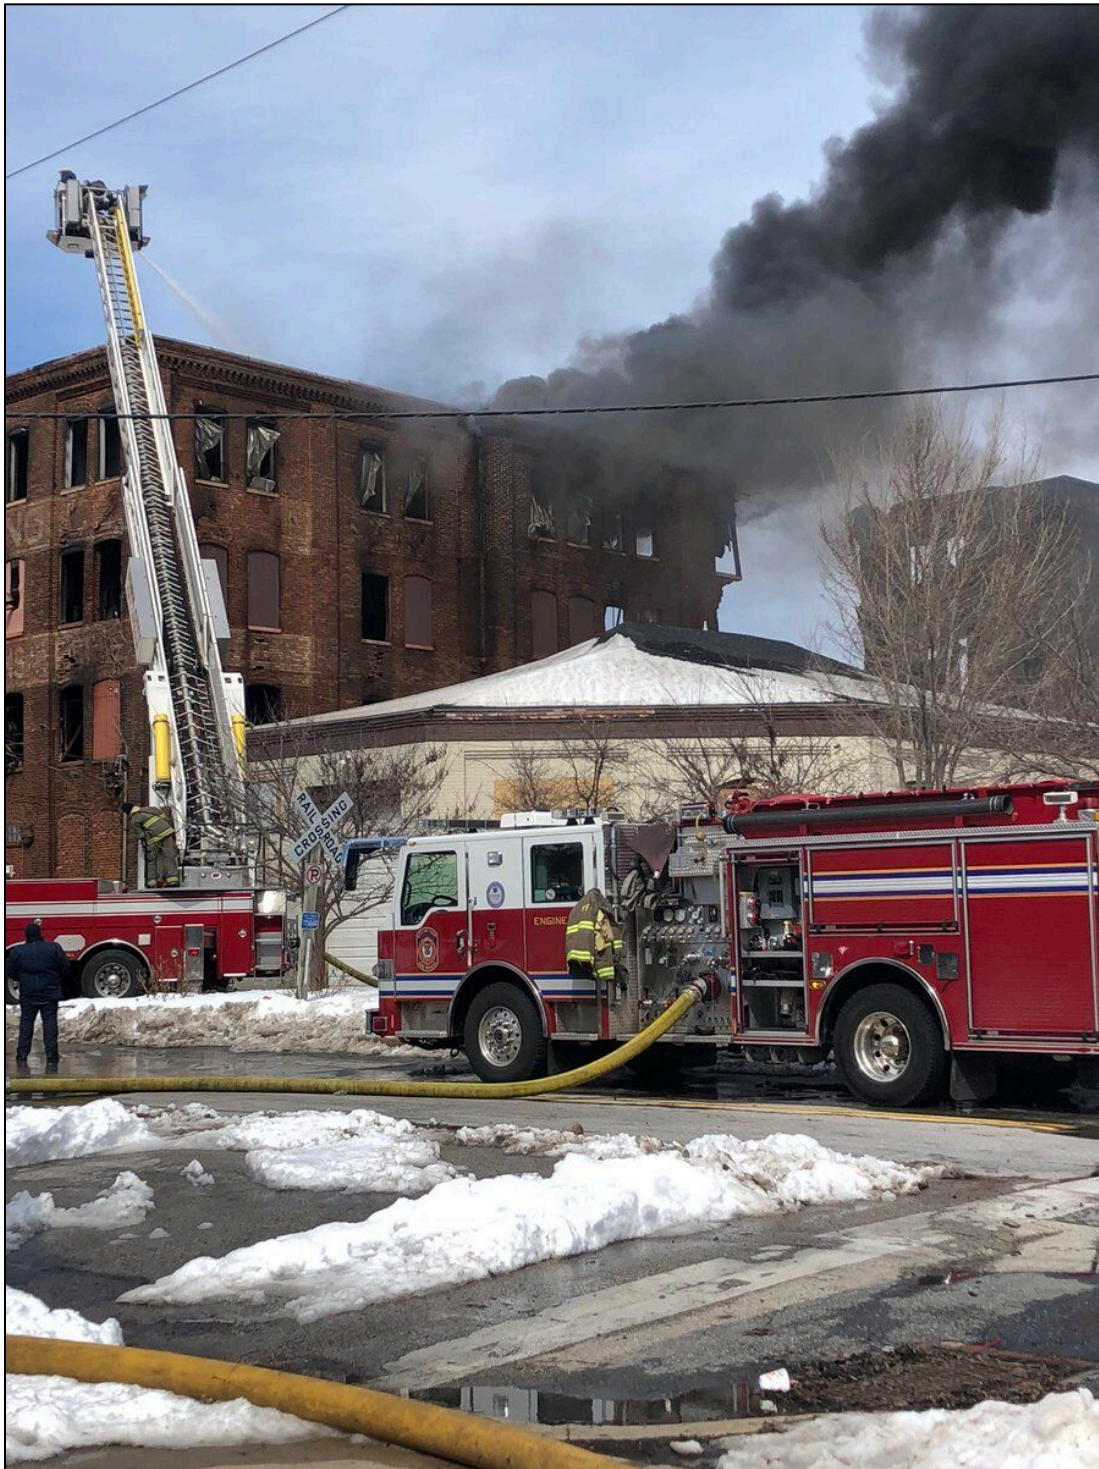
Photo 6. Photo shows defensive master stream operation on March 22, 2018 at Side Alpha / Delta corner.

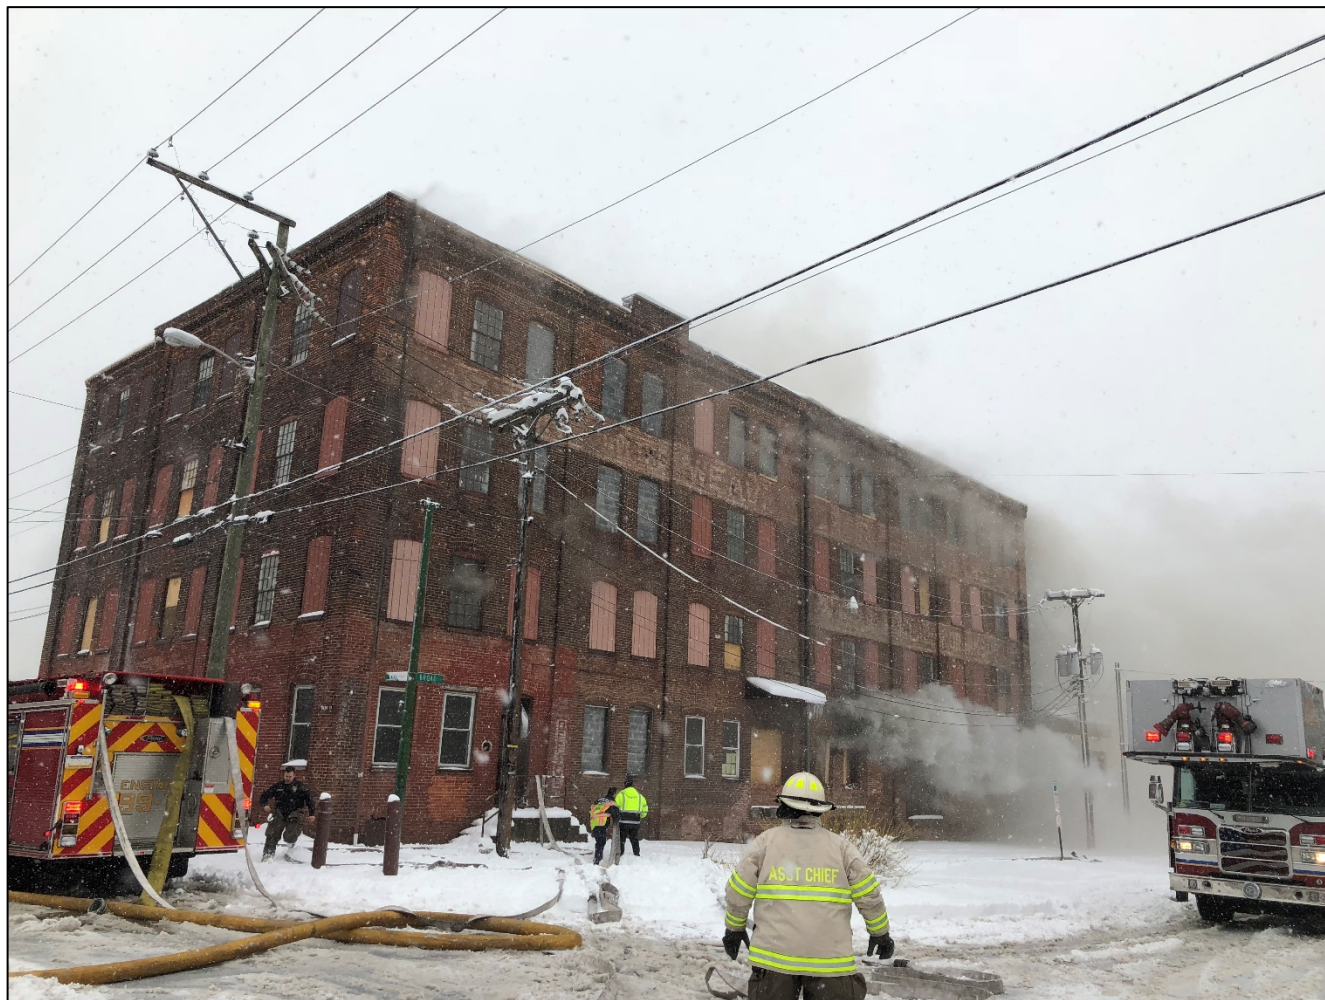
Photo 7. View of Side Alpha / Bravo corner soon after initial crews arrived on scene. Time approximately 1626 hours.

Engine 99-1 staged on Side Bravo just past the Side Alpha-Bravo corner. The Engine 99-1 acting officer and fire fighter set up a ground monitor near the middle of the structure at Side Alpha. Then they pulled a 1 ¾-inch preconnected hand line from Engine 99-1 and pulled it to the front door (see Photo 7). The Engine 99-1 acting officer had the nozzle and the Engine 99-1 fire fighter handled the hose line. At approximately 1620 hours, they advanced the hose into the structure. The Engine 99-1 crew did a right hand search looking for possible victims since the original dispatch was for possible entrapment. They searched the basement and the first floor (Division 1) but never flowed any water. The hose line got stuck in the front door. The Engine 99-1 fire fighter went outside to retrieve a thermal imager and returned inside the structure where he met up with the shift captain in the basement. The interior crew reported high heat, moderate smoke, and no visible fire in the areas they searched.

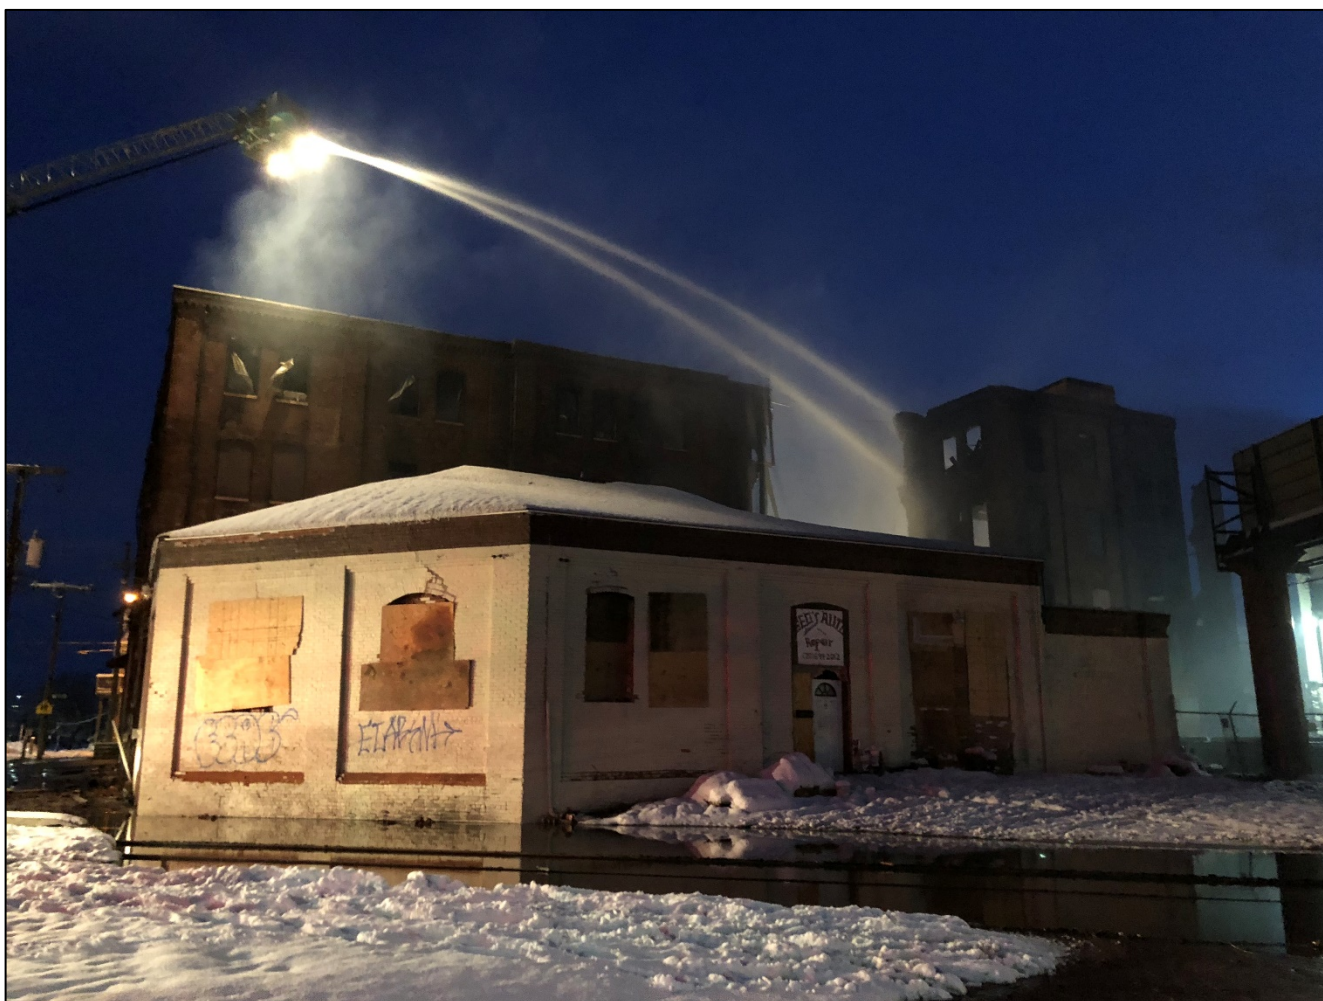
Defensive operations continued throughout the night (see Photo 10). The deputy fire chief returned to the fireground around 0730 hours and assumed command from the C-shift assistant chief. Engine 99-7 was staged in the street at the Side Bravo / Charlie corner. Engine 99-5 and Truck 99-1 were in the street on Side Alpha.

Photo 10. Defensive operations with Truck 99-1 master streams in operation at Side Alpha / Delta corner. Defensive operations continued throughout the night of March 21, 2018 and continued into March 22, 2018.
