A summary of a NIOSH fire fighter fatality investigation

April 14, 2015

## ***Two Career Fire Fighters Die in a Rapid Fire Progression While Searching for Tenants—Ohio***

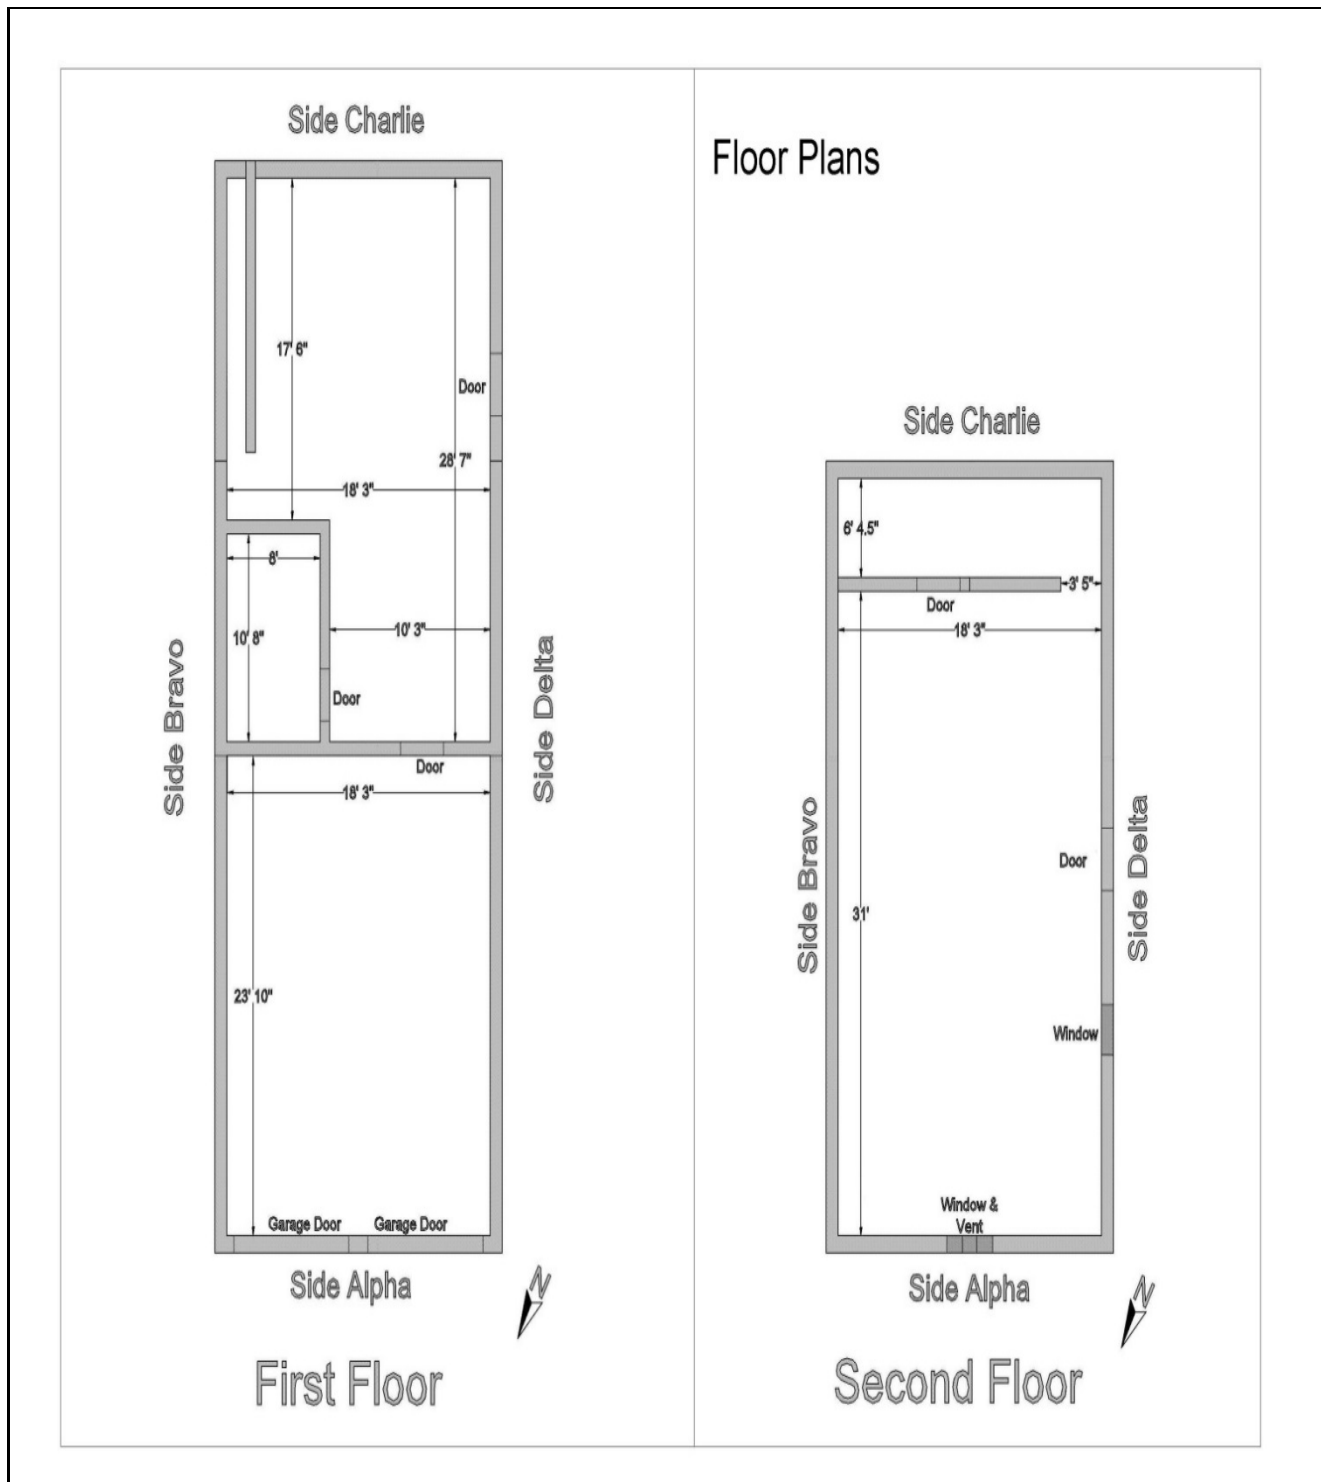
**Diagram 1. Dimensional layout of the first and second floors of the fire structure.**  
(Diagram courtesy of the city's Engineering Services.)

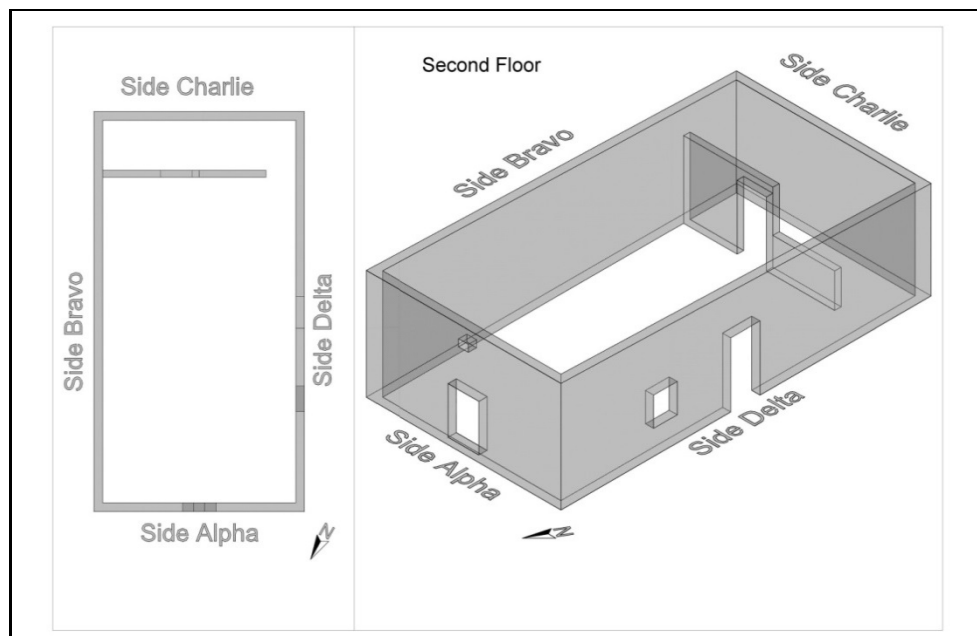
**Diagram 3. Second-floor three-dimensional view of the fire structure.**  
(Diagram courtesy of the city's Engineering Services.)

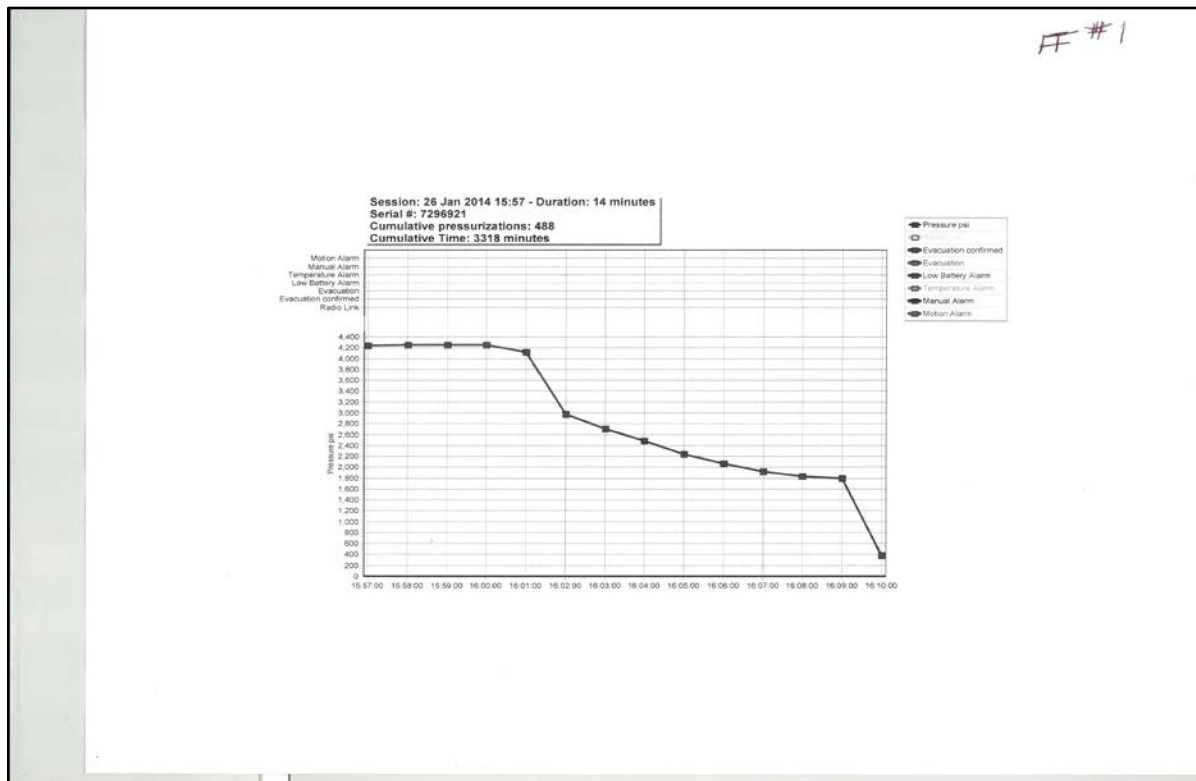
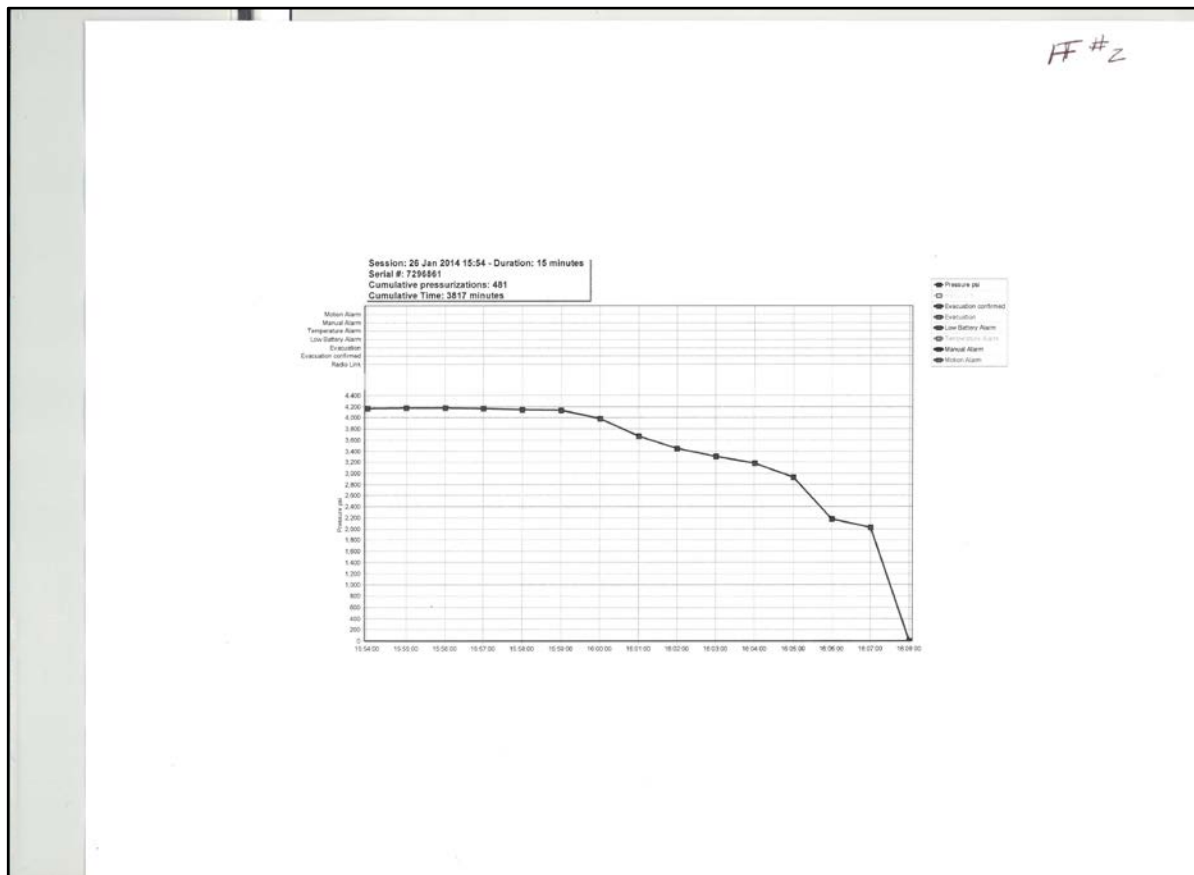
On June 19, 2014, representatives of the Mine Safety Appliances Company (MSA) down loaded the data loggers included with these SCBA units. The data downloads were performed at the MSA facility in Cranberry Township, Pennsylvania and the downloads were witnessed by NIOSH and Fire Department personnel. Attached are the SCBA cylinder pressure versus time charts for both fire fighters. Please note the cylinders were close to full and the duration was 14 minutes and 15 minutes, respectively. Places where the graph indicates a sudden drop in pressure suggests that that the by-pass was used for cool air, the face piece may have dislodged, or the face piece seal was broken by accident or on purpose.
