## Career Captain Sustains Injuries at a 2-1/2 Story Apartment Fire then Dies at Hospital – Illinois

***A summary of a NIOSH fire fighter fatality investigation***

***September 24, 2013***

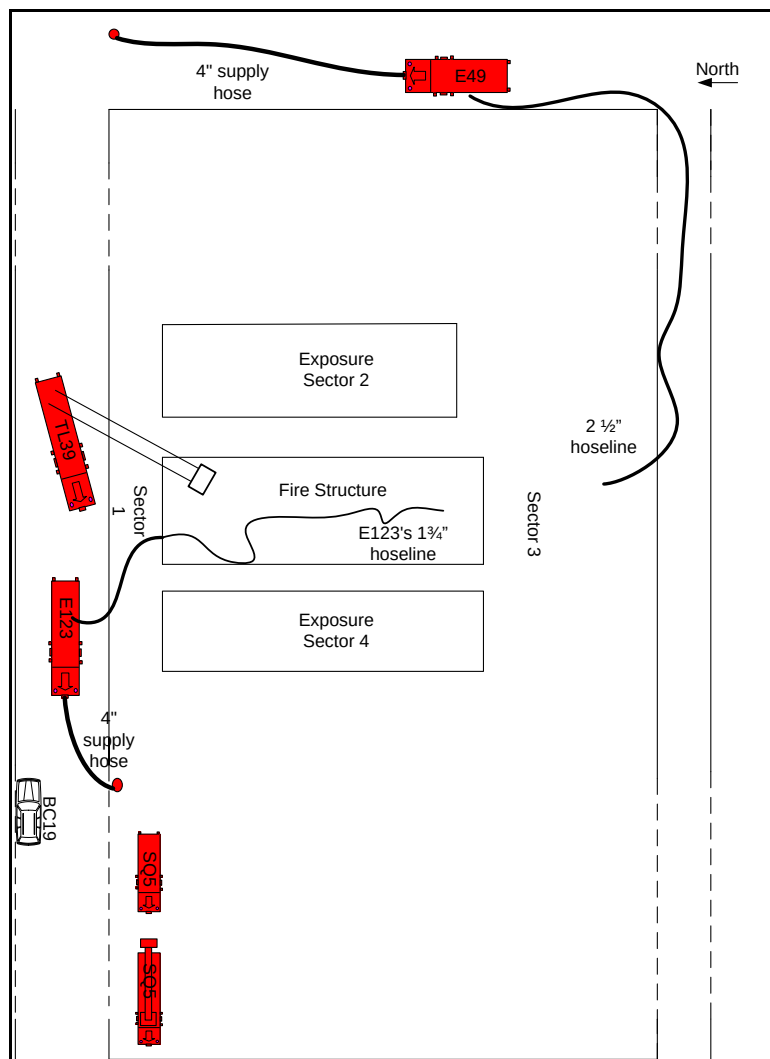
**Diagram 1. Apparatus and hoseline placement**

On November 2, 2012, a 54-year-old male career captain sustained injuries at a 2-1/2 story apartment building fire then died at the hospital. At 1716 hours, dispatch called a Still alarm for smoke in the area. Battalion Chief 19 was the first to leave the station that was just blocks away. He approached the fire structure by driving behind it then around to the front arriving on scene at 1717 hours. He reported a working fire with heavy smoke coming from the rear (Sector 3) and front (Sector 1) of the structure's attic. Per fire department standard operating procedures, dispatch initiated a RIT response. At 1718 hours, E123 arrived on scene and BC19 was on scene and had assumed incident command. The IC spoke with one of the occupants who stated everyone was out. The IC made entry through the front door to the stairwell to survey the interior of the 2<sup>nd</sup> floor. He noticed only a light haze throughout and glow around the Sector 3 door to the covered porch. The IC came back to the front door and met the E123 Captain (victim) and a fire fighter (pipeman). They had stretched a horseshoe load which is 100 feet of 2 ½ -inch , a gated wye, and 150 feet of 1 ¾-inch hoseline to go to the 2<sup>nd</sup> floor, which is a standard department hose lay for this type occupancy. At 1720 hours, E49, T33, and TL39 arrived on scene (see Diagram 1).

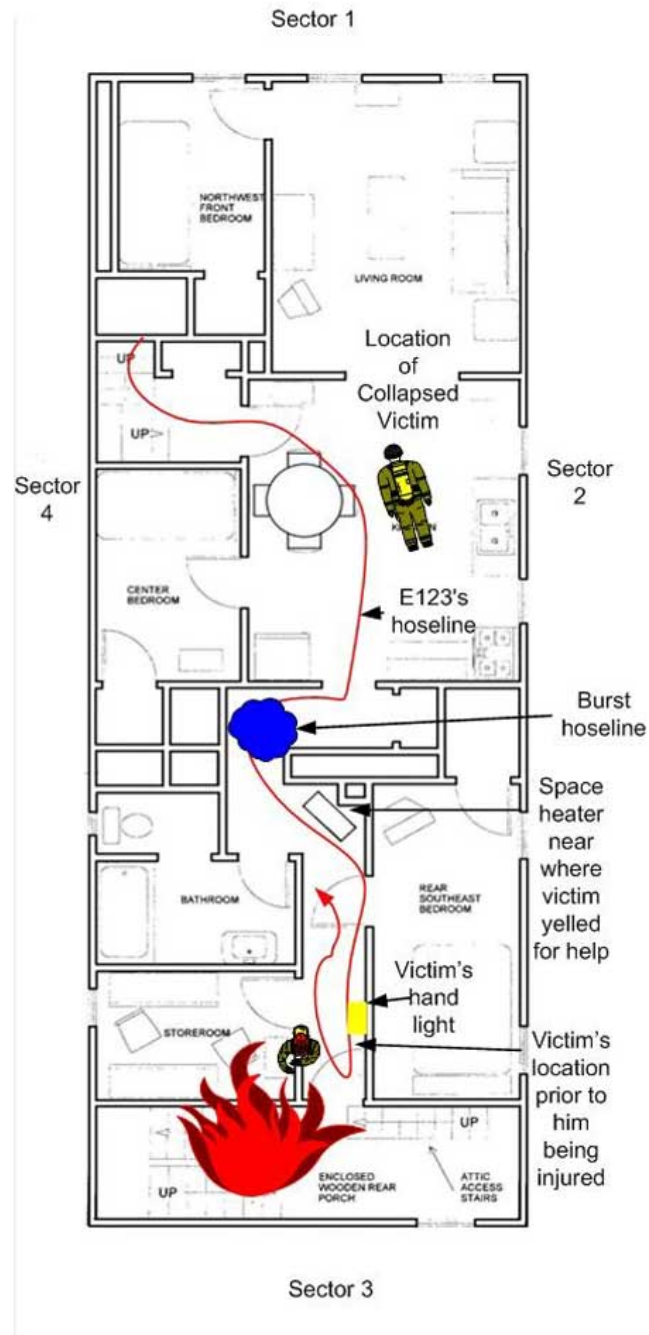
Diagram 2. Location of Victim and hoseline when found.

The Lieutenant from TL39, the Lieutenant and 2 fire fighters from SQ5, and a E123 firefighter/paramedic (FF/PM) were near the kitchen area on the 2<sup>nd</sup> floor when they heard a loud commotion. The FF/PM heard the victim yell “get out of here” (see Photo 3 and Photo 4). The FF/PM felt the victim’s air cylinder and noticed it was hot. Also, he felt a mask that was dangling and thought it was the victim’s but it was actually the E123’s pipeman, who was tangled up with the victim. *Note: The E123 pipeman was on air and his facepiece became dislodged while assisting the victim.* The FF/PM had no radio and he couldn’t locate the victim’s radio so he yelled Mayday as he tried to get the victim and other crew member untangled. The TL39 Lieutenant and SQ5 fire fighters heard the FF/PM’s verbal Mayday and the SQ5 Lieutenant tried to transmit a Mayday over heavy radio traffic (see Diagram 2). *Note: The victim’s hoseline in the hallway (see Diagram 2) had burst but it is believed to have occurred during the thermal incident or post incident.*
