Volunteer Lieutenant Killed and Two Fire Fighters Injured Following Bowstring Roof Collapse at Theatre Fire – Wisconsin

Executive Summary

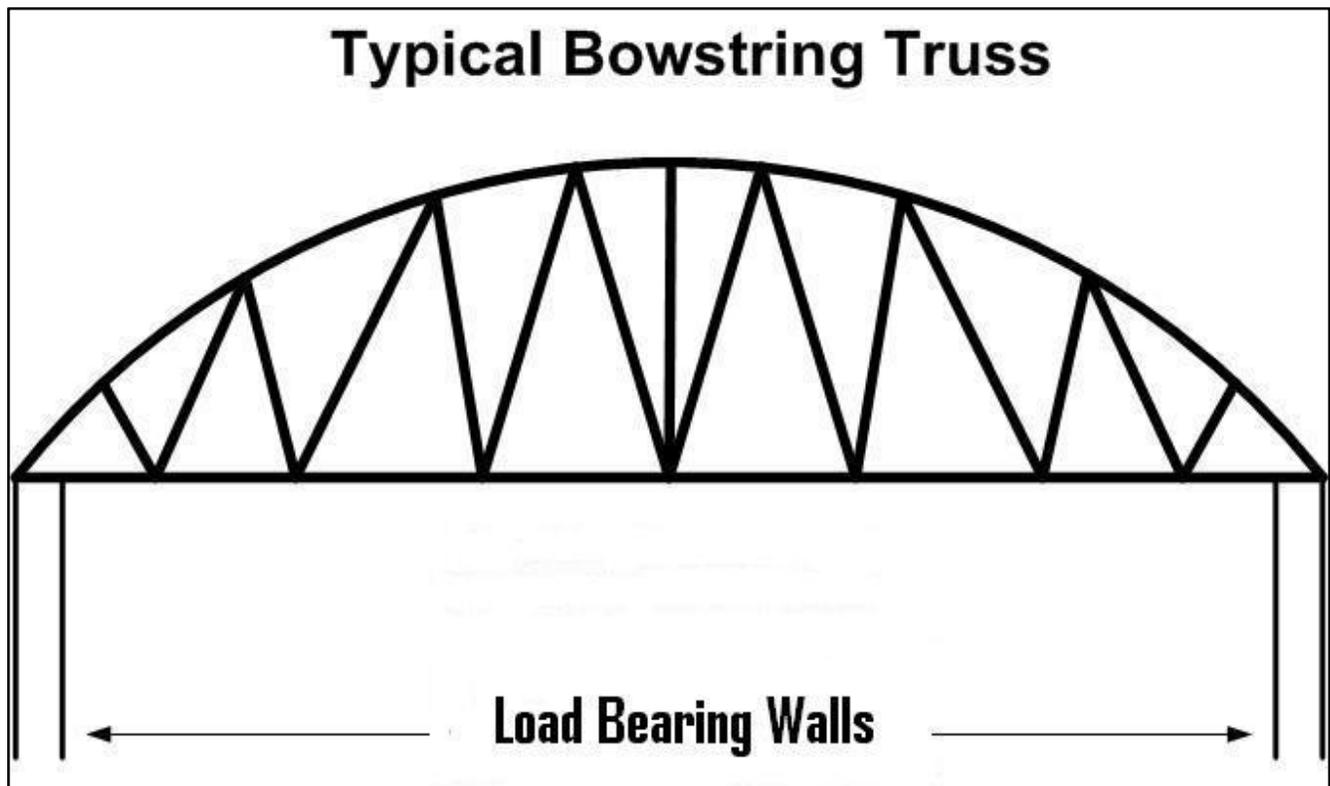
Diagram 2. Typical bowstring truss roof spanning between load bearing walls.

Bowstring truss roofs are easily identified by the roof's arched or curved outline (see Diagram 2). Bowstring truss roofs became popular in the 1930's. Prior to 1960, the bowstring truss roof design was one of the most common design types for large commercial and industrial structures. The bowstring truss roof was commonly used in facilities such as automobile dealerships and repair facilities, bowling

alleys, grocery stores, and industrial complexes wherever large open floor spaces with limited interior supports were needed. The curved top chord members were made either by sawing straight lumber into curved shapes or laminating multiple smaller pieces bent over a jig to the desired shape. Bottom chord members were typically constructed with large, straight lumber members joined with either wood or metal bolted splice plates, located near mid-span, to achieve the required length. The top and bottom chord members were fastened together at the truss ends with U-shaped steel heels, or end shoes, bolted to both chord members.

The principles of bowstring truss construction are similar to other types of truss construction in that web members are used to form multiple series of triangles that transfer tension from the bottom chord and compression from the top chord of the truss onto the load bearing walls. One big difference with the bowstring truss is that the compressional forces within the top chord act to force the load bearing walls outward as well as downward.

Bowstring truss roof systems may suffer from a little-known phenomenon related to inaccuracies in early industry-accepted truss design assumptions. One significant design deficiency involves the tensile strength of the bottom chord. Early truss designs assumed wood tensile strength could be defined by bending tests of small, straight-grained wood samples free of common wood defects. Prior to the 1960s, large-scale test facilities were uncommon, so full-size lumber tests were rarely
