## ***Two Career Fire Fighters Die and 19 Injured in Roof Collapse during Rubbish Fire at an Abandoned Commercial Structure – Illinois***

On December 22, 2010, a 47-year-old male (Victim # 1) and a 34-year old male (Victim # 2), both career fire fighters, died when the roof collapsed during suppression operations at a rubbish fire in an abandoned and unsecured commercial structure. The bowstring truss roof collapsed at the rear of the 84-year old structure approximately 16 minutes after the initial companies arrived on-scene and within minutes after the Incident Commander reported that the fire was under control. The structure, the former site of a commercial laundry, had been abandoned for over 5 years and city officials had previously cited the building owners for the deteriorated condition of the structure and ordered the owner to either repair or demolish the structure. The victims were members of the first alarm assignment and were working inside the structure. A total of 19 other fire fighters were hurt during the collapse.

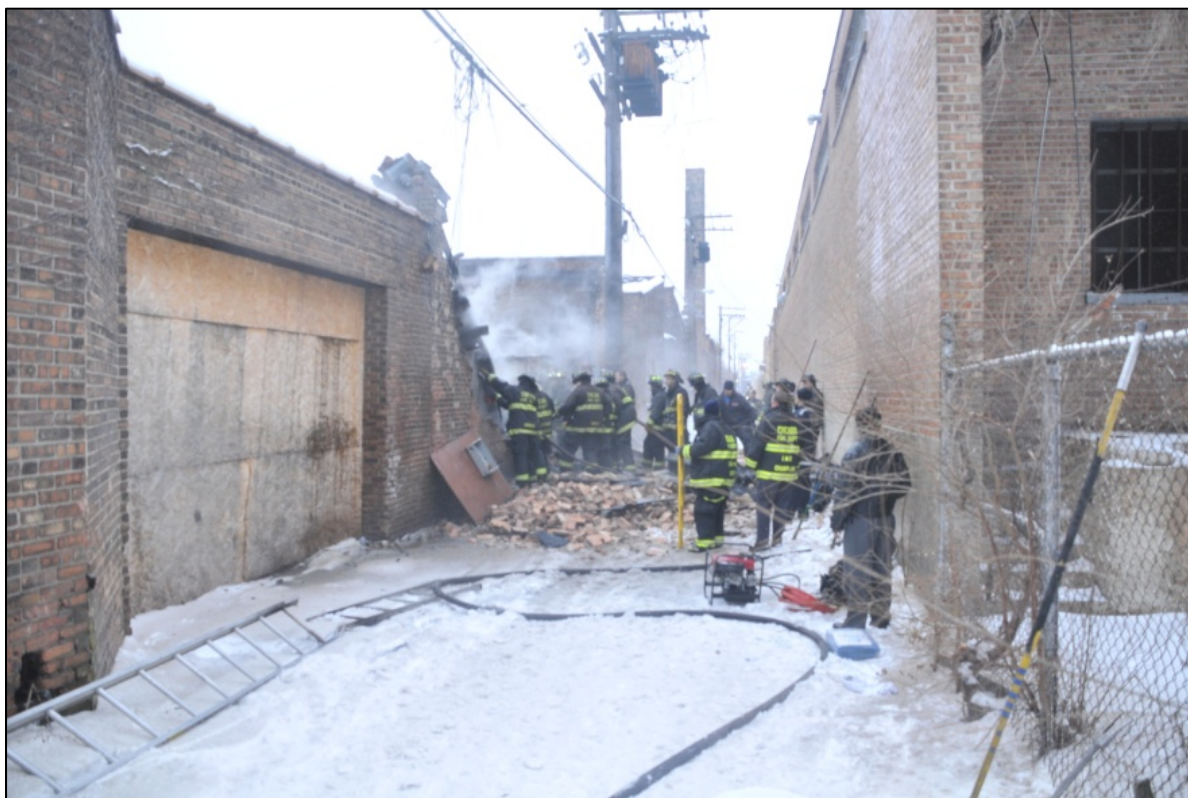
**Photo 1. 12-foot wide public alley directly behind structure (Sector 3).**  
*(Photo courtesy of fire department)*

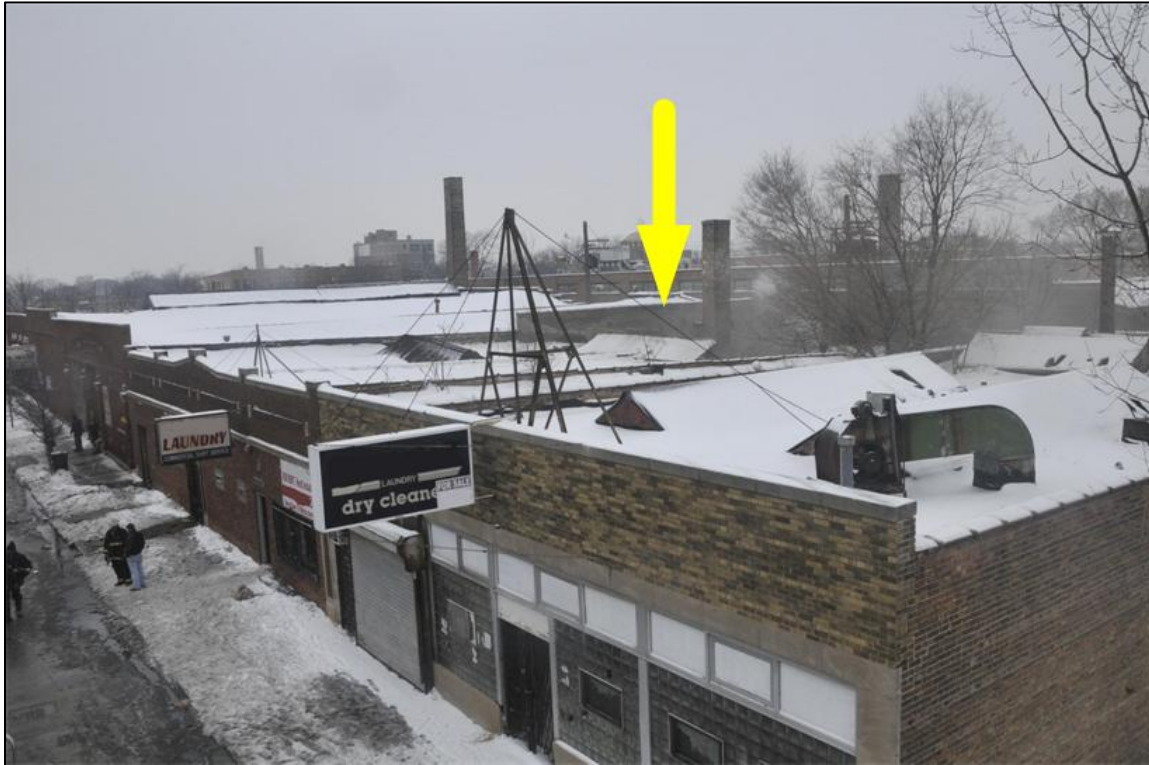
The structure was located in an area that contained both vacant and abandoned buildings (see Photo 4). The structure had been abandoned<sup>b</sup> by the owner for more than 5 years, and was formerly the site of a commercial laundry. The structure had never included a sprinkler system. It was reported that natural gas service to the building had been shut off since 2005 and electrical service had been shut off since 2009.

**Photo 4. Elevated view of the block where the incident occurred, taken the day of the fire. The arrow marks the location of the collapse. The photo has been edited to remove names and identifying information from signs.**  
*(Photo courtesy of fire department)*

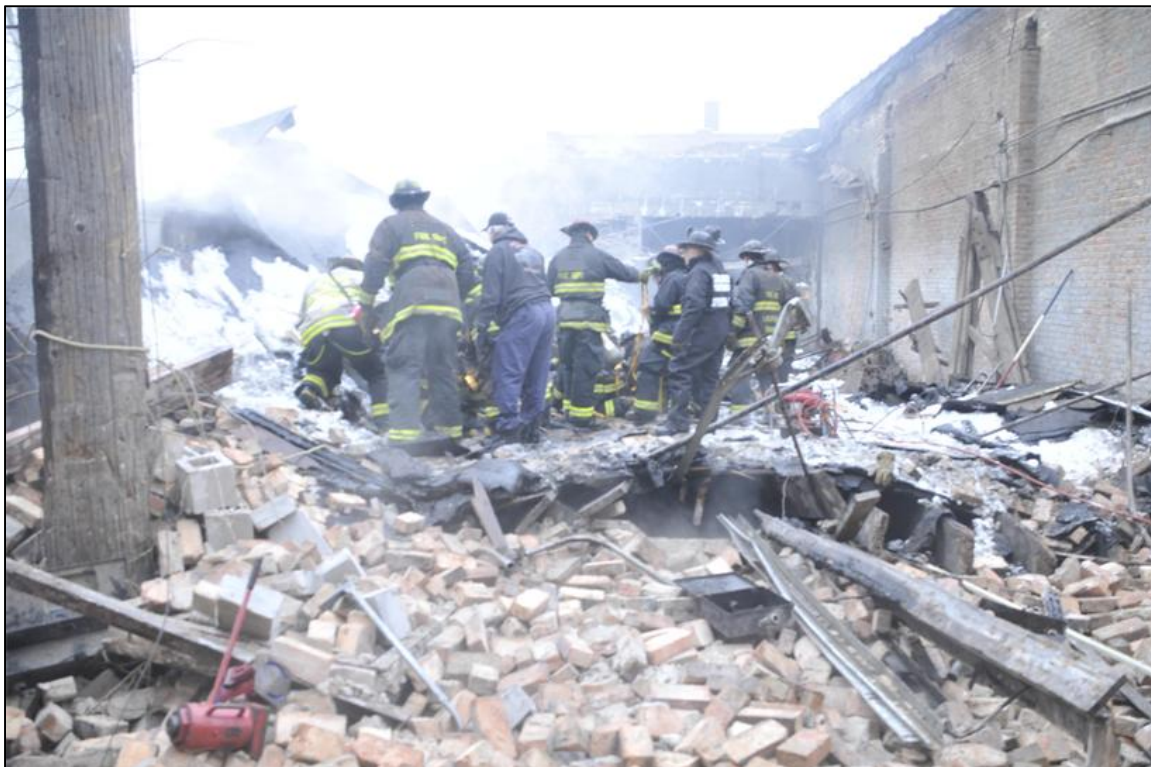
Five fire fighters were working in close proximity to the area enclosed by the wooden wall studs west of the concrete block room. The E-72 fire fighter working the nozzle was closest to the Sector 3 wall. The collapsing roof pushed the E72 fire fighter down to a crouching position (during the interview with NIOSH investigators, he referred to the position as a baseball catcher’s position). His head and shoulders were pinned by the collapsed roof so that he could not move and his facepiece was dislodged. He began to yell out for help and the Truck 30 crew along with the E-126 lieutenant and other fire fighters began to dig the bricks and roof material from around his head (see Photo 11).

**Photo 11. Crews work to free fire fighters from Engine 72, Truck 49 and Truck 16 trapped under collapse.**
