# Volunteer Fire Fighter Dies After Falling Through Floor Supported by Engineered Wooden-I Beams at Residential Structure Fire - Tennessee

## Death in the Line of Duty...A summary of a NIOSH fire fighter fatality investigation

F2007-07 Date Released: November 16, 2007

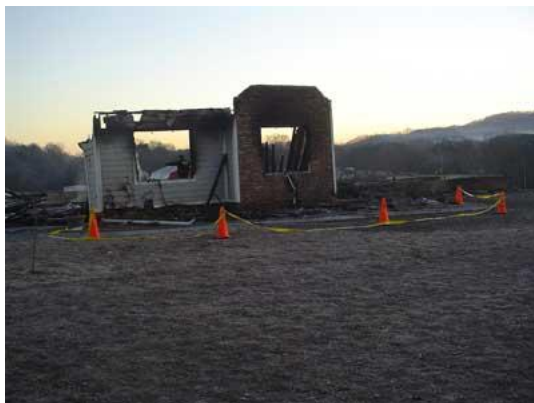
On January 26, 2007, a 24-year-old male volunteer fire fighter died at a residential structure fire after falling through the floor which was supported by engineered wooden I-beams. The victim's crew had advanced a handline approximately 20 feet into the structure with zero visibility. They requested ventilation and a thermal imaging camera (TIC) in an attempt to locate and extinguish the fire. The victim exited the structure to retrieve the TIC, and when he returned the floor was spongy as conditions worsened which forced the crew to exit. The victim requested the nozzle and proceeded back into the structure within an arm's distance of one of his crew members who provided back up while he stood in the doorway. Without warning, the floor collapsed sending the victim into the basement. Crews attempted to rescue the victim from the fully involved basement, but a subsequent collapse of the main floor ceased any rescue attempts. The victim was recovered later that morning. NIOSH investigators concluded that, to minimize the risk of similar occurrences, fire departments should:

- use a thermal imaging camera (TIC) during the initial size-up and search phases of a fire
- ensure fire fighters are trained to recognize the danger of operating above a fire and identify buildings constructed with trusses or engineered wood I-beams
