One Career Fire Fighter Dies and Two are Injured in Apparatus Crash - California

One Career Fire Fighter Dies and Two are Injured in Apparatus Crash - CA

Fatality Assessment and Control Evaluation
Investigation Report # F2005-28

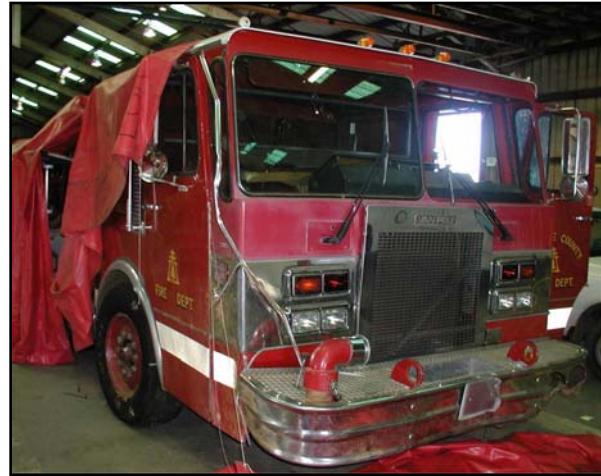
The apparatus involved in this incident was a 1987, 1,000 gallon-per-minute (GPM) engine with an automatic transmission and an auxiliary braking system (engine brake) (Photo 1). The engine's gross vehicle weight rating was 40,000 pounds (16,000 gross axle weight rating for the front and 24,000 gross axle weight rating for the rear). The engine had two axles with six tires (two in the front and four in the rear) all in good condition. The 500-gallon rectangular-shaped water tank was filled to capacity at the time of the incident. This was an open-cab engine that was equipped to carry six passengers with two front seat positions and four rear-facing seating positions. All six seats had lap belt restraints. The vehicle had passed a safety compliance inspection (required by the state) conducted at an area service station on June 15, 2005 and had traveled approximately 21 miles since the inspection.
