## **Downed Power Line Claims the Life of One Volunteer Fire Fighter and Critically Injures Two Fellow Fire Fighters - Missouri**

## Fatality Assessment and Control Evaluation Investigative Report #99F-37

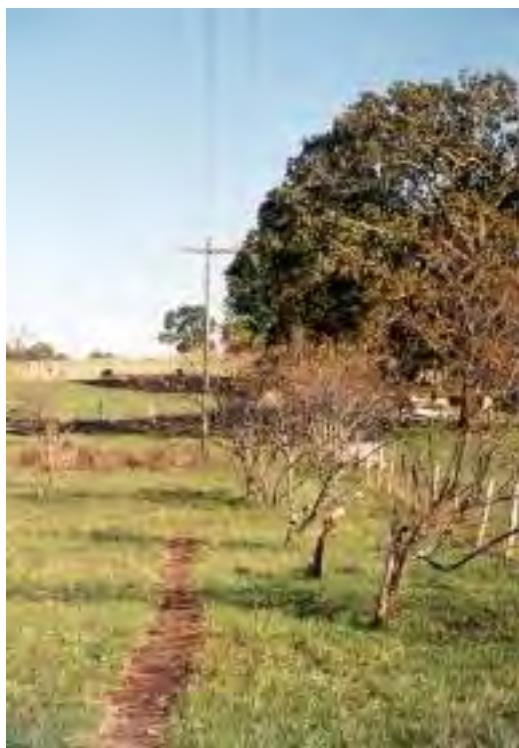
*Incident Site*

On October 4, 1999, a 20-year-old male volunteer fire fighter (the victim) was electrocuted and two other fire fighters were injured when they contacted an electric fence while fighting a grass fire. Central Dispatch notified the fire department at 0700 hours of a fire which was started when a downed power line ignited the surrounding grass. The Chief was the first to arrive on scene, and he confirmed that a power line was down. He also indicated to Central Dispatch and to the responding fire fighters that the electric fence bordering the area was energized by the downed power line. The Chief parked his truck on the road near the end of the downed line to warn arriving units of its location. Engine 1, with a driver and one fire fighter (Injured #1), was next to arrive and was positioned in a driveway on the north flank

of the fire (Figure 3). Two fire fighters (the victim and Injured #2) arrived in their privately owned vehicles and assisted the driver of Engine 1 and Injured #1 pull a booster line off Engine 1. After the victim, the driver of Engine 1, and Injured #1 and #2 pulled a booster line, they crawled underneath the bottom wire of the electric fence. Injured #1 and Injured #2 positioned themselves approximately 50 feet from the downed power line and attacked the primary fire. To prevent the fire from spreading to brush piles in the adjoining piece of property, the driver of Engine 1 rolled back under the energized fence to get a rake and create a fire control line around the brush piles. After approximately 15 minutes on the fire ground, the Chief yelled for assistance to the driver of Engine 1, stating that he had three fire fighters down. The three fire fighters were lying in the area of a secondary fire (Figure 1). The Chief grabbed Injured #1 by the collar of her bunker coat and pulled her from the fire. The driver of Engine 1 grabbed Injured #2 and the victim and removed them from the fire. Basic first aid procedures were administered until the ambulance arrived. Injured #1 was transported by helicopter to an area hospital, and Injured #2 was transported
