**REPORT#:** 21CA004

**REPORT DATE:** January 5, 2022

## Construction Laborer Died When Struck by an Excavator Bucket that Detached from a Quick Coupler — California

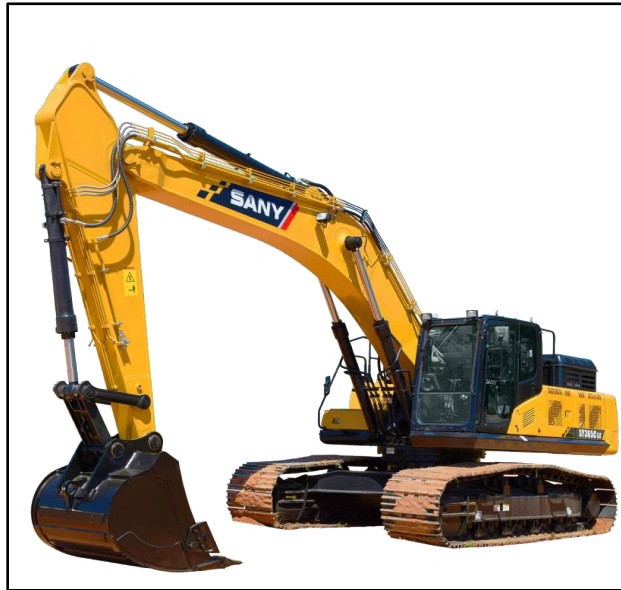
The machine involved in this incident was a Sany SY365C large excavator (Exhibit 1). The excavator weighed approximately 80,000 pounds. and had the ability to dig a trench approximately 24 feet deep. Attached to the end of the excavator boom was the original equipment quick coupler (Exhibit 2) to which the bucket attached. Quick couplers are hydraulic devices that are installed at the end of booms by pins that would normally be the mountings for the bucket or attachment. Quick couplers facilitate the rapid exchange of working tools or buckets.

*Exhibit 1. Excavator similar to the one involved in incident. Photo courtesy of SANY America.*
