REPORT#: 15MI104

Caretaker of a Farm Held in Trust Died Due to a Tractor Overturn to the Rear While Moving Downed Tree

Michigan Fatality Assessment and Control Evaluation (FACE) Program

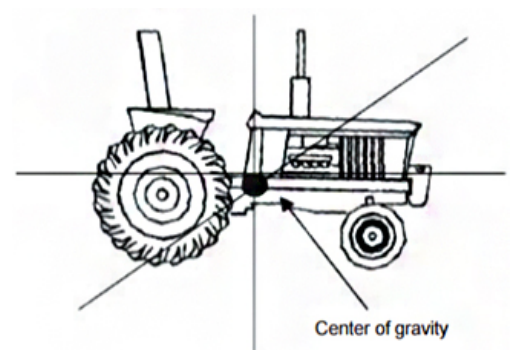
Figure 1. Location of center of gravity on two-wheel drive tractor

A tractor's CG is the point where all parts balance one another. Typically, for a two-wheel drive tractor sitting with all wheels on level ground, the CG is about 10 inches (25.4 cm) above and two feet (0.6 m) in front of the rear axle when looking from back to front, and in the center of the tractor body when looking left to right (Figure 1). Note that when adding weights to a tractor, the added weights can affect the CG.

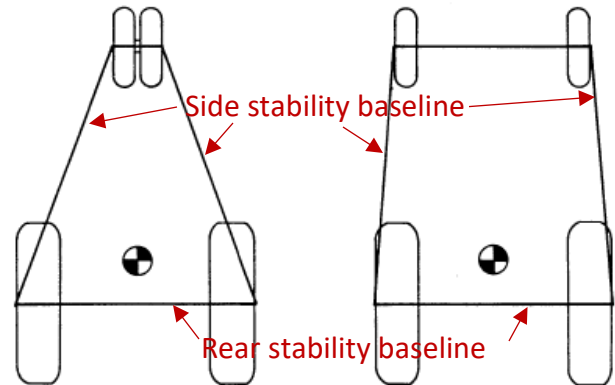
Figure 2. Rear and side stability baselines for narrow front and wide front tractors

The tractor stability baseline is determined when the tractor is sitting on level ground and is defined as the area within the points where the tractor’s wheels contact the ground (Figure 2). The base of stability depends upon the front and rear wheel spacing and the axle-to-axle spacing. To determine the tractor stability baseline, draw imaginary lines to connect all the wheels of the tractor. During tractor operation, the CG moves around. If the CG stays inside the stability baseline, the tractor will not overturn.

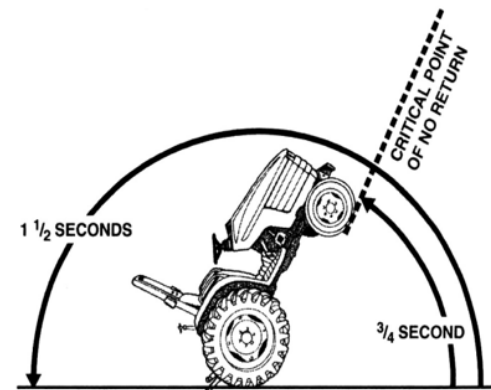
Figure 3. Critical point of no return for tractor overturn to the rear

When the CG moves outside of the stability baseline, the tractor overturns (Figure 3). In this incident, there were several possible reasons why the decedent’s tractor’s CG moved outside the stability baseline:

- The load was hitched high (not hitched to the drawbar).
- The tree may have had limbs embedded in the ground, hooked on a stump or other object, or even the vines were holding the fallen tree in place.
- Power was applied to the tractor’s rear wheels too quickly.
- The front passenger side wheel was not on level ground.

An overturn to the rear may also be caused by rear axle torque. Rear-axle torque relates to the energy transfer between the tractor’s engine and the rear axle of two-wheel drive tractors. When the operator engages the clutch, the result is a twisting force, called torque, to the rear axle. This torque is then transferred to the tractor tires. Under normal circumstances the rear axle (and tires) should rotate and the tractor will move ahead. However, if the rear axle is unable to move in response to the torque, the tractor chassis rotates about the axle. The energy transfer between the engine and the rear axle can result in the front-end of the tractor lifting off the ground until the tractor’s center of gravity passes the rear stability line. Once the center of gravity passes this point, the tractor continues rearward until it comes in contact with the ground.

A tractor may only have to raise up to about 75 degrees from a level surface before its CG passes the rear stability baseline and the tractor weight causes the tractor to continue to overturn to the rear. This position is commonly called the “point of no return.” This point can be reached more quickly than an operator can recognize the problem.

Recommendation #1: Tractor owners should ensure older tractors are retrofitted with a manufacturer approved, certified, tractor specific rollover protection structure (ROPS) and seat belt.

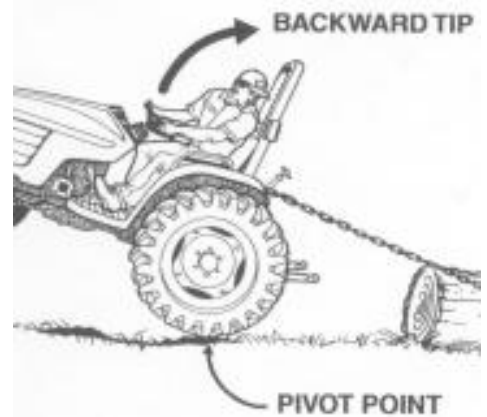
Figure 4. Angle of pull and leverage of load

A tractor, including its drawbar, is designed to safely counteract the rearward tipping action of pulled loads. When loads are attached to a tractor at the drawbar, if the front end of the tractor lifts, the rear drawbar will lower, as the drawbar lowers, the angle of pull and the leverage the load has to tip a tractor rearward is also lowered.

If the load is hitched to a point higher than the drawbar, both the “angle of pull” and the leverage of a load is increased. As the tractor tips rearward, the angle of pull and load leverage are not lowered, the tractor continues to tip and the tractor’s CG reaches the rear stability baseline, and the tractor flips rearward. A higher hitch point also increases the pressure of the rear tires against the ground. If the rear tires don’t slip, rear axle torque will begin lifting the front end.

The decedent hitched high, near seat height, which increased the angle of pull, the leverage of the tree being pulled, and the pressure of the rear tires against the ground. When loads are attached to a tractor at any point other than its designed location (drawbar or other hitch points recommended by the tractor manufacturer), the design of the tractor for pulling loads is defeated.

Recommendation #2: Ensure proper hitching techniques are utilized when using the tractor to pull loads.
