REPORT#: 18KY007 REPORT DATE: 11-5-18

Police Officer Drives into Flood Waters and Drowns

Fatality Assessment and Control Evaluation (FACE) Program

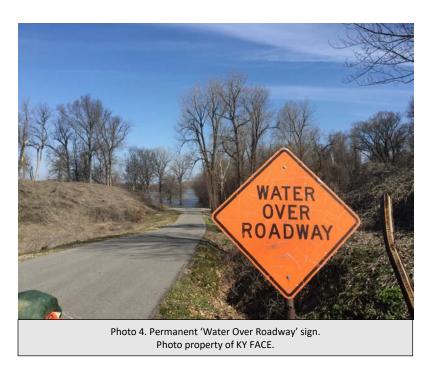
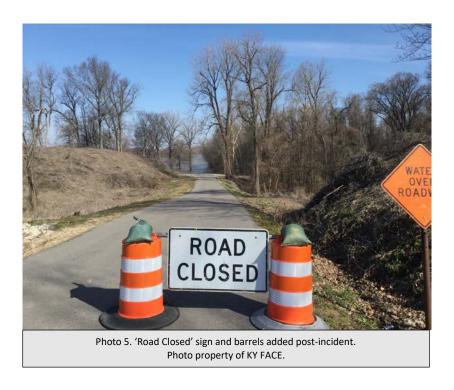
Discussion: When questioned why there were no barriers to prevent vehicles from accessing the area, the chief of police stated the reason was that boaters would use the natural downward slope of the road to launch their boats into the water while the road was flooded, since the permanent dock for launching was under water and inaccessible. At the time of the incident, the only signage warning drivers of floodwaters was a permanent sign stating "Water Over Roadway"; however, since the sign was permanent and not removed during the dry season, it may have been easy for drivers to become complacent and ignore the sign. After the incident, two orange barrels holding a removable sign stating "Road Closed" was placed on the road blocking access to the water. The sign, however, was small and lightweight, and a driver could easily move the sign in order to obtain access to the water. To prevent all vehicles from entering the flooded area, the county road department should consider installing a roadway sign that warns of quick flooding during heavy rains and close the road as quickly as possible with temporary barricades when the road becomes impassible.

Recommendation #1: County road department should install a roadway sign that warns of quick flooding during rain and close the road as quickly as possible with temporary barricades.
