## Fatality Investigation Report

OR 2014-42-1

### Forestry worker in vehicle killed from timber falling activity

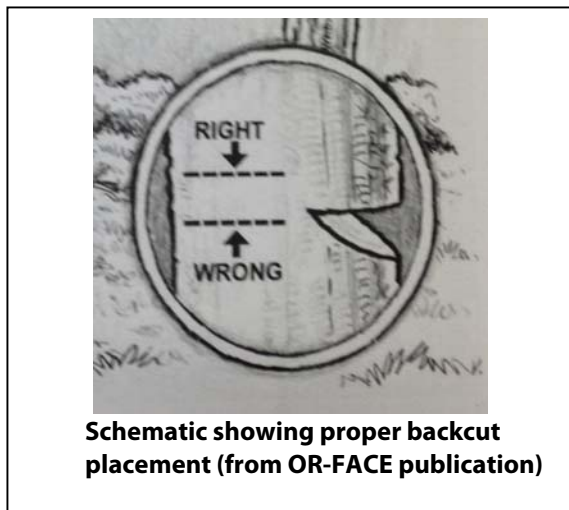
was over 140 feet tall), with a diameter of 36 inches. The OR-OSHA report indicated the distance from the tree stump to the center of the road was approximately 145 feet. The ground below the stump sloped downward toward the road at an approximate 30% grade. The intended lay of the tree was parallel to the road. However, the tree fell 135 degrees away from the intended lay of the tree into the road. The OR-OSHA report noted that in their examination of the tree stump, several unsafe cutting practices were apparent (shown in adjacent photo): sufficient

holding wood was not maintained<sup>2</sup>; low backcuts<sup>3</sup>; and improper cleaning of the face cut. The holding wood on the uphill side of the tree was nearly completely sawn off and only a small 2-inch x 2-1/2-inch hinge remained on the downhill side of the stump. These conditions would

**Schematic showing proper backcut placement (from OR-FACE publication)**

make it more difficult to fall the tree in the intended direction, as its natural lean was toward the road. As the work was being performed the faller used three wedges in an attempt to fall the tree in its intended direction.

- **Employers should assess tree fallers' skills for felling and bucking logs, and require that novice or inadequately performing workers are directly supervised by a qualified person until the faller demonstrates the ability to safely perform these tasks independently.**
