# MIFACE INVESTIGATION REPORT: #09MI085

## Subject: Truck Driver Struck by Semi-Tractor When Walking in Parking Lot

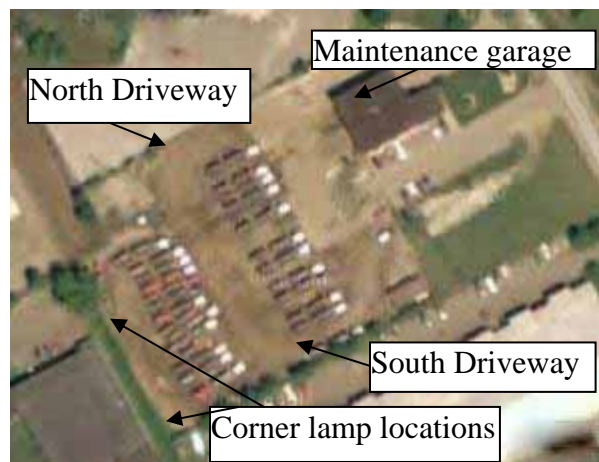
Figure 2. Overhead view of firm's property courtesy of Google Maps.

The parking area was a secured lot by a chain link fence around the property and was restricted to employee access (Figure 2). The surface was dirt and gravel and was muddy at the time of the incident. The parking lot was dark because two corner pole lights located at each corner end at the rear of the parking lot were not functional. There was one white mercury vapor lamp

functional; the light was located behind the open parking space to be used for the gravel train. The parking area was located west of the maintenance shop and had two wide driveways located at its north and south to provide access to the lot. There were two truck rows with a large open area between them (Figures 2, 3 and 4). The lights on the maintenance building were working, as well as one light at the front of the lot. The parking area did not have marked parking spaces or pedestrian walkways.

The firm investigated the reason for the two corner lights not working. On the day of the crash, it was discovered that an underground cable was corroded. The cable was fixed two days later. The sheriff's department tested the mechanic for alcohol at the incident scene and the firm tested him for drugs post accident: no alcohol or drugs were noted.

1. Repair and maintain the lighting at the rear of the parking lot in good working order at all times.
2. Ensure that truck drivers use their head lights when driving in the parking lot at night so that pedestrian are readily seen
3. Do not move truck from repair bay into the parking lot during periods of darkness to avoid employees on foot walking through the lot.”
