Massachusetts Department of Public Health Occupational Health Surveillance Program Fatality Assessment and Control Evaluation Project

Municipal Laborer Dies after Falling Off the Back of a Forward Moving Refuse Collection Truck – Massachusetts

Investigation: # 09-MA-020-01 Release Date: November 6, 2009

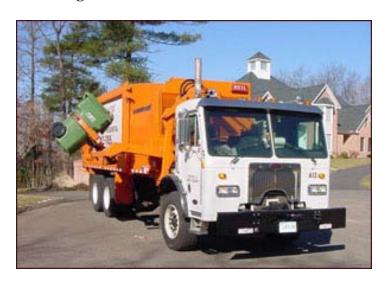
Discussion: In this case, the city was preparing to pilot an automated refuse and single stream recycling pilot program for refuse collection in four city neighborhoods. This program will implement the use of large wheeled carts (65-gallon and 95-gallon) that residents wheel to the street curb. Most collection trucks will have crews of two workers, including the drivers. The trucks will be newly purchased with or retrofitted with an automated arm that will hook onto the carts and dump the cart's contents into the truck's hopper (Figure 3).

Figure 3 – Automated collection truck.

Recommendation #7: Employers should consider the feasibility of implementing automated processes for refuse collection.

Automated systems will reduce the need for workers to ride on the truck's rear riding steps and limit the amount they are lifting each day. As with all new processes, a complete hazard analysis should be performed prior to and during the implementation stages of this program. ⁴
