# MIFACE Investigation #06MI007

## Subject: Forklift Driver Pinned Under an Overturned Forklift Dies

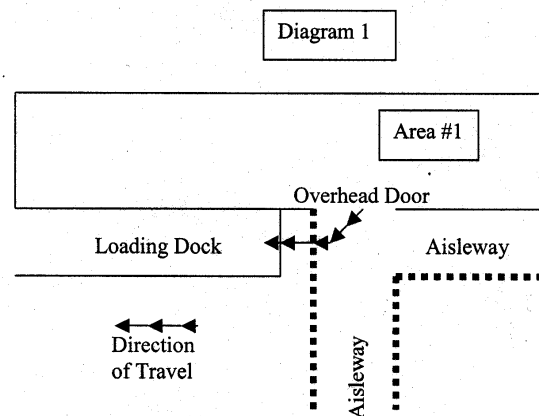
Figure 4. Position of loading dock in relation to overhead (O/H) door

Investigation of the incident scene noted that there were no skid or brake marks on the plant floor. The decedent was not carrying a load at the time of the incident. It appears that the forklift was driven off the dock while traveling in reverse based upon the position of the truck. Neither the forks nor the mast appeared bent, as would have been the case if he had been traveling forward and drove off of the dock edge. The counterweight attachment bolt sheared, and the counterweight had detached from the machine and was lying to the side. A fresh impact point was noted in the cement of the truck well approximately three and one-half feet from the top of the loading dock. The left rear tire was approximately five and one-half feet from the edge of the loading dock platform.

- Employers should install drop-off protection capable of withstanding forklift impact on a loading dock entrance when the dock entrance is near a normal path of travel for a forklift or pedestrian.
- Employers should enforce employee use of the operator restraint provided by the forklift manufacturer (in this case, a seatbelt).
- If the truck is not transporting a load that obstructs forward vision, forklift operators should limit the distance that the truck travels in reverse.
