# MIFACE INVESTIGATION #05MI089

## SUBJECT: Retired Teacher/Farmer Dies When Pinned Under Overturned Tractor.

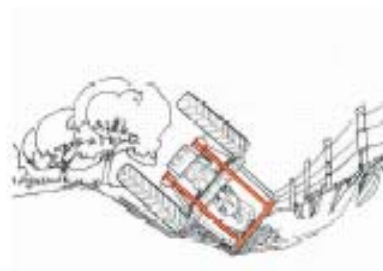
Figure 7. Operator Zone of Protection

Older tractors can be equipped with rollover protection structures and seatbelts. Rollover protection structures (ROPS) have been required by federal and state law for all tractors used by employees (with limited exception) in agricultural operations that were built after October 25, 1976. There are two basic types of ROPS for farm tractors: protective frames (two- or four- post structures attached to the tractor chassis) and protective enclosures (cabs or enclosures built around a protective frame). ROPS are designed to help limit a tractor overturn to 90 degrees and to provide the operator a “zone of protection” (Figure 7). The operator must stay within this zone. The operator will not be protected by the ROPS during an overturn if the operator is not wearing a seatbelt. Without a seatbelt, the operator may be totally or partially thrown off the tractor. The seatbelt keeps the operator within the "zone of protection" provided by the ROPS. Even inside a cab, seat belts are important to keep the operator from being thrown against the frame, through a window, or out a door. Therefore, when an older tractor is retrofitted with a ROPS, approved seatbelts must also be installed. Seat belts may or may not be included with an available ROPS package.

- Retrofit older tractors with properly designed, manufactured and installed rollover protective structure (ROPS) and seat belt when available.

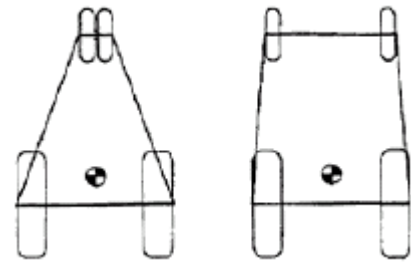
Figure 8. Stability baselines for tricycle and wide front-end tractor

To prevent an overturn to the rear or side, the tractor operator must keep the tractor's center of gravity within the tractor's stability baseline. A tractor's center of gravity is the point where all parts balance one another. Stability baselines are imaginary lines drawn between points where tractor tires contact the ground (Figure 8). If the tractor's center of gravity moves outside the stability baselines, the tractor will overturn. When a tractor (or any piece of equipment) is on a hill, the distance between the equipment's center of gravity and the stability baseline is reduced.

While on the slope, the decedent may have struck the stump or steered the tractor toward the base of the slope. The stump and/or the slope were sufficient to “move” the center of gravity to the outside of the stability baseline between the front and rear tire. When the center of gravity moved outside the stability baseline, the tractor overturned to the side (Figure 9). It is unknown how fast he was driving; his speed may also have played a role in the overturn.

- Practice safe work procedures when operating tractors and/or tractors and accessory equipment on slopes or where there may be unseen obstacles.

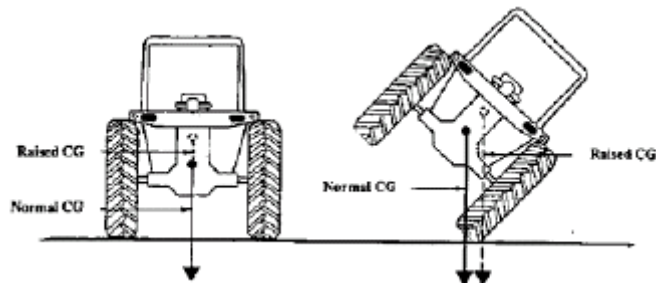
Figure 9. Higher center of gravity allows a side overturn to occur more quickly

It is very difficult to visually calculate whether a slope is too steep to safely operate a tractor. There are many work practices that can be adopted to minimize the risk of a side overturn. Equipment operators should set the wheel tread at the widest setting suitable for the job to be performed and restrict speed according to operating conditions (if towed equipment fishtails, speeds should be reduced). It is unknown if the mower had stabilizer bars to prevent side-to-side movement. Operators should not let the tractor bounce and slow down before turning. When possible, avoid crossing steep slopes. Keep the heavy end of a tractor pointed uphill on the slope. Back up steep slopes and keep side-mounted equipment uphill. If you must cross a slope, inspect the terrain prior to crossing. Depressions on the downhill side and obstructions on the uphill side can contribute to a tractor overturn to the side.
