### **Deckhand killed when struck by collapsed boom**

**FACE 99-AK-020**

**Release Date: August 28, 2000**

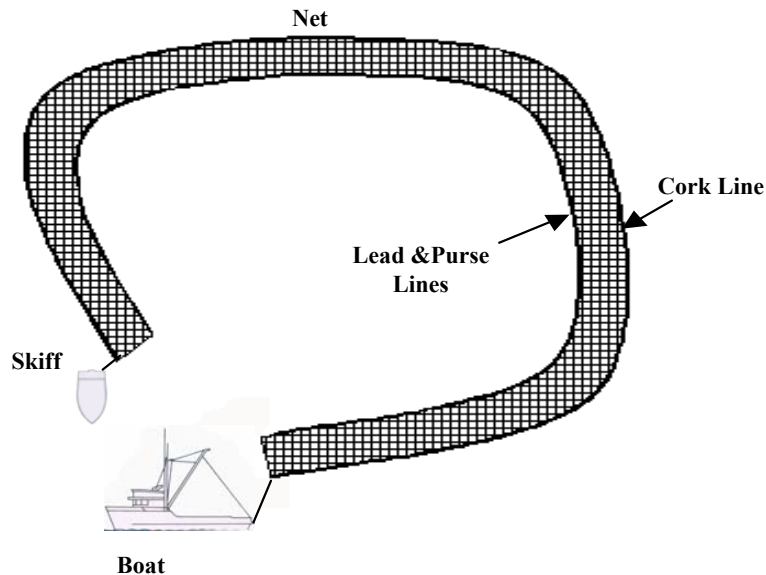
Figure 3. Diagram of net placement in nurse seine fishing

To place the net in the water, one end of the net was attached to a skiff. The other end was fastened to the vessel. The skiff drew out the net and circled back around to the vessel (thus encircling the fish to be harvested) (Figure 3). The net floated in the water like a curtain, held vertical by a cork line (on top) and a lead line (on the bottom). A purse line was used to close the bottom of the net to create a bag or a purse.

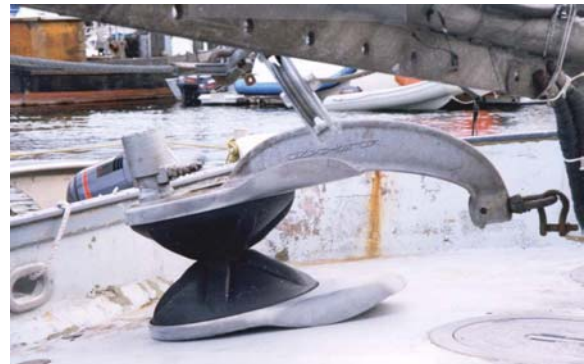
Figure 4b. Power block

A power block was used to pull the net back on board the vessel. The block was hydraulically powered with a V-shaped sheave lined with rubber (Figure 4a and 4b). The power block hung from the boom above the aft part of the vessel. As the power block brought the net on board, one or two deckhands stood under the boom to pull down on the net (to help it through the block) and
