FATALITY ASSESSMENT AND CONTROL EVALUATION

**Ironworker Foreman Crushed when Bridge Support Element
Broke During Dismantling
Case Report: 05NY013**

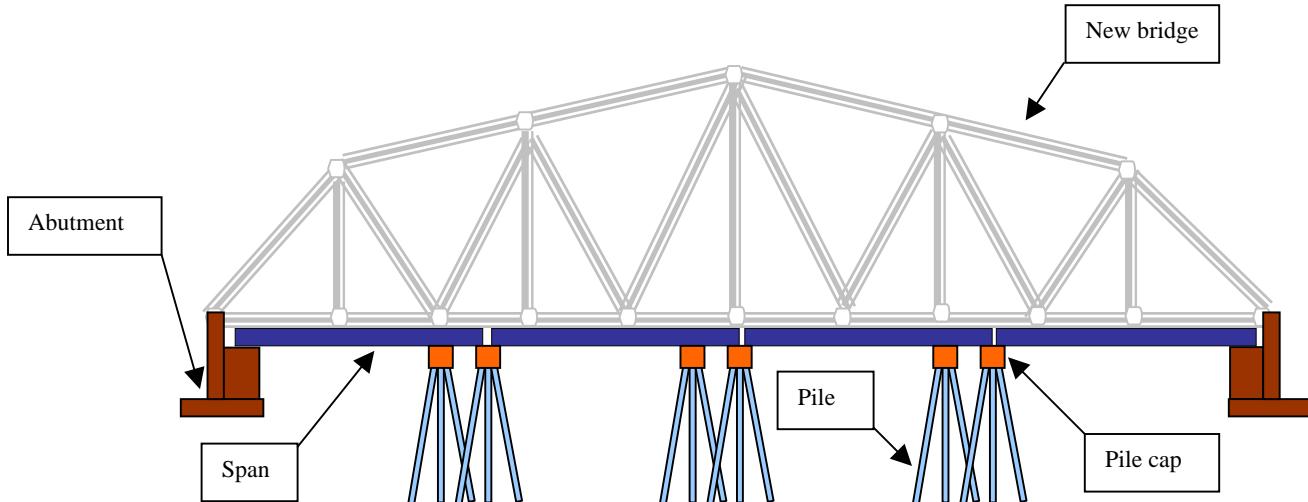
The temporary under-bridge had four spans that were supported by six steel piles and the abutments (Figure 1). There was a pile cap (Figure 2 and Photo 1), a triangular-shaped steel element weighing approximately 8,000 lbs., on top of each pile and the spans rested on the six pile caps. A span was a steel framework consisting of two pairs of 77-foot-long steel W36 I-beams and several W12 I-beams (Figure 2). In preparation for dismantling, the caps were welded and chained to the ends of the W36 beams by a test steel chain. The spans along with the attached pile caps were then removed one at a time from the temporary bridge support and placed on a floating barge where the remainder of the dismantling took place (Photo 2).

Figure 1. Illustration of the four-span steel under-bridge.

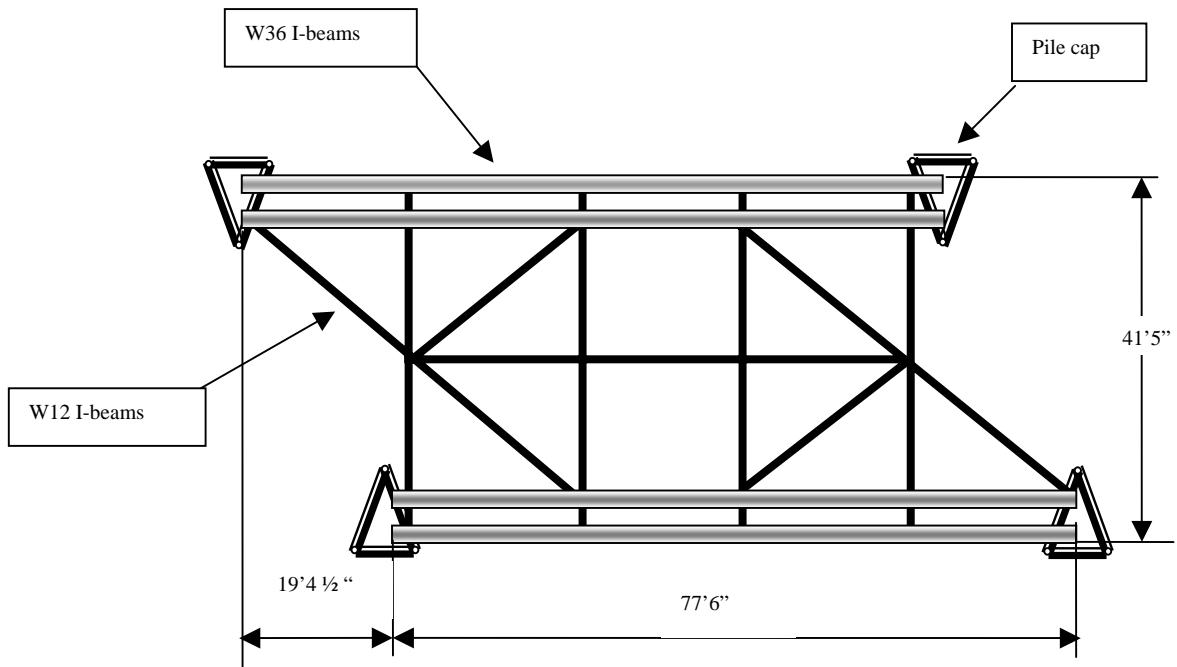
Figure 2. Overhead depiction of the third span of the temporary under-bridge.

The major task of that day was dismantling the third under-bridge span along with the four pile caps attached to it. The span was placed on the barge approximately ten feet above the water. The company required workers to wear fall protection and to be tied to an anchorage when working ten
