Nebraska FACE Investigation NE-2005-12

Construction Worker Struck by Falling Steel Roof Beam

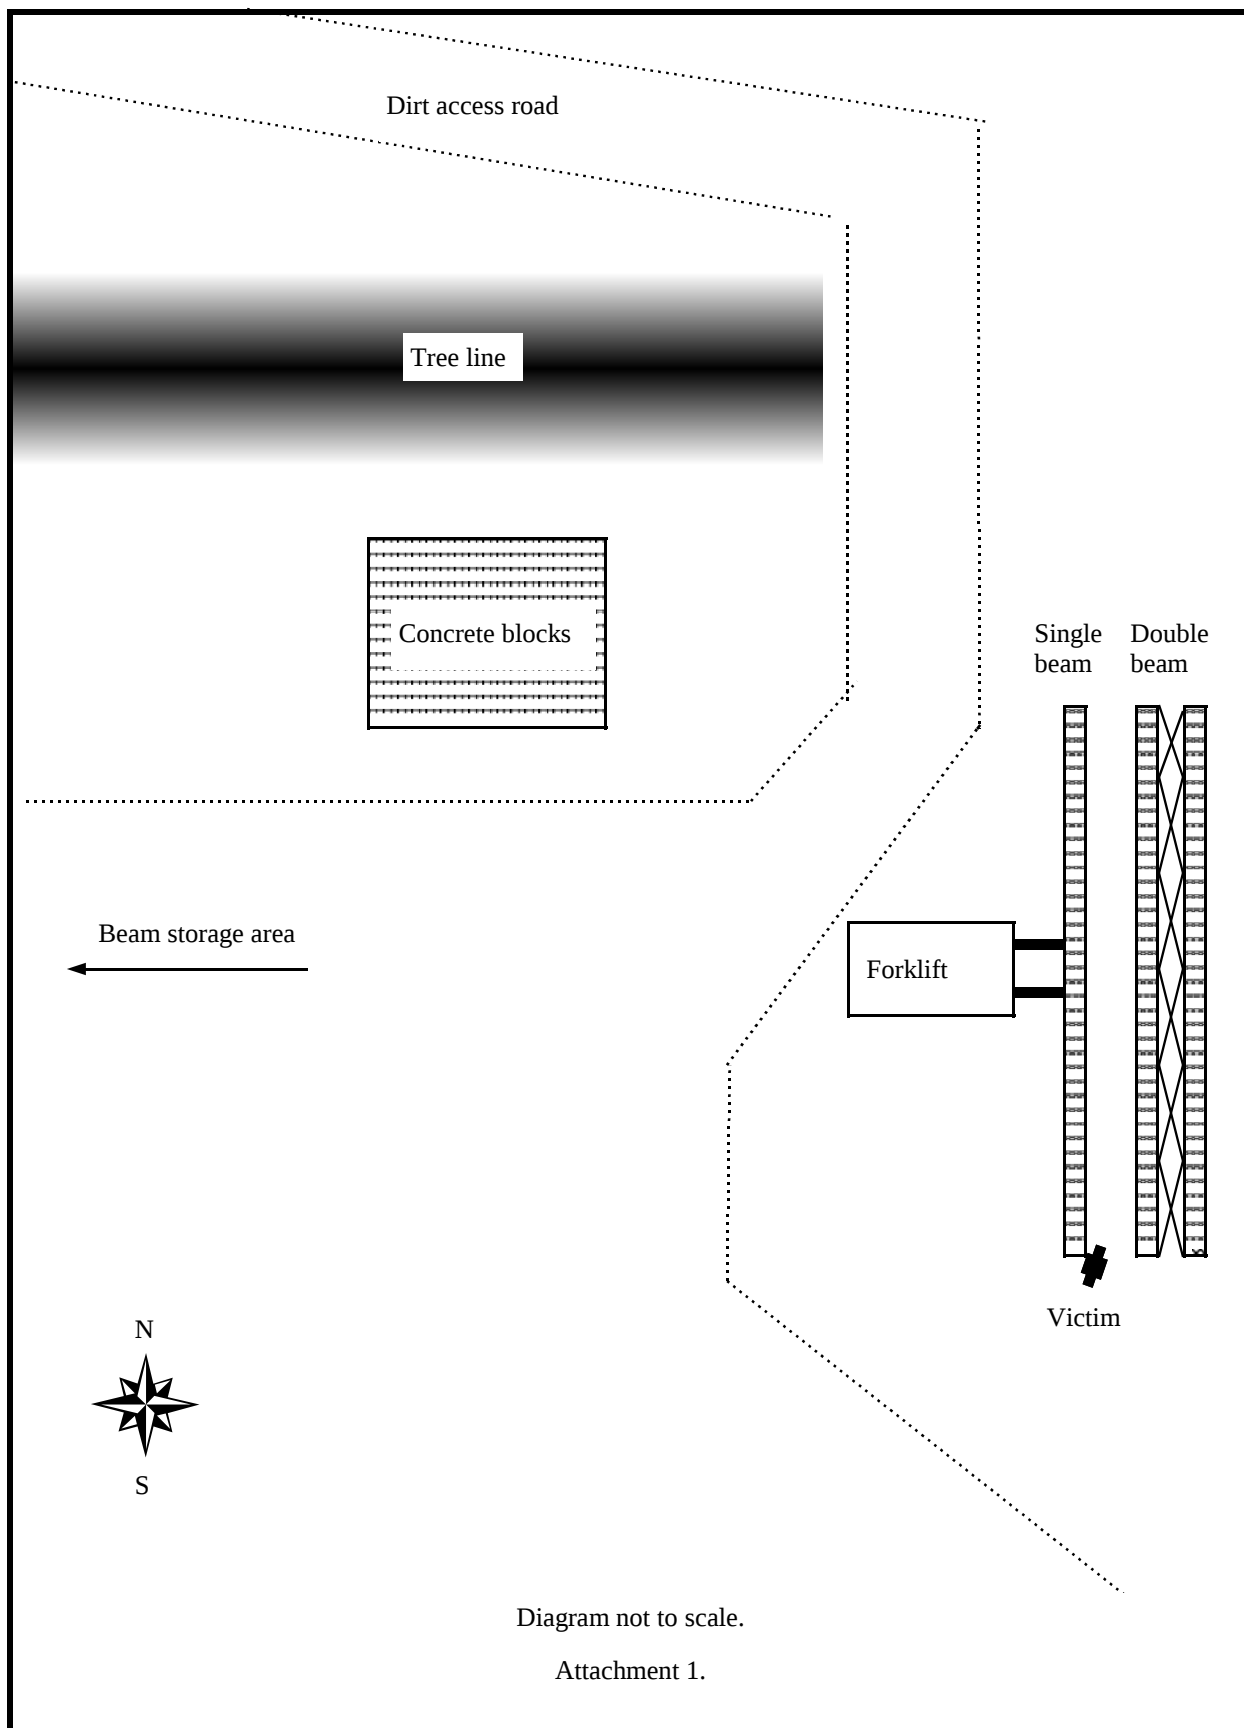
This picture was taken the day after the incident looking north. This is the single beam that fell from the forklift tines. The black oval indicates the approximate location of the victim's body after being struck by the beam, which was in a crouched position. The black arrow points to the two 4x4s that this end of the beam was to rest on. It is believed that the top 4x4 was not centered properly and the victim darted underneath the raised beam end to align the boards. The victim was struck by the beam, but was not trapped between the single beam and the paired beam to the right.
