FATALITY ASSESSMENT AND CONTROL EVALUATION

Department Store Employee Crushed In a Baling Machine Case Report: 04NY013

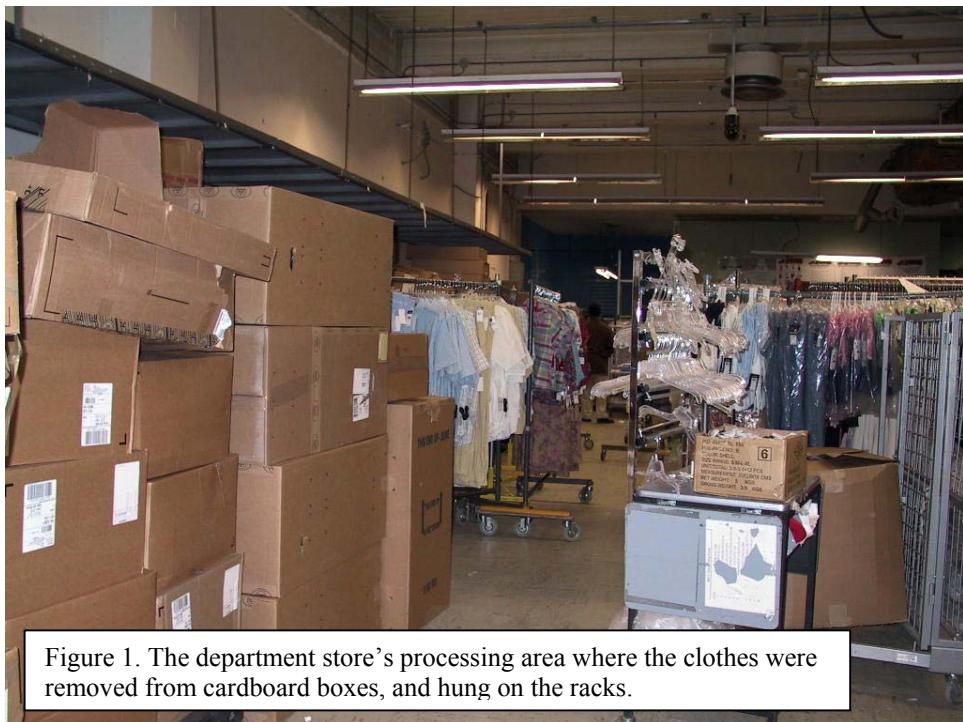
The department store was housed in a three-story building consisting of a lower level, the main floor and the second floor. The processing department (Figure 1) was on the second floor. Merchandise (clothing) in cardboard boxes was brought up to the processing department through a freight elevator. The processing associates were responsible for removing the clothing from the boxes, placing sensor pins on the clothing, and hanging them on the racks to be taken onto the store floor. After the merchandise was removed, the cardboard boxes were stacked to be baled.

Figure 1. The department store's processing area where the clothes were removed from cardboard boxes, and hung on the racks.
