Separate Rotating Shafts Entanglements Kills Two Massachusetts Fishermen

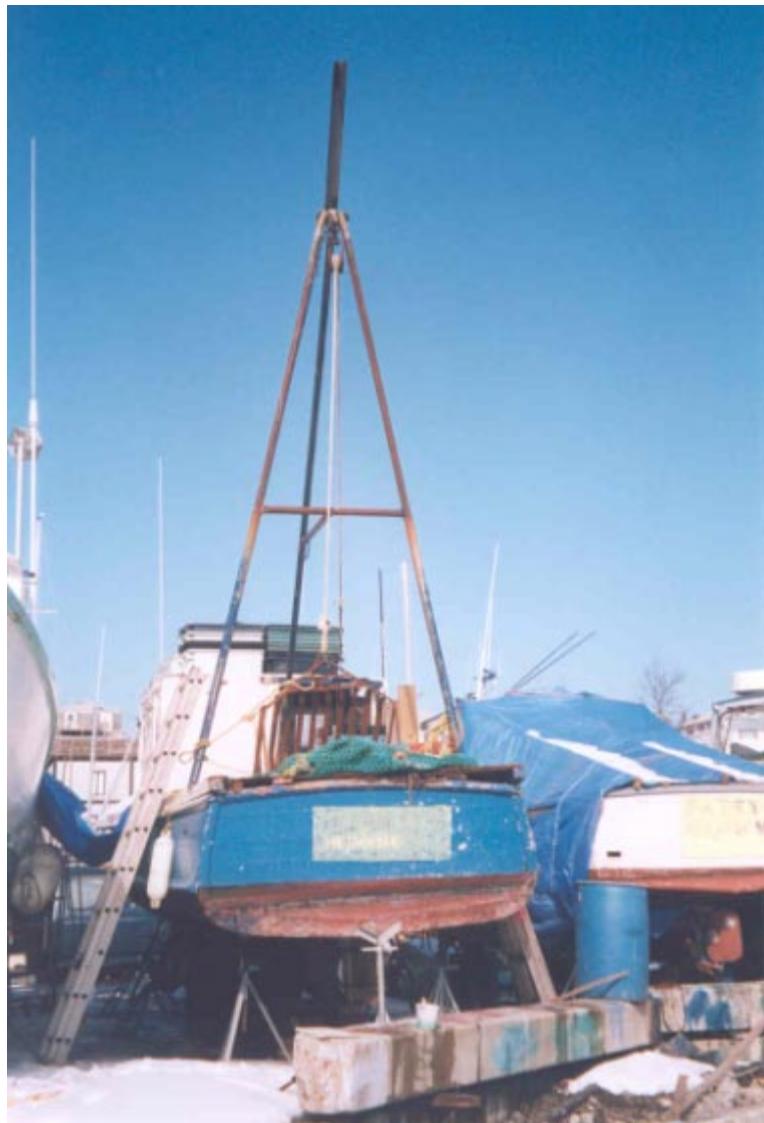
Prior to checking the transmission, the victim had removed the rectangular wooden deck cover exposing approximately 1½ feet of the 1½ inch diameter transmission propulsion shaft and coupling. It was stated in the Coast Guard Report that the son heard a loud clanging sound and then the engine immediately shut down. The son turned around and found his father entangled in the propulsion shaft.

Figure 1 - Open deck cover exposing a section of the transmission, flanged coupling and propulsion shaft. (Incident #2)

Recommendation #1: Fishermen should disengage the transmission before attempting to work on or near a propulsion shaft and coupling.

Recommendation #2: Fisherman should guard moving machine parts, such as propulsion shafts and couplings, to avoid contact.
