THE UNIVERSITY OF IOWA
Iowa City, Iowa 52242

SUBJECT: Two mechanics crushed to death when tow truck falls from jack stand.

SUMMARY

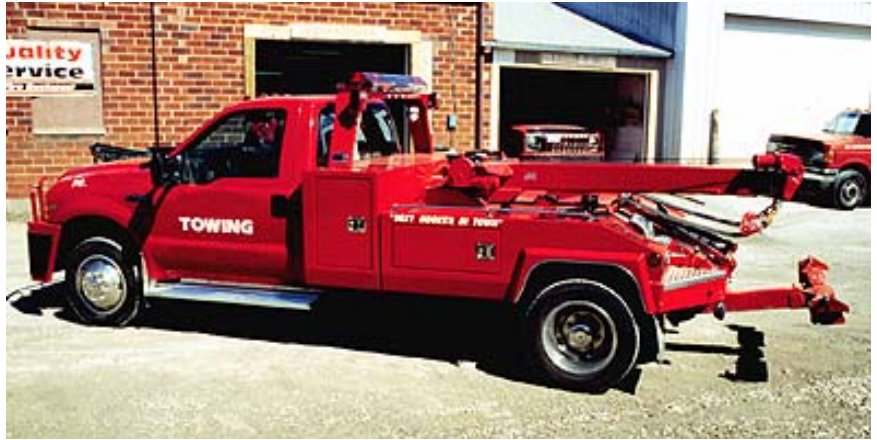
During the spring of 1998, two male auto mechanics, ages 42 and 48, were killed while working under the back end of a tow truck. The men were doing routine repair work on the rear axle and differential of the truck. The back end of the truck was raised from the floor and supported by

the hydraulic central arm of the wheel lift at the rear of the tow truck. One jack stand was placed under the central arm to gain more height. This is a common practice during maintenance of tow trucks, as the wheel lift hydraulics are both power-up and power-down, and therefore, are capable of raising the back of the tow truck. Older wheel lifts had 4-way operation, up-down, and in-out. This wheel lift was a newer 6-way model, which had two additional movements, tilt up, and tilt down. The wheel lift arm was tilted up slightly when the jack stand was put underneath. The parking brakes were ineffective on the truck because the rear wheels had been removed after the truck was raised. The front wheels were not chocked, therefore there was little resistance to the truck rolling forward. No additional jacks or supports were put under the truck before the men began work. As the men worked on the rear axle, they caused the truck to roll slightly forward. The jack stand slipped backwards off the tilted wheel lift, and the rear end of the truck fell to the floor, instantly killing both men underneath.
