**FATALITY ASSESSMENT & CONTROL EVALUATION
OCCUPATIONAL FATALITY REPORT**

Subject: Hispanic Tower Erector
Falls to Death from Television Tower

January 4, 2005

Nebraska FACE Investigation NE 2003-019

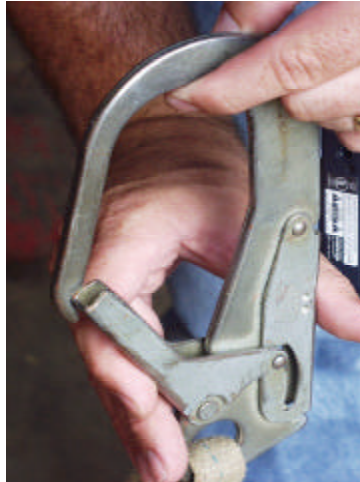
Two examples of other off-set pelican hooks found in the on-site equipment trailer. Note both have the tip off-set from the latching device due to side load pressures being applied.
