Truck Driver Dies After the Off-Highway Truck He was Operating Rolled Over an Embankment and Came to Rest on Its Top-Pennsylvania**SUMMARY**

*Truck rollover***Fatality Assessment and Control Evaluation (FACE) Program**

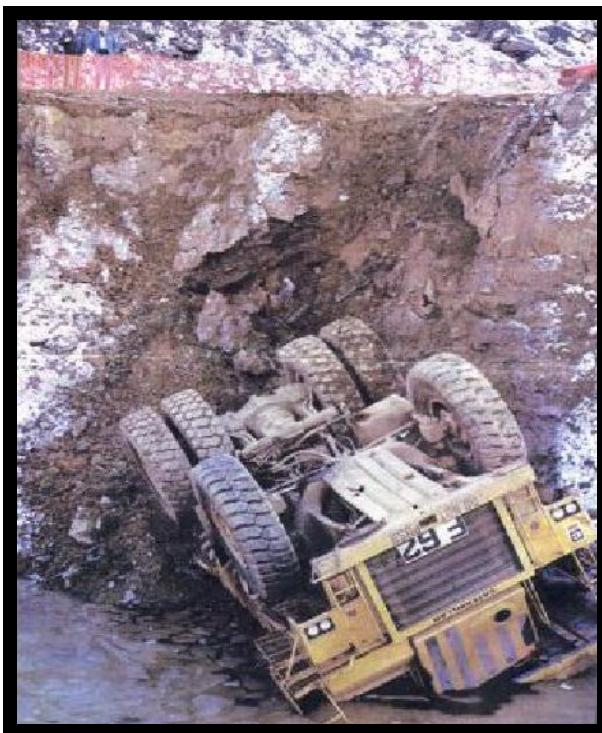
A 48-year-old male truck driver (the victim) died after the off-highway truck he was operating rolled 49 feet over an embankment and came to rest on its top in 4 feet of water. The victim was hauling dirt that was being cut from a bank to clear ground for a 3-mile stretch of a new freeway project. As the victim was traveling up a haulage road, a road grader that was scraping mud from the road was traveling toward him from the opposite direction. The victim steered the truck to the right to allow the grader to pass. As he did, a portion of the built-up haulage road gave way under the truck's right-side tires, causing the truck to overturn. The truck rolled over twice while traveling 49 feet down the embankment, and came to rest on its top in 4 feet of water. The grader operator immediately ran to the truck and pulled the victim clear. With the help of two flaggers, they placed the victim on the bottom of the truck cab. The two flaggers initiated cardiopulmonary resuscitation (CPR) on the victim while the emergency medical service (EMS) was called from a company truck. The EMS arrived at the scene within 8 minutes and summoned the county coroner, who pronounced the victim dead at the scene.
