# **Chinese Immigrant Restaurant Owner Electrocuted**

**Incident Number: 02KY131**  
**Date of Incident: August 12, 2002**  
**Report Release Date: August 14, 2003**

## **Kentucky Fatality Assessment and Control Evaluation (FACE) Program**

**Subject:** Chinese Immigrant Restaurant Owner Electrocuted

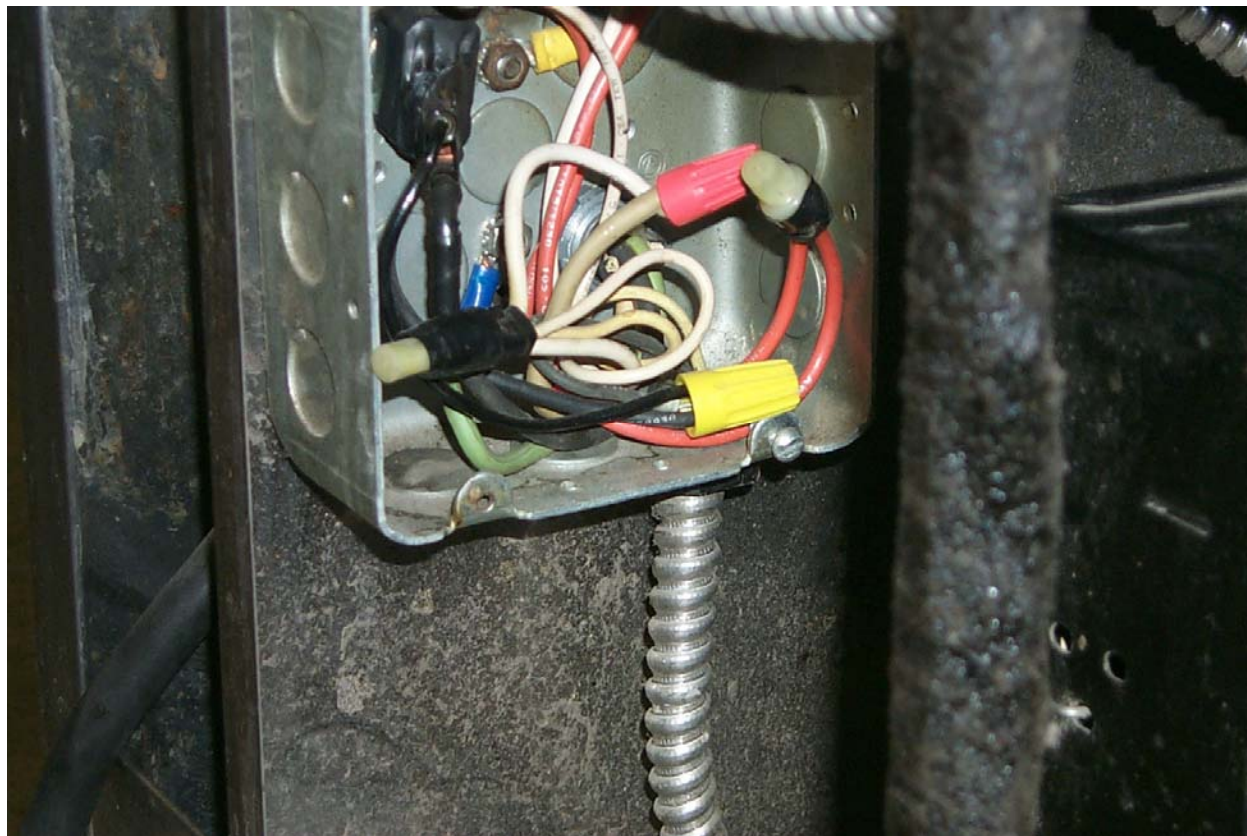
around the kitchen to keep it out of the way as they cleaned. The electrical cord to the cooler was not long enough to allow much mobility of the cooler and have it remain plugged into the wall. In order to increase the distance the cooler could be moved and still remain plugged into the wall, the restaurant owner replaced the electrical cord of the unit with a self-fabricated extension cord composed of a 10 foot length of 10/2 wire and a one foot length of extension cord. The decedent wired the 10/2 wire to the electrical panel in the back of the cooler and spliced the other end into one foot of extension cord. He wrapped the spliced area with electrical tape then plugged the unit into the wall receptacle. During the course of the day, the man and his wife moved the cooler to different locations around the kitchen. The first time the cooler was moved, it felt normal to the touch. However, subsequent to the initial move, each person moving the cooler felt a slight tingling to their hands when they touched the metal frame. The ground wire had detached from its connection to the electrical panel inside the cooler. The exposed ground came into contact with the metal side of the cooler. This energized the outside of the cooler.

The wire the decedent chose to use to fabricate the extension cord is very rigid and does not allow flexibility in movement. The stiffness of the wire caused the connection to fail and the

wire to become loose and touch the metal frame of the cooler. It is unknown why he chose 10/2 wire instead of a more flexible wire to fabricate the extension cord. Also unknown is why the decedent chose not to plug the existing cord into an approved extension cord to lengthen the existing cord.

**Perform a hazard evaluation at work site before any work is commenced.**

A hazard evaluation should be conducted of any worksite.
