SURVEY REPORT

OPTIONS FOR THE CONTROL OF BORDER AGENTS EXPOSURE TO VEHICLE EMISSIONS: RECOMMENDATIONS FOR A PILOT STUDY

**United States Port of Entry
Calexico, California**

**REPORT NO.:
EPHB 010-04a**

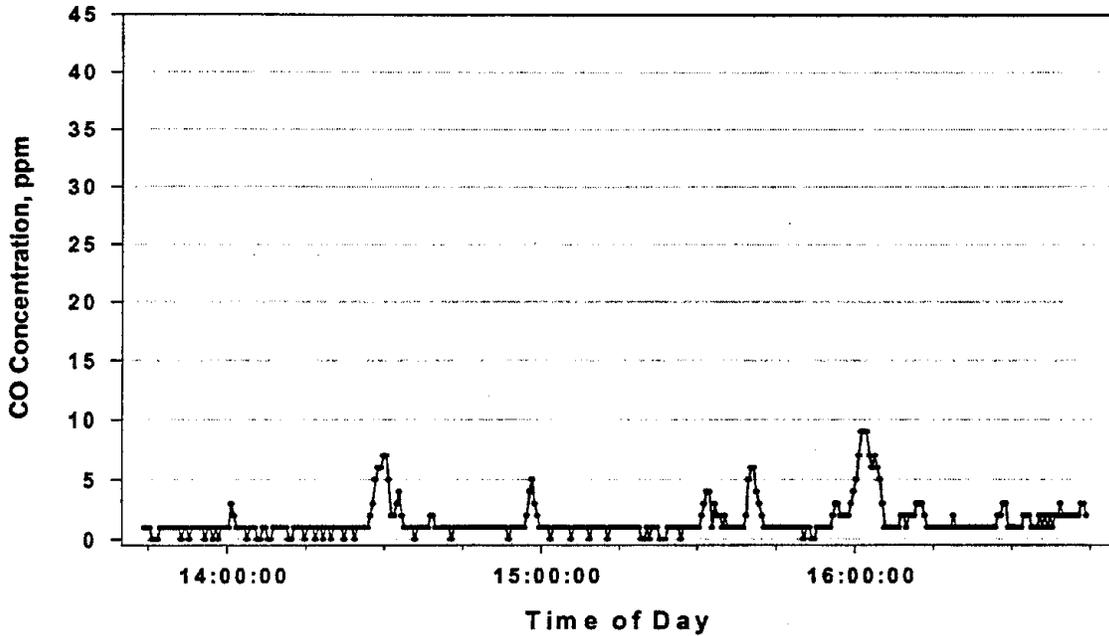
Figure 8
CO Concentration-Area Sample
Primary Inspection Lane 3
November 15, 2000

Figures 8 through 13 show area CO measurements taken from inside booths and around the primary inspection area. Where possible, the CO concentration scale on these graphs has been kept constant to allow for better comparison from agent to agent and booth to booth. Figure 10 shows the CO concentration at the inlet to the fan which provides air to the pedestal supply blowers. Area concentrations were logged at a rate between 1/ 10 seconds or 1/minute using the ToxiUltra CO monitors. Figures 14-20 show paired CO measurements which were taken for comparison between agent and booth interior concentrations. The paired samples were collected for a duration between 10-50 minutes. The ToxiUltra was set to log data at a rate of 1/second during these measurements. This high rate was necessary to capture the temporal CO variations necessary for video exposure monitoring.

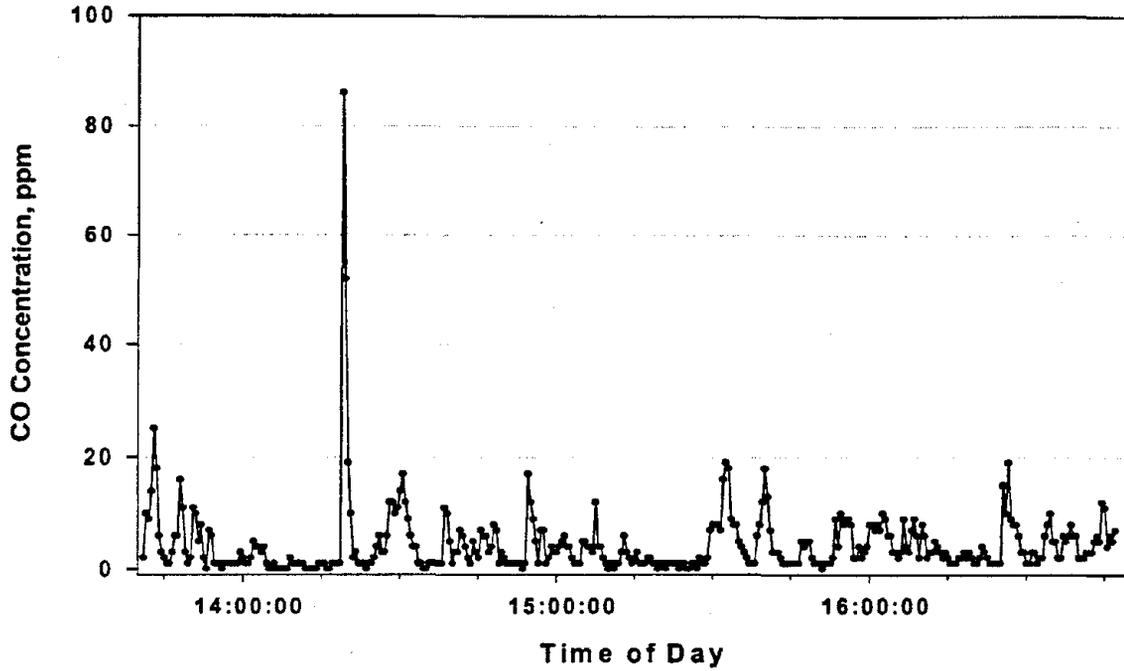
Figure 10
CO Concentration-Area Sample
Inlet to Pedestal Supply Fan, SF-1
November 16, 2000

The design and operation of the pedestal blowers is also a concern. The current system is not located or directed properly, has not been well maintained, and the inlet is located in an area that is easily contaminated with vehicle exhaust. The primary problem with the current system is the placement of the pedestal with respect to the tailpipe. This current system is ineffective at blowing the vehicle exhaust away from the inspection stations and diluting the contaminants. The louvers on all of the pedestal blowers were damaged and the airflow dampers were not labeled as to which position was open and which was closed. Further, the supply for these blowers is taken from supply fan, SF-1, which is located at ground level in the primary inspection area near lanes 1-3 (see Figure 1). The inlet location is in an area that is easily contaminated with vehicle exhausts. The CO monitor which was placed at the inlet to SF-1 showed a peak concentration of 86 ppm with a 3 hour average of 5 ppm. Each of these problems must be addressed in order to improve the performance of the current system.

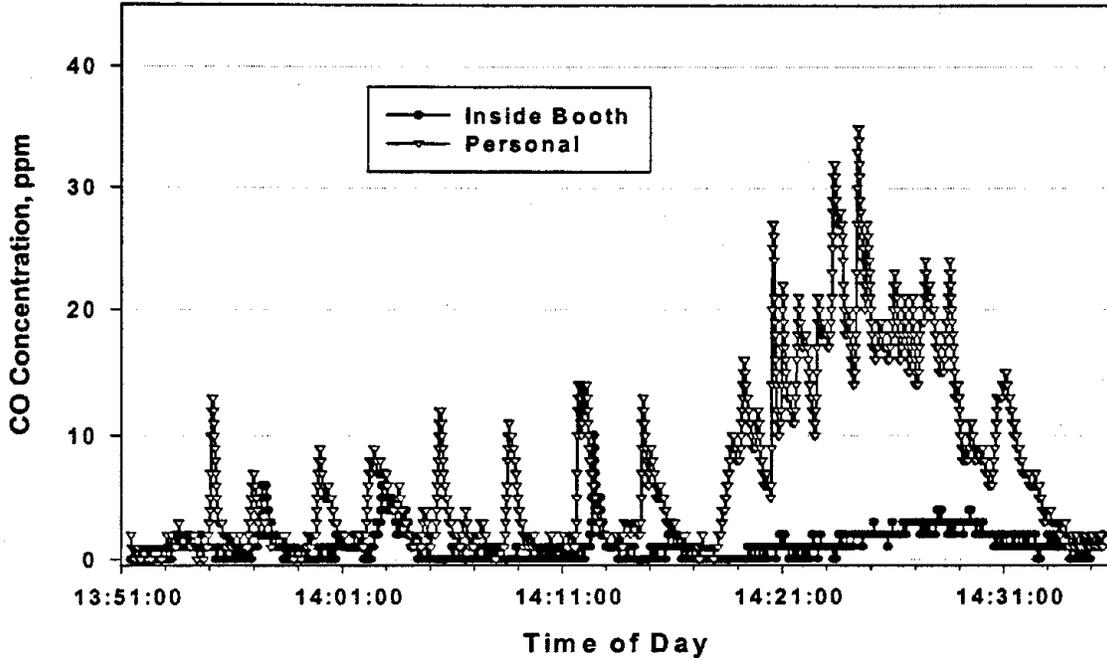
Figure 14
CO Concentration-Area and Personal
Primary Inspection Lane 4
November 15, 2000

The matched area/personal samples were collected for two primary reasons: 1) to evaluate the protective nature of the booth ventilation and 2) to provide data for video exposure monitoring. The key findings were that the booths seemed to provide good protection when the ventilation systems were operating properly. Figures 14, 15 and 16 show the effectiveness of the booth in controlling CO concentrations in lanes 4 and 1. The average CO concentrations in Lane 4 during the time period from 2:46 p.m.-3:01 p.m. (see Table 2 and Figure 15) was 15 ppm for the personal sample on the agent while the average inside the booth was 1 ppm showing a reduction of 93% over a 15 minute time period. Also the peak exposure was 95 ppm on the agent versus 11 ppm inside the booth resulting in a reduction of greater than 88%. In Figure 14, the peak CO concentration reaches 35 ppm while the corresponding peak in the booth is approximately 3 ppm. These examples indicate the exposure reduction potential of adequate ventilation.

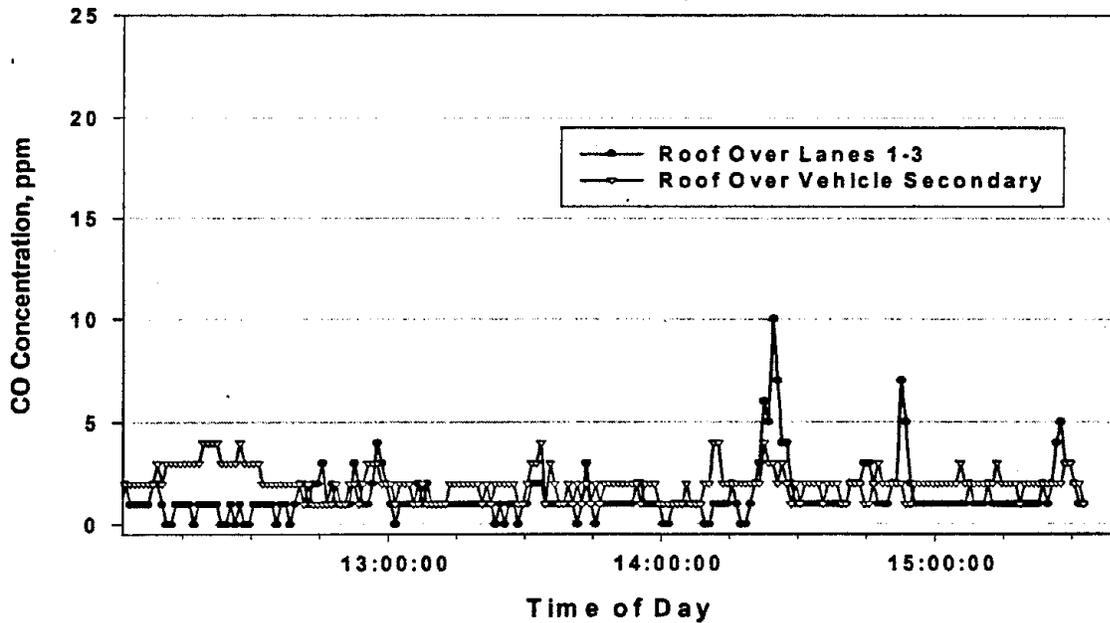
Figure 21
CO Concentration-Area Sample
Roof Top Area
November 15, 2000

Rooftop area CO concentrations are shown in Figures 21-23. These measurements were made at a sample rate of 1/minute or 1/10 seconds using the PHD Ultra Multi-gas monitor. These areas were monitored at a frequency of 1 sample/minute in the afternoon of November 15 and overnight and at a rate of 1 sample/10 seconds on the morning of November 16. Figure 21 shows the result of CO sampling from 12:00 p.m. until 3:30 p.m. on the afternoon of November 15. Figure 22 shows the results of CO sampling 4:35 p.m. to 12:25 a.m. on November 15-16. And Figure 23 shows the results of CO sampling from 8:56 a.m. until 9:50 a.m. on the morning of November 16.

The roof top CO measurements showed low CO concentrations during the day and much higher concentrations during the evening period. For November 16, from 8:56 a.m. to 9:50 a.m., the three rooftop area CO concentrations were low with averages of 0 ppm. The afternoon time frame on November 15, from 12:02 p.m.- 3:32 p.m. showed averages of 1 ppm or less. The evening time period, from 4:35 p.m. to 12:35 a.m. showed averages of around 7 ppm for all sensors. The CO concentration trace shown in Figure 22 shows all sensors tracking together during this time period. This indicates that the concentration of CO was fairly homogeneous throughout the roof area. It also indicates that CO concentration increases during the period when car traffic increases and as winds subside consistent with evening atmospheric inversion. This phenomenon is important in that a source of fresh air may not be available during the evening hours at the roof top level. It may be necessary to build a stack or research pollutant removal options for the fresh air supply to reduce CO concentrations in the primary inspection area. It would also be prudent to evaluate the exposure of office workers during the swing (4 p.m.- 12 a.m.) and graveyard shifts (12 a.m.-8 a.m.). The source of fresh air for those areas is also on the rooftop and may be contaminated during periods of inversion, high traffic, or if the exhaust from the soffit fan stack is re-entrained.
