NIOSH CONTROL TECHNOLOGY ASSESSMENT
at
Uniroyal Tire Company
Ardmore, Oklahoma

Date of Survey:
April 14 - 24, 1980

Report Written by:
Matthew K. Klein, P. E.
William A. Heitbrink, C. I. H.
Date of Report: August 5, 1981

Engineering Control Technology Branch
Division of Physical Sciences and Engineering
National Institute for Occupational Safety and Health
Cincinnati, Ohio

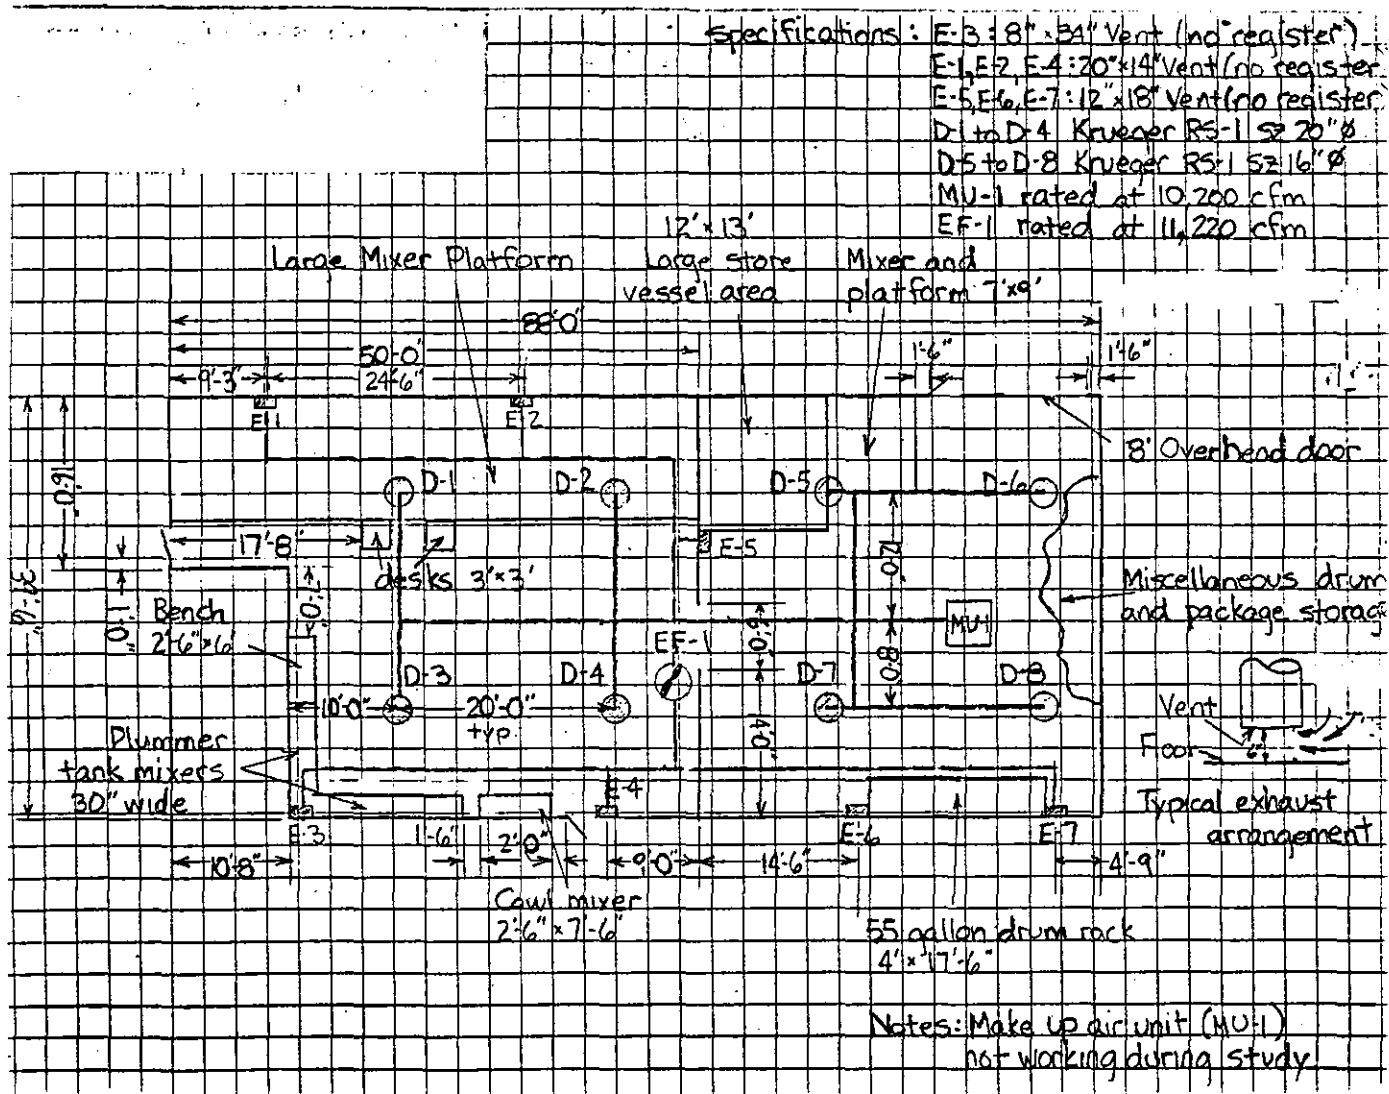
Figure 10-1. Cement house layout.

Make up air was supplied to the cement house by circulated cone diffusers located about 17 feet above the floor. Their locations are shown in Figure 10-1. During the study the make-up air system was not operating.

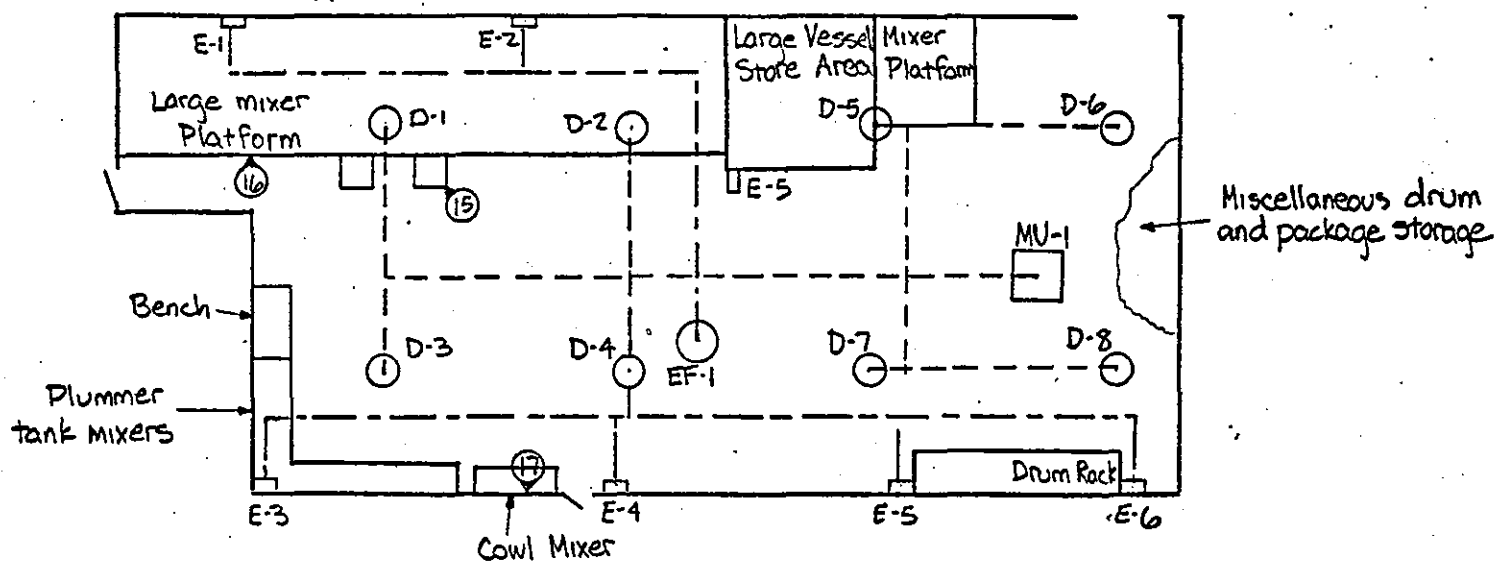
Figure 10-4. Cement house sample locations.

Note: Make up air unit (MU-1)
not working during study

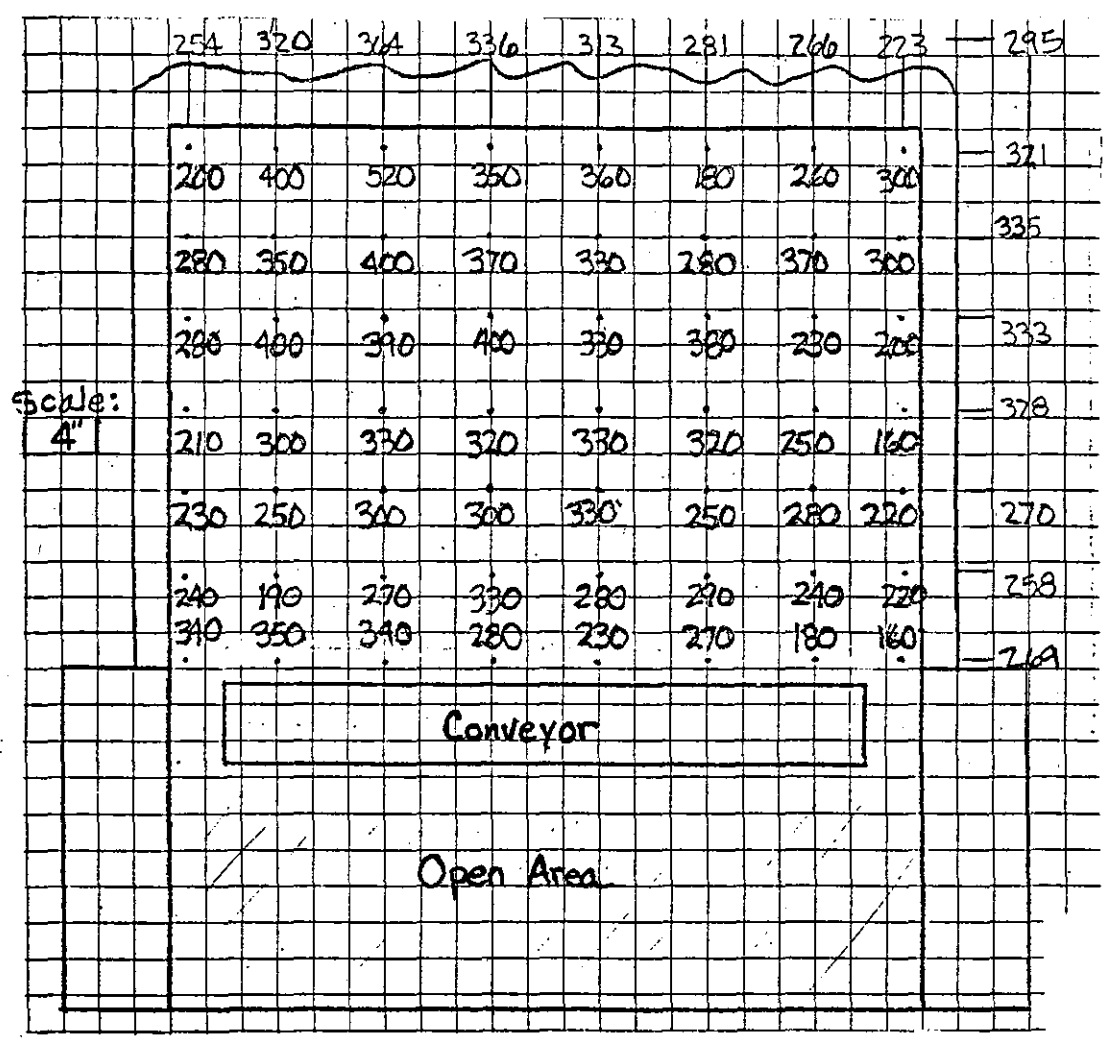
Figure 4-5. Mixer charge door hood slot velocities.

1. The original design called for dust ring hoods on the mixer, but these had been removed and appear to have been used for the items in (2).
2. The drawings do not call out two of the internal mixer vent exhausts (not the "tell-tale hood" vents) and two slots on the charge door hoods (slots C and F in Figure 4-5 in Appendix IV). The exhaust supply for one or both of these sets appears to have come from the hoods mentioned in (1).

3. The tell-tale hoods were added after original installation of the ventilation system as mentioned above.
4. Cleanout doors were added to the lower slot duct entrances on the charge door hood (slots B and G in Figure 4-5) shortly after the original installation.

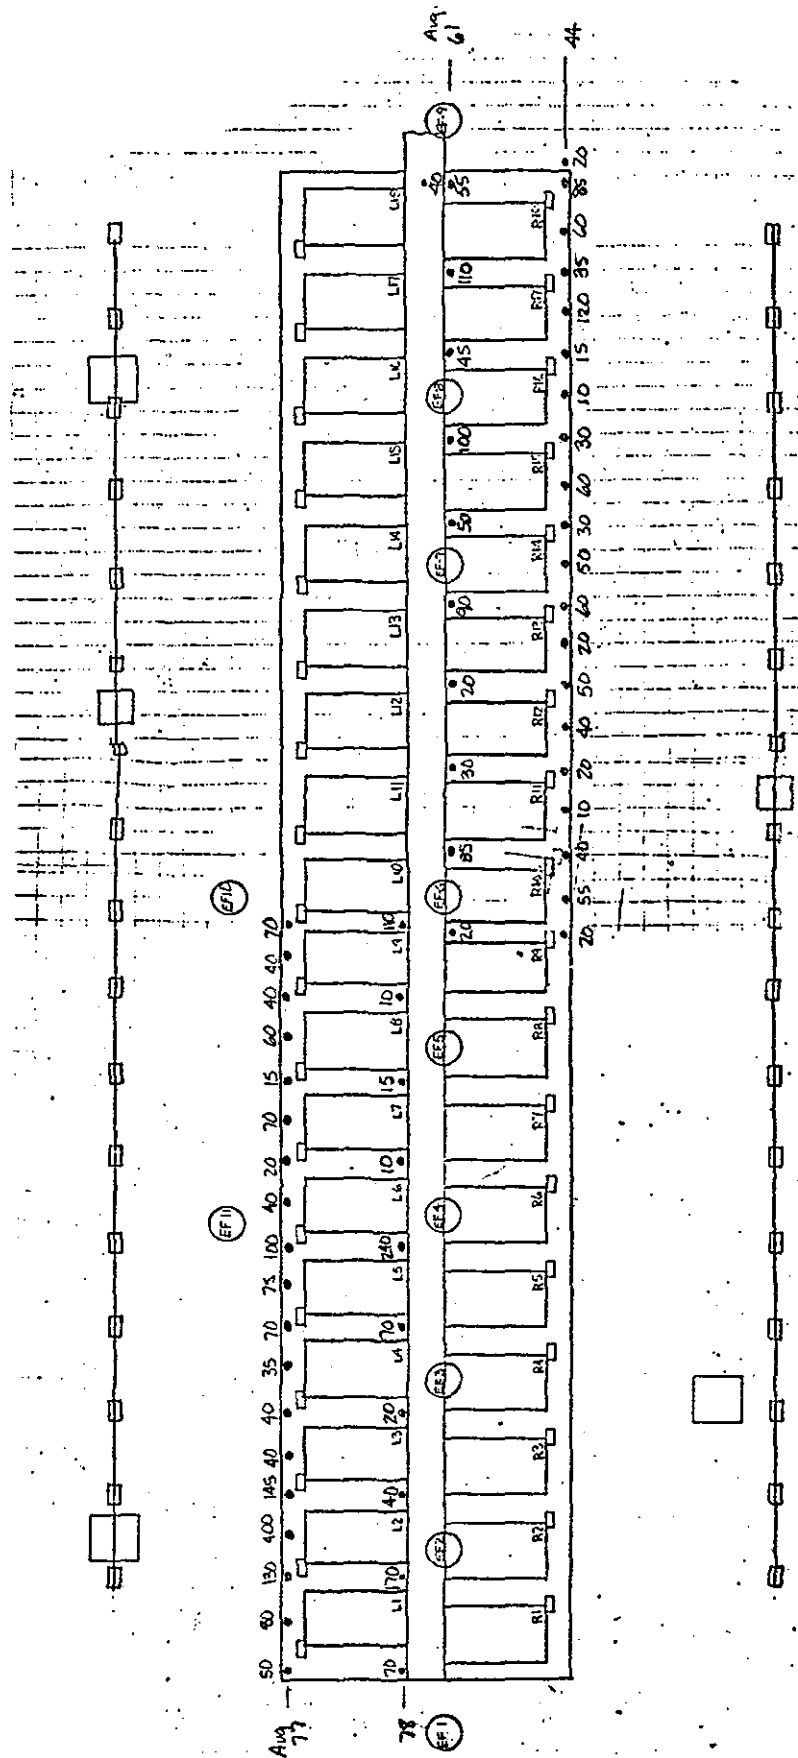
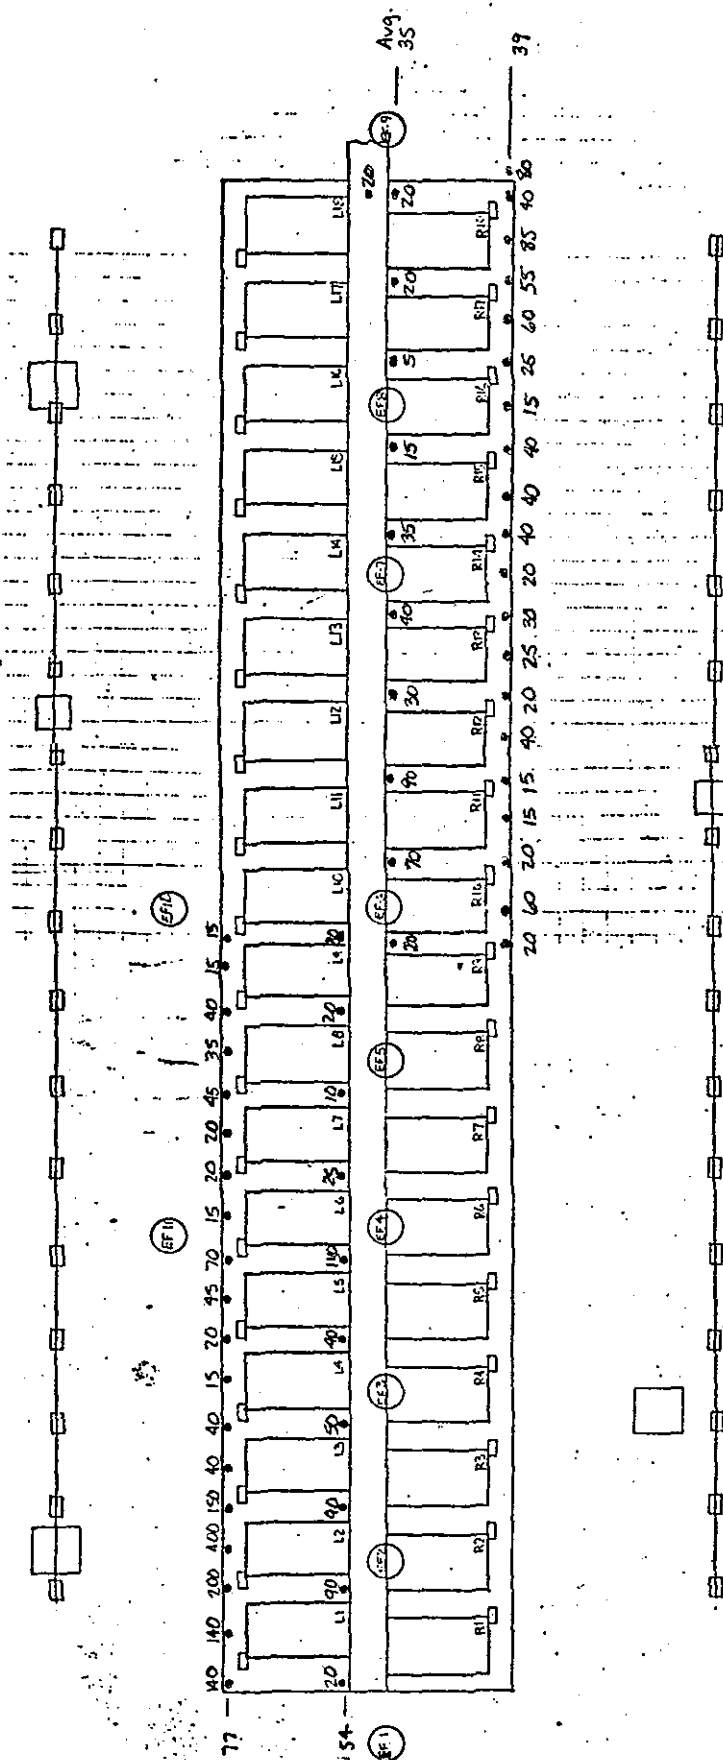
The ventilation measurements are summarized in Table 8-4 and shown in Figures 8-5 through 8-12 in Appendix IV. Figures 8-10 through 8-12 show the velocity measurements around the perimeter of the hood at heights of 3, 5, and 7 feet. Normally, the measurements from these three heights are averaged and presented in one figure. But at this plant, the airflow at the 3 and 5 feet heights was into the hood, while at 7 feet it was out of the hood and an average was not appropriate.

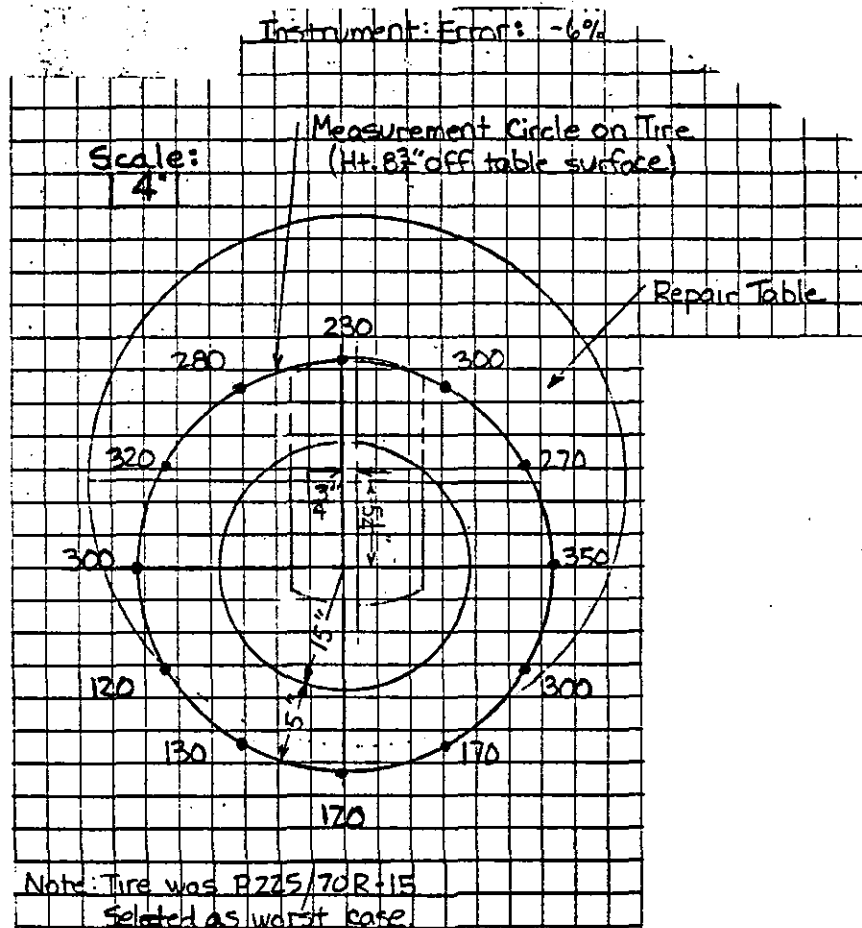
Figure 9-3. Tire repair table hood capture velocities.

Depending on the size of tire being repaired and the orientation of the grinder, particulate was captured by the hood. However, particulate could also escape the hood. The times when it escaped the hood primarily occurred when the grinder spray was aimed away from the duct entrance and when small rim-size tires were repaired. In the latter case, these tires partially obstructed the hood face, as shown in Figure 9-3.

Most grinding was done on the lower portion of the table. Yet, the greatest capture velocities occurred at the upper portion of the tire, as shown in Figure 9-3. Part of the reason for this appears to be that the lower area of the tire is farther away from the hood face than the upper area. In some cases, the upper part of the tire is positioned directly over the hood face. Such was the case for the tire used to measure the capture velocities.
