NIOSH CONTROL TECHNOLOGY ASSESSMENT
AT
GENERAL TIRE AND RUBBER COMPANY
CHARLOTTE, NORTH CAROLINA

Date of Survey:
November 26-30, 1979

Date of Report:
May 13, 1981

The purpose for this study is to evaluate and document effective controls for air contaminants in the tire manufacturing industry. (SIC 3011)

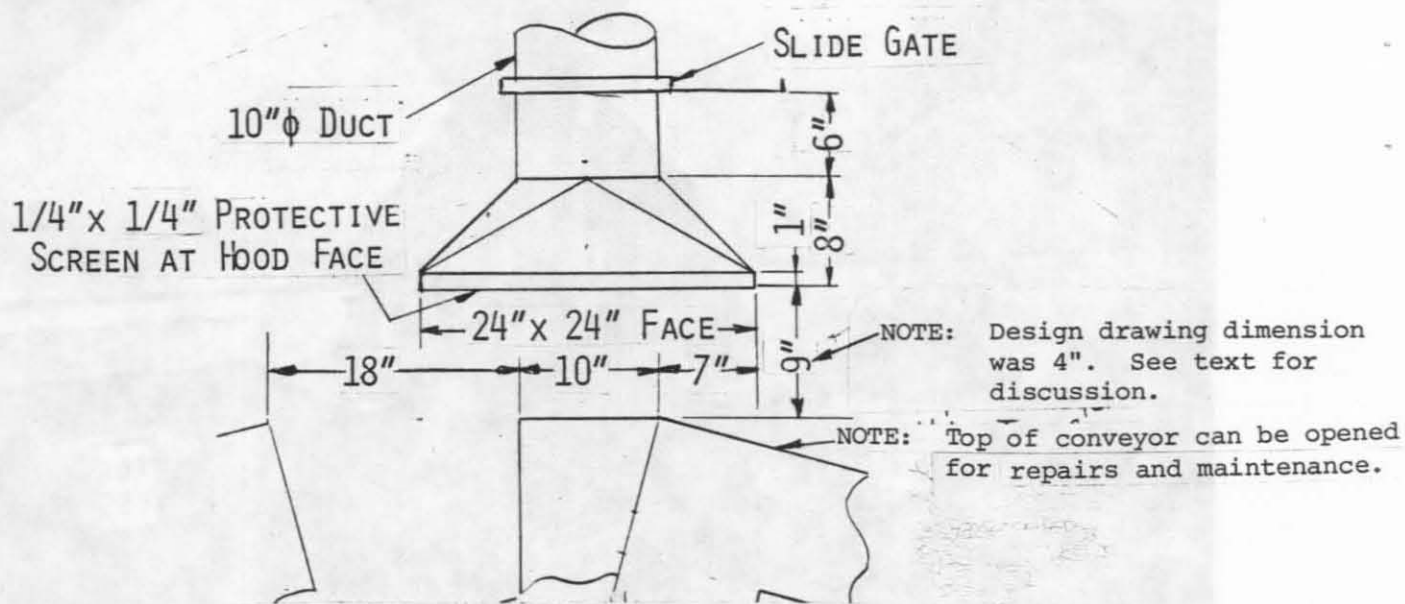
Figure 2-3. Surge hopper hood detail.

1. Not repairing leaks in bin door seals.
2. Not tightly sealing bin doors before transporting bins.
3. Not replacing bin filler port lids after filling.
4. Spilling materials on top of the bins during filling and not cleaning it up prior to transport and installation.
5. Not cleaning up material spilled in the bottom slots of the tilt stand ventilation. This spill is reported to result from the practice listed in Item 2.
6. Not cleaning up material spills around the charging station or sweeping them beneath the tilt stands.
7. Not cleaning up material that had accumulated on structures.
8. Dumping material traveling down the dust collector return into an open container at some locations.
9. Not repairing a tear in one flexible duct.
10. Not cleaning material from the screen at the surge hopper hood faces. This accumulation plugged parts of the hood face.

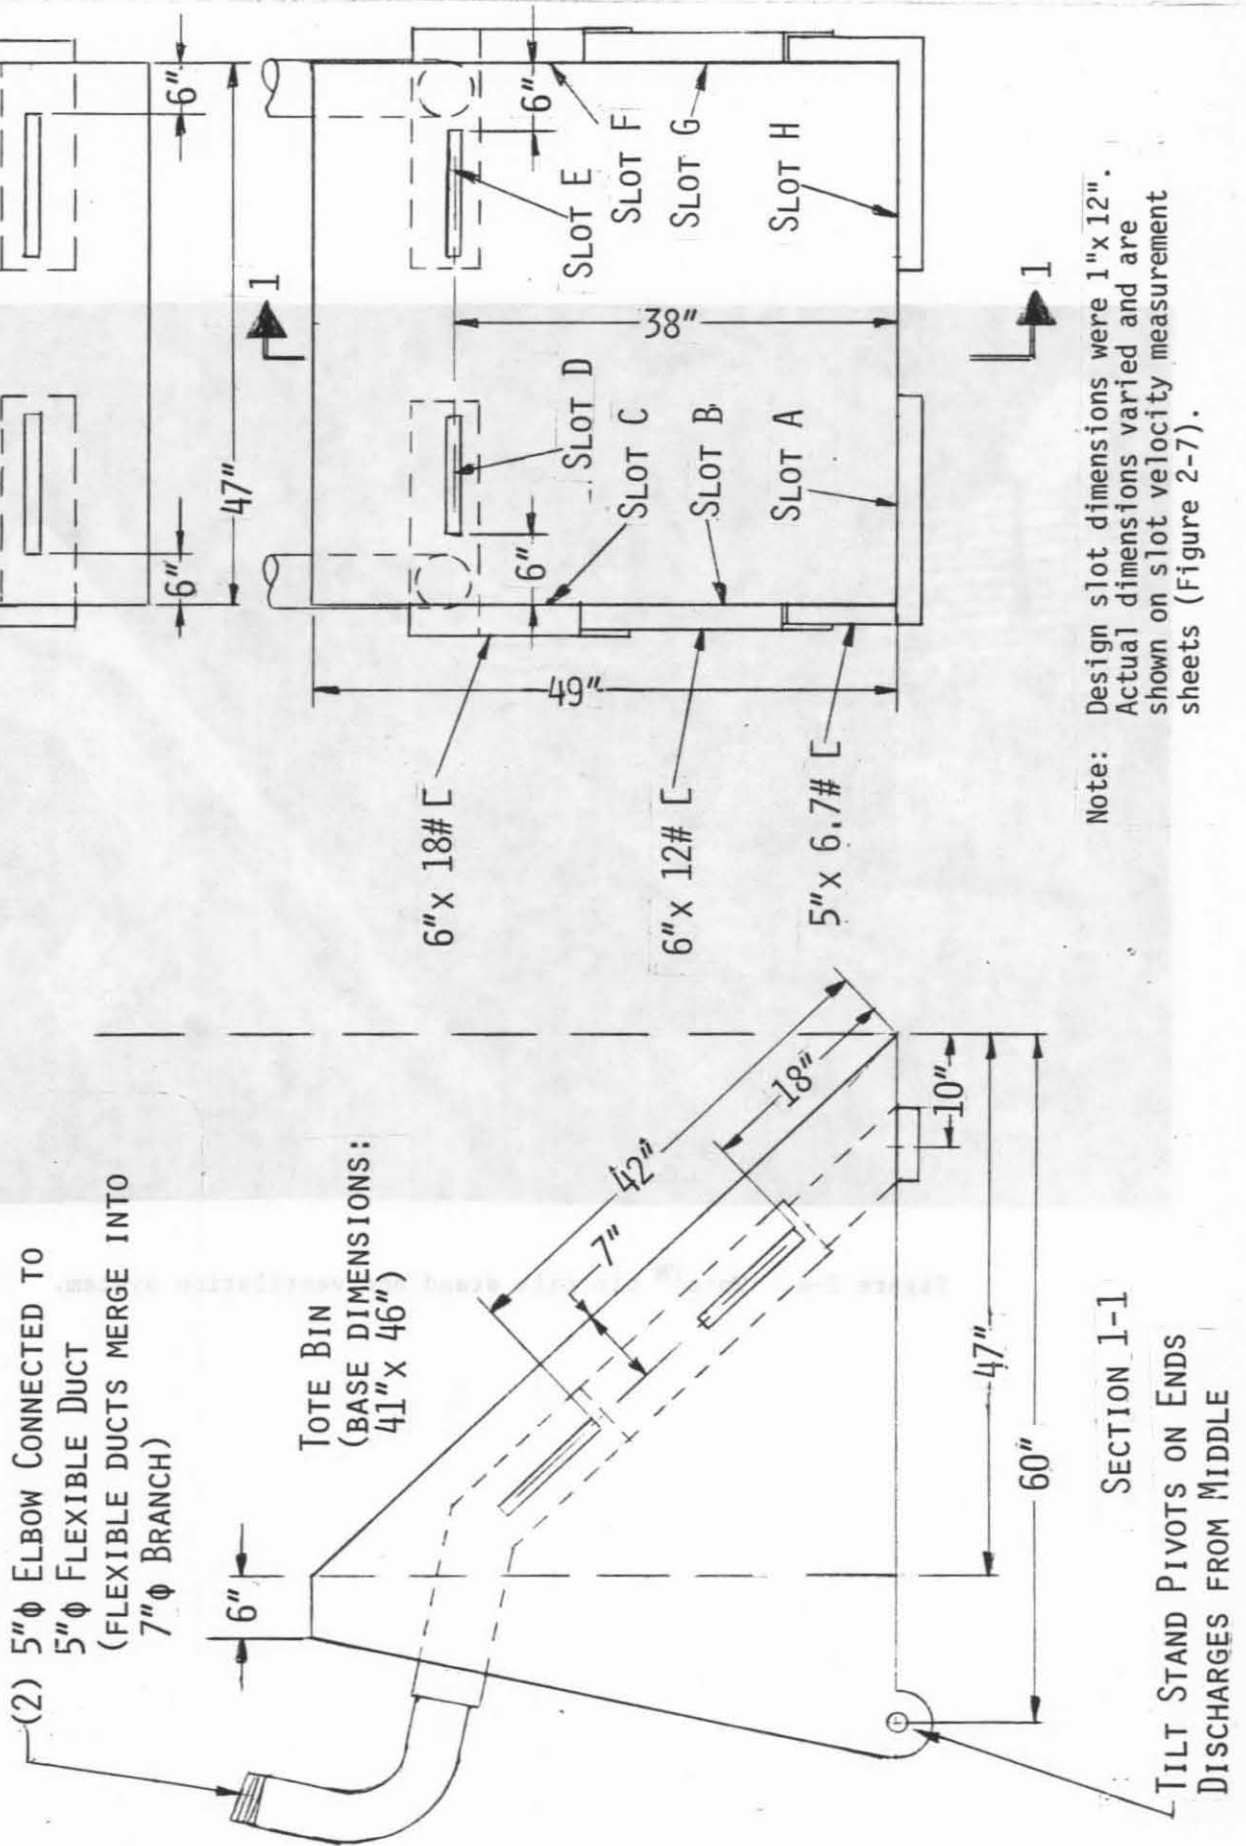
Figure 2-5. Tilt stand ventilation detail.

4. The combination of 90° elbows and too long flexible ducting for the tilt stand branch ducts caused kinks in the flexible ducts whenever the tilt stand was in the non-tilt position. A difference of about 160 cfm exists between the flow calculated from the slot velocities and that from the duct velocities. The former was measured with the tilt stand in the non-tilt position and the latter in the tilt position. Additionally, this combination could cause extra losses to the system with the tilt stand tilted by creating "artificial elbows," as shown in Figure 2-2.

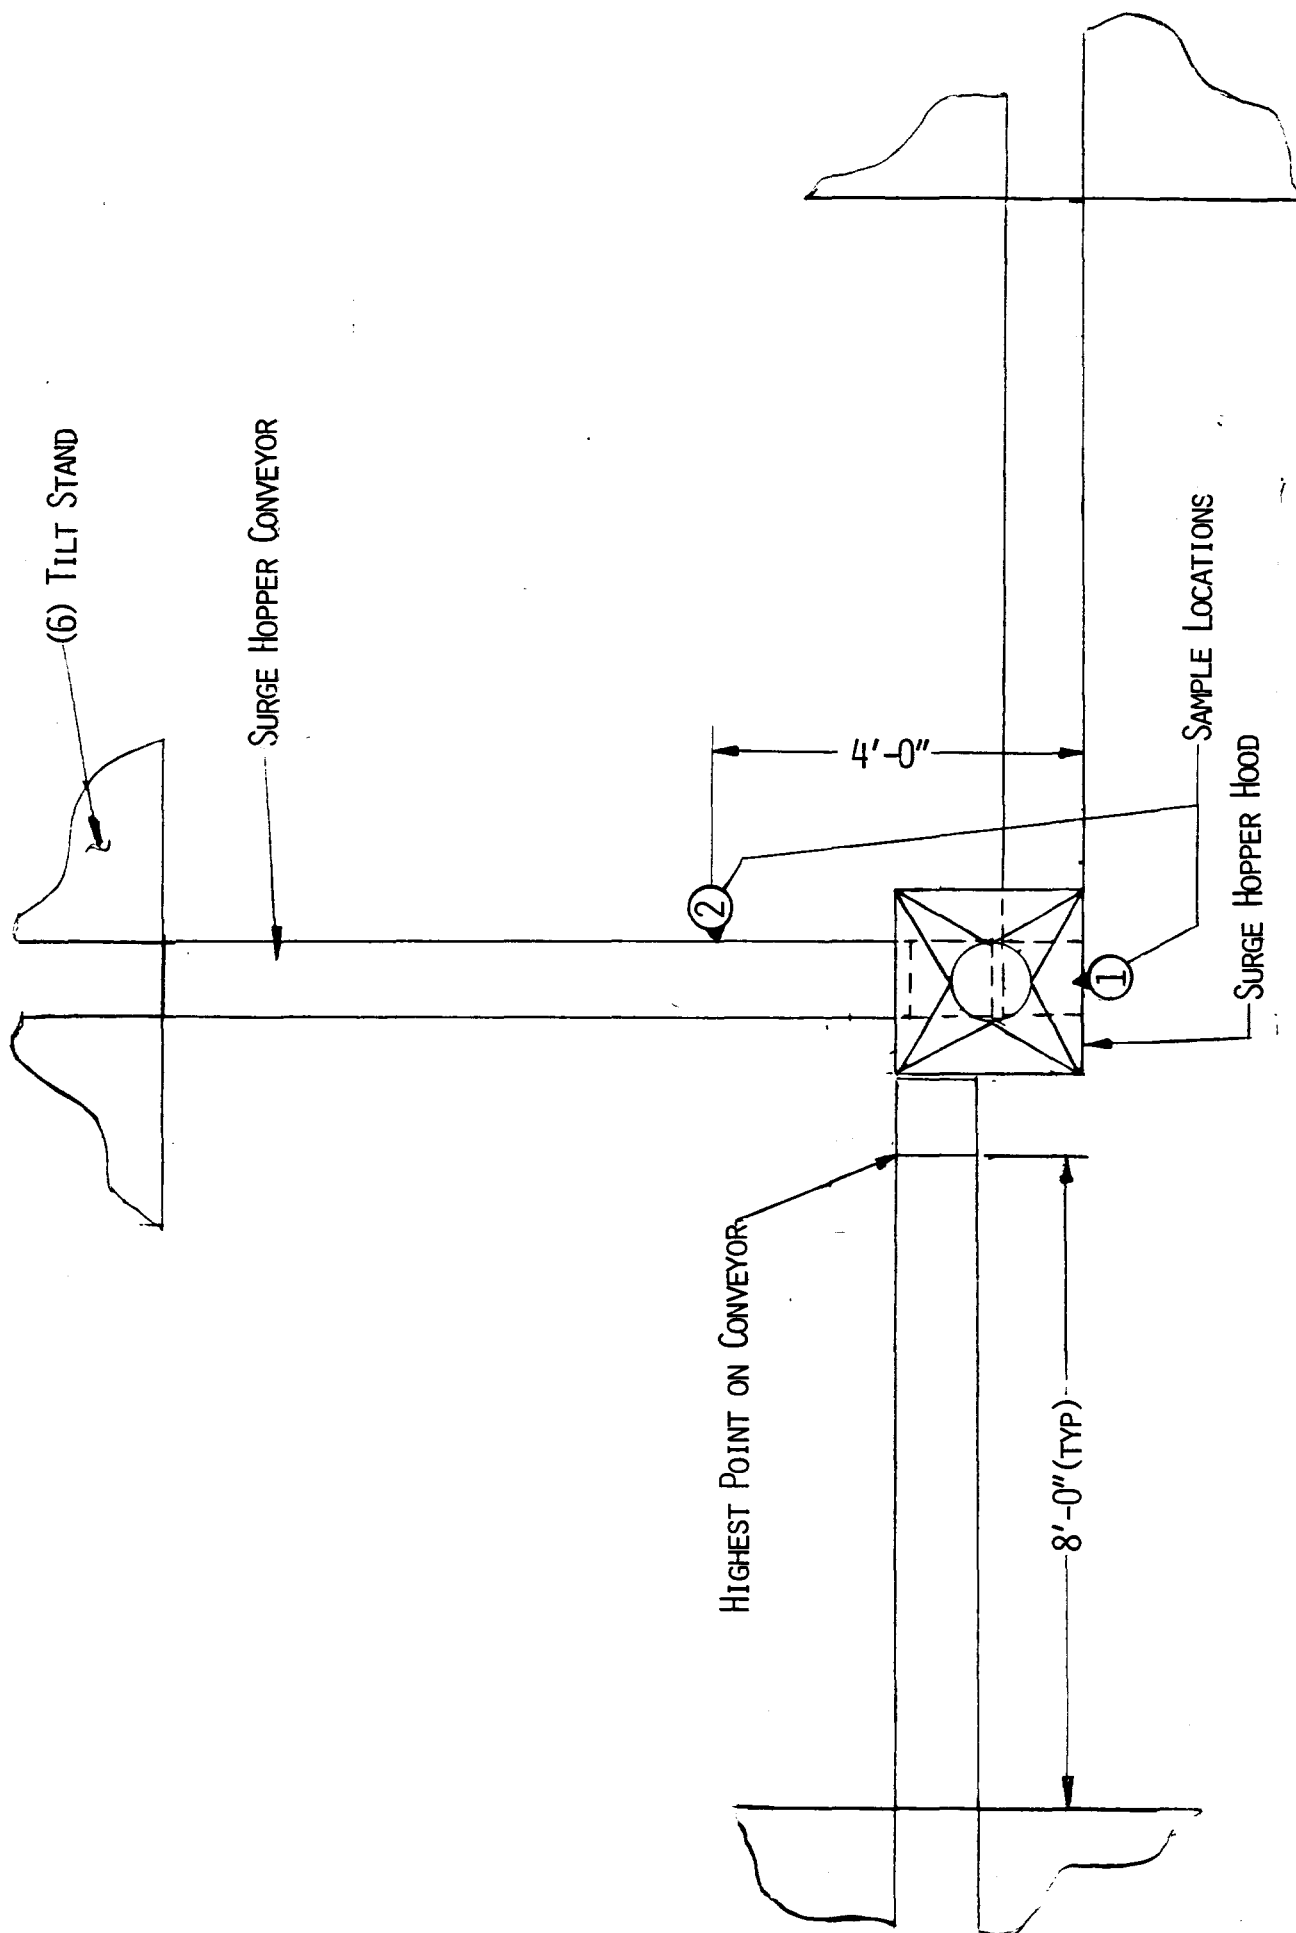
Figure 2-6. Carbon black charging station sample locations.

Location (Number from Fig. 2-6)	N	GM (mg/m ³)	GSD	AM (mg/m ³)	Range (mg/m ³)
Surge Hopper Hood (1)	3	0.38	2.61	0.49	0.13-0.82
Surge Hopper Conveyor (2)	3	0.37	2.70	0.49	0.13-0.94

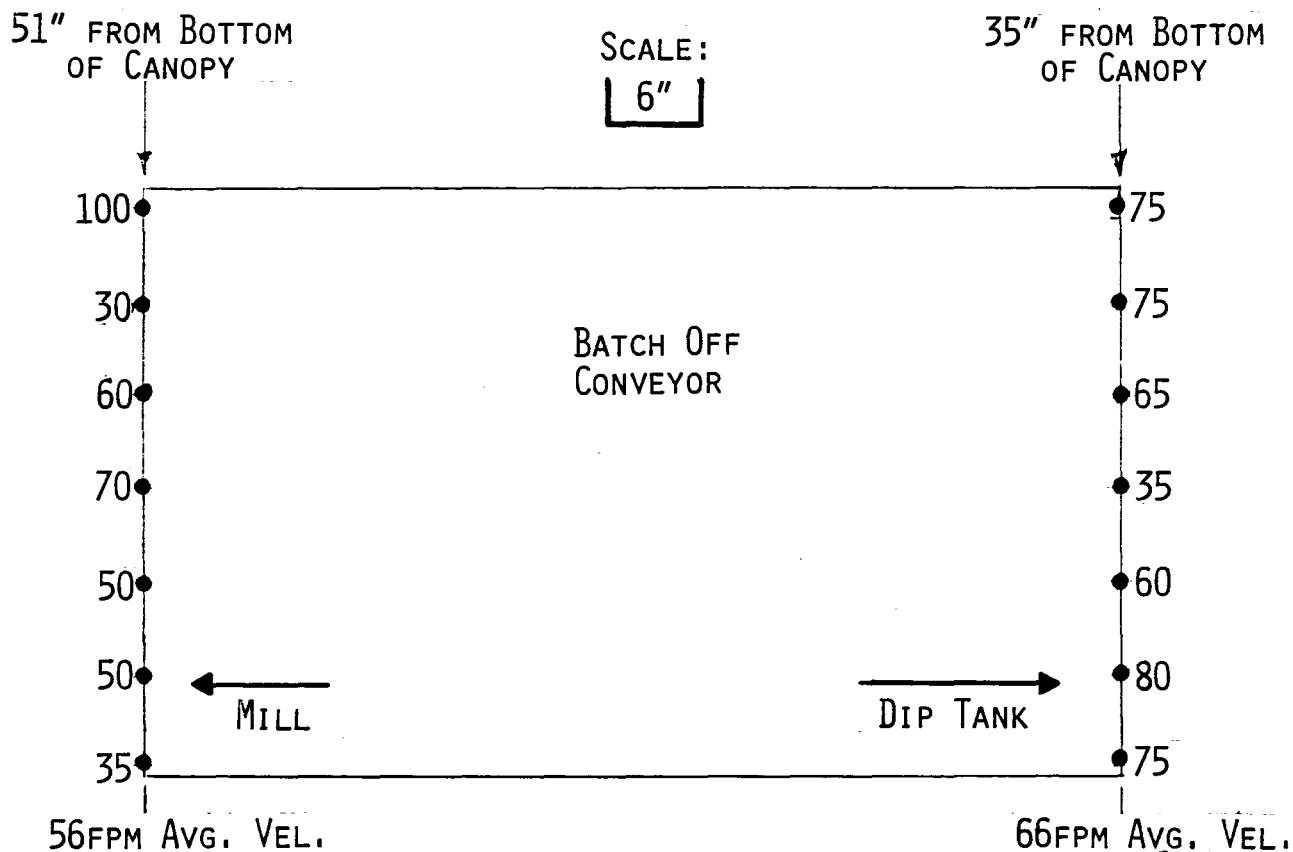
Figure 5-7 Mill hood capture velocities at batch-off conveyor.

Notes: Mill not operating during test.
 Velocities shown are average of range.
 Anemometer probe pointed at a right angle to canopy during measurements.
 Measurements made 1-2" above conveyor.
 View is looking down from canopy.

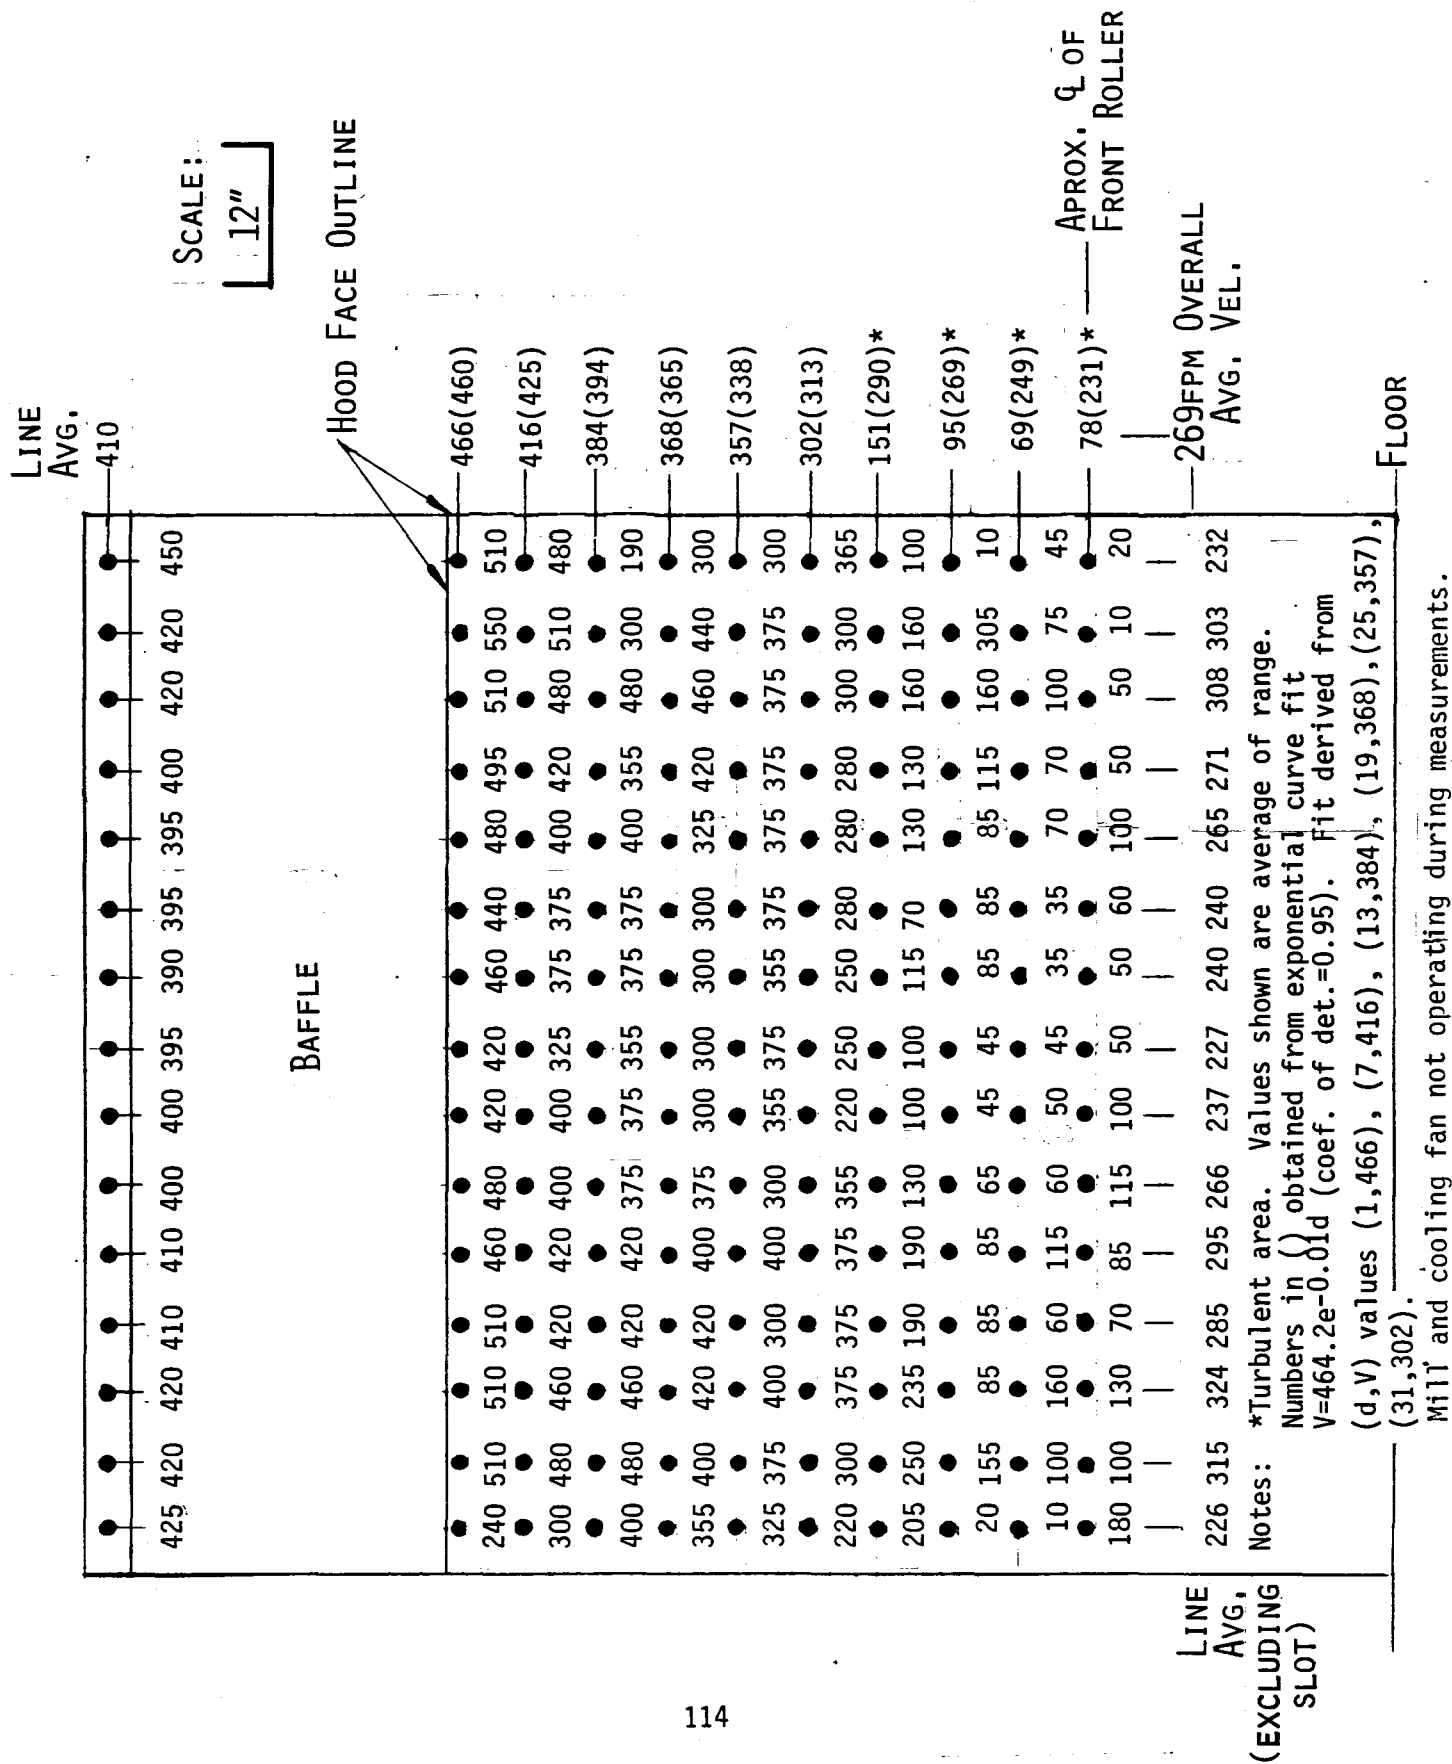
Figure 5-8. Mill Hood Face Velocities

d. Measured while mill and cooling fan were not operating. Also, air turbulence was encountered in front of mill roller. See Figure 5-8 for explanation of data treatment.

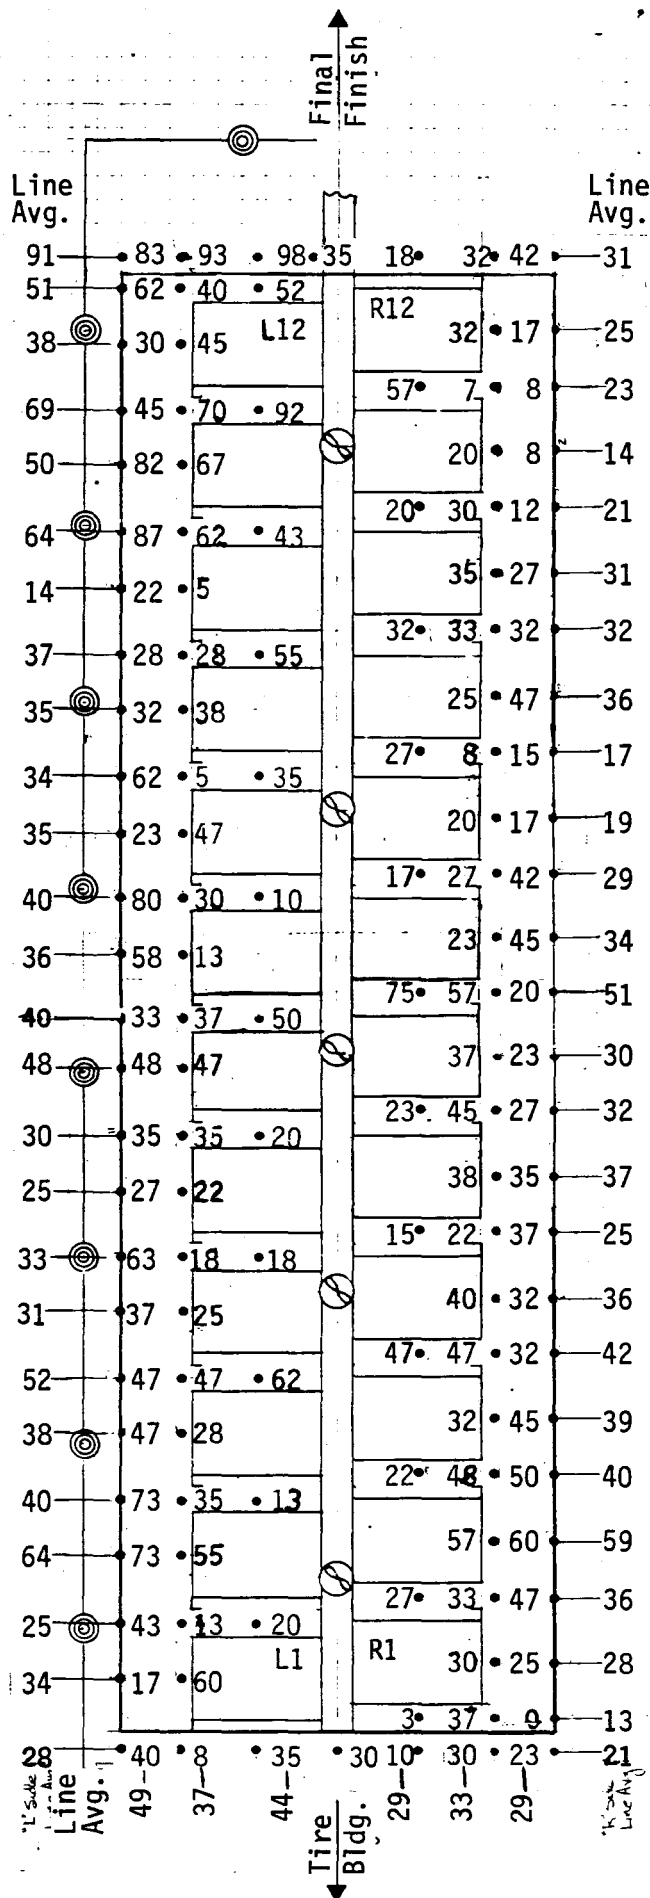
Figure 6-7. Curing press row canopy hood average velocities from 3, 5, and 7 feet heights.

b. See noted conditions in Figure 6-7.
