WALK THROUGH SURVEY REPORT
OF THE
CENTRAL BRASS MANUFACTURING COMPANY
Cleveland, Ohio

DATE OF SURVEY:
March 20, 1987

DATE OF REPORT:
November 1988

REPORT NUMBER:
158.12

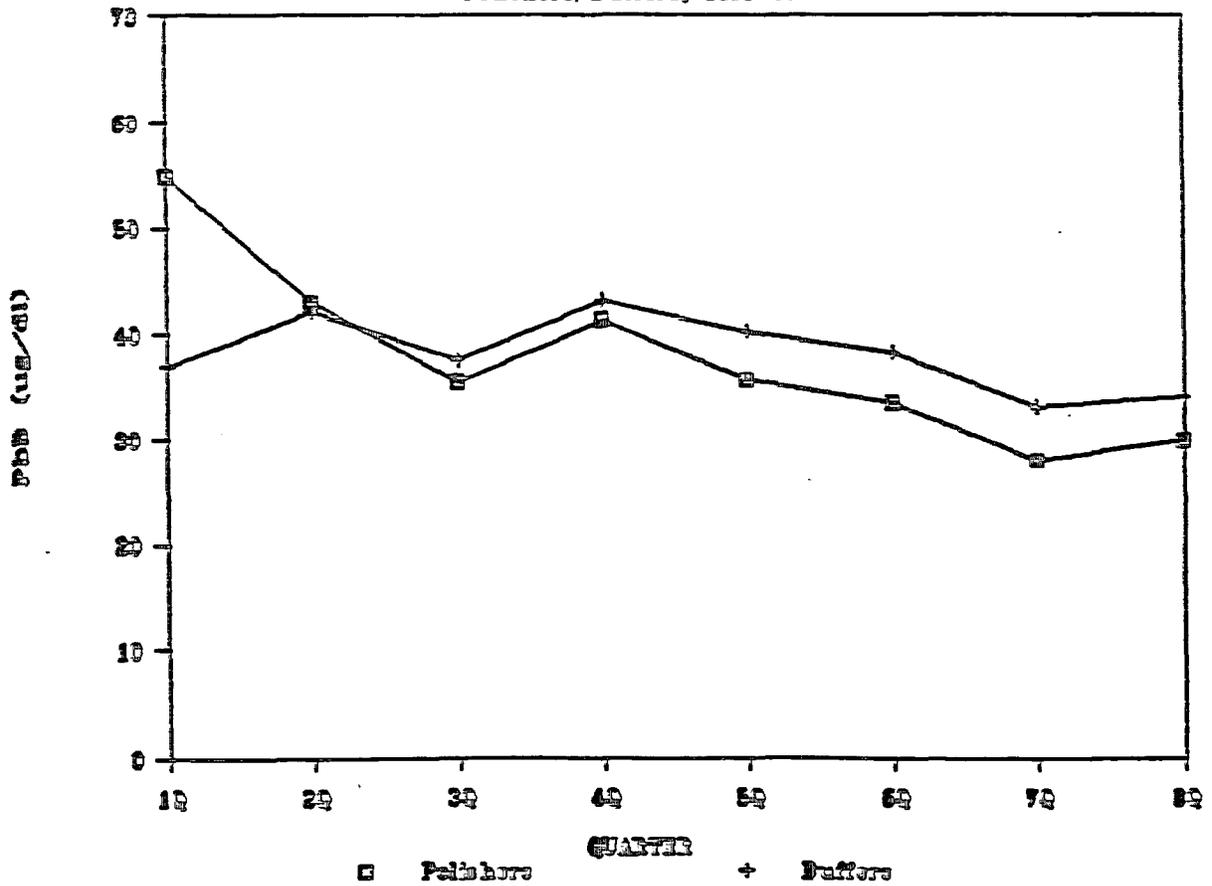
FIGURE 5.

Observation of the data plotted in Figures 4, 5, and 6 (Appendix A) suggests that blood lead levels have declined in both the foundry and finishing departments. In finishing, the mean PbB has declined from a GM of 51 ug/dl during the first quarter of 1985 to 39 ug/dl during the last quarter of 1986 (Appendix A, Figure 4). Declines in blood lead levels (PbBs) were observed among both polishers and buffers (Appendix A, Figure 5).

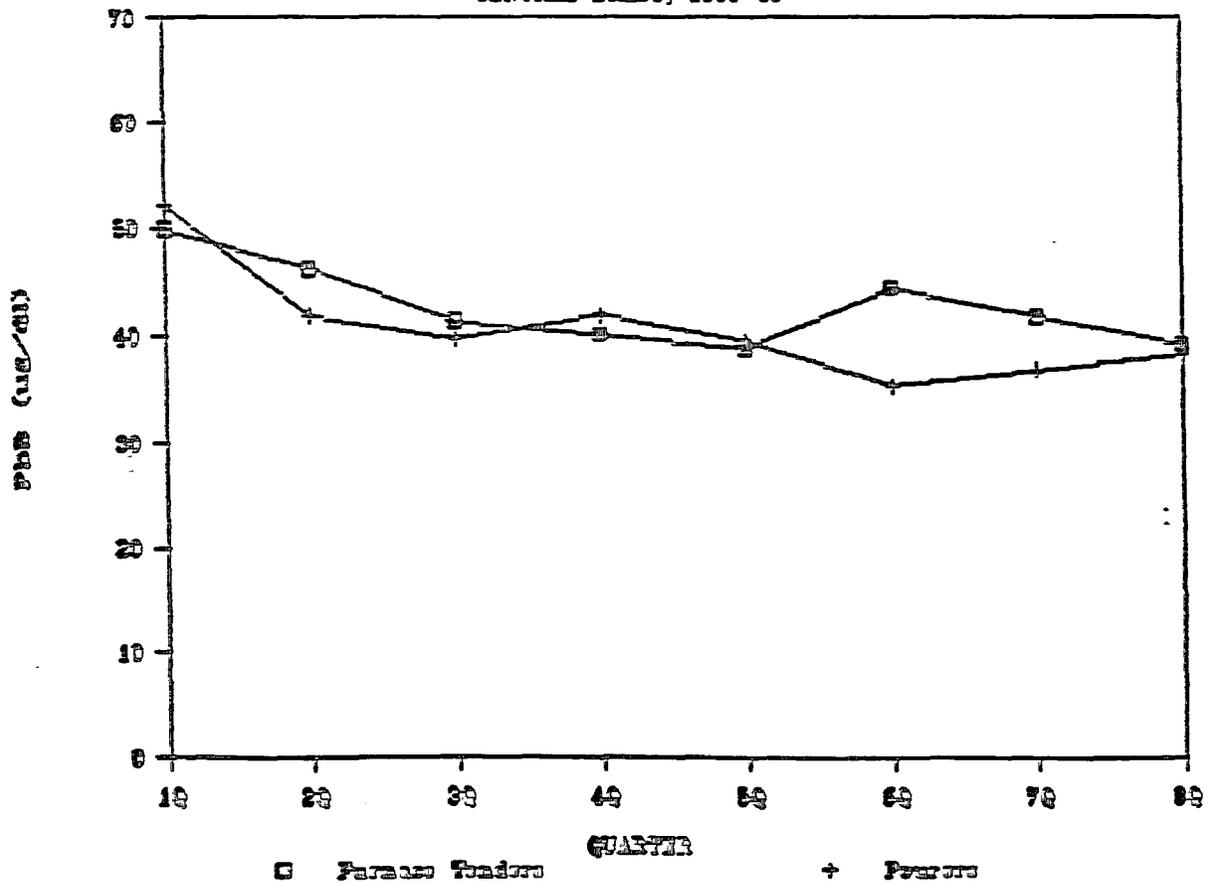
FIGURE 7.

A similar, but less dramatic change has occurred in the foundry with PbBs declining from 45 ug/dl to 41 ug/dl over the two year period (Appendix A, Figure 6). Declines in PbBs were observed in all job categories (Appendix A, Figures 7, 8, and 9).
