**NIOSH**  
Fire Fighter Fatality Investigation  
and Prevention Program

***July 8, 2015***

## ***4 Career Fire Fighters Killed and 16 Fire Fighters Injured at Commercial Structure Fire – Texas***

*Revised on April 5, 2017 to update the Executive Summary and the Cause of Death*

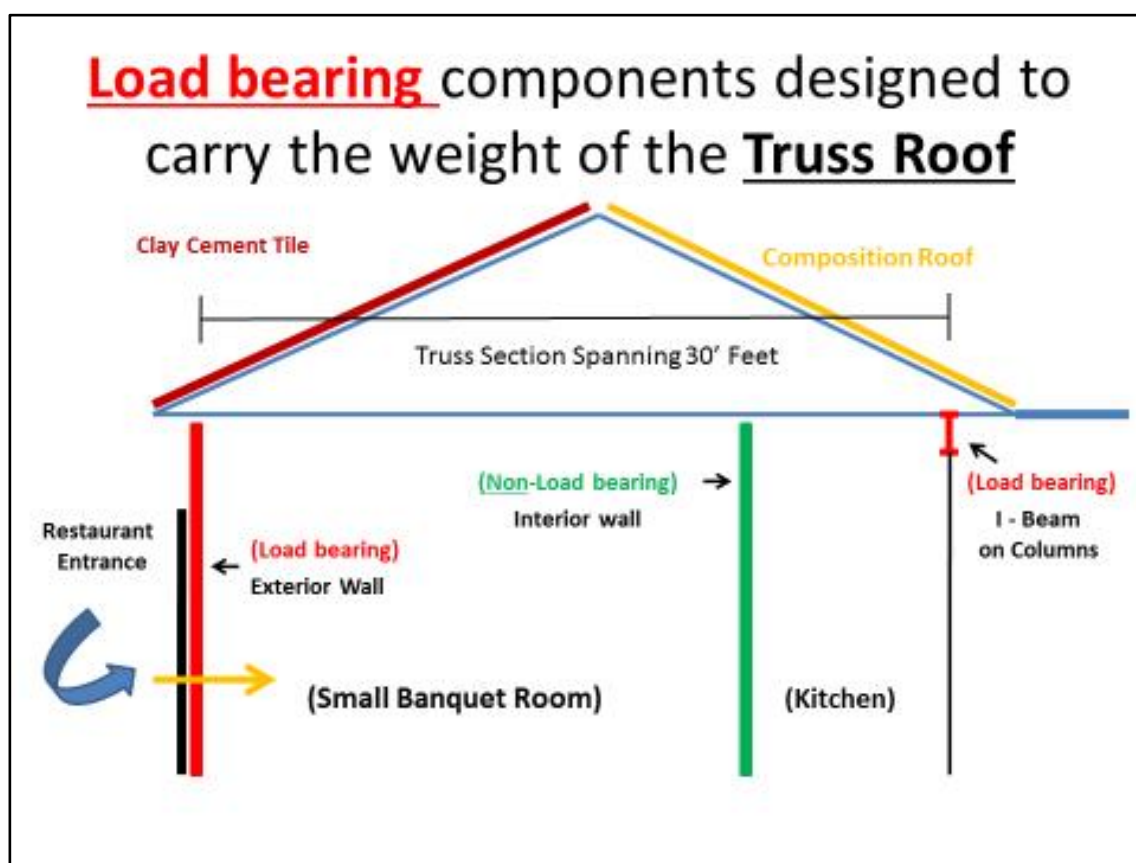
The restaurant facility located at the east side of the main entrance (lobby building) with its main entrance on Division Alpha, had a gable-style roof assembly constructed of an engineered wood truss components incorporating a lap-nailed truss configuration. This type of truss configuration is not commonly found or referenced in fire service case studies or incidents. Unlike other conventional engineered gable truss systems that utilize sized wood components that are fastened and secured utilizing a metal-plate-connected (MPC) that result in an engineered truss, the lap-nailed wood truss system utilizes nails (versus MPC) as the mechanical fastener to secure the truss components together in an assembly to provide structural support as a configured truss component. The truss webs and cords are configured in their defined orientation and angles and fastened utilizing a defined quality and sized metal nail fasteners and connected on the vertical face of the corresponding truss component.

Diagram 2. The truss roof design of the small Banquet Room and the Kitchen.  
(Diagram courtesy of the fire department)

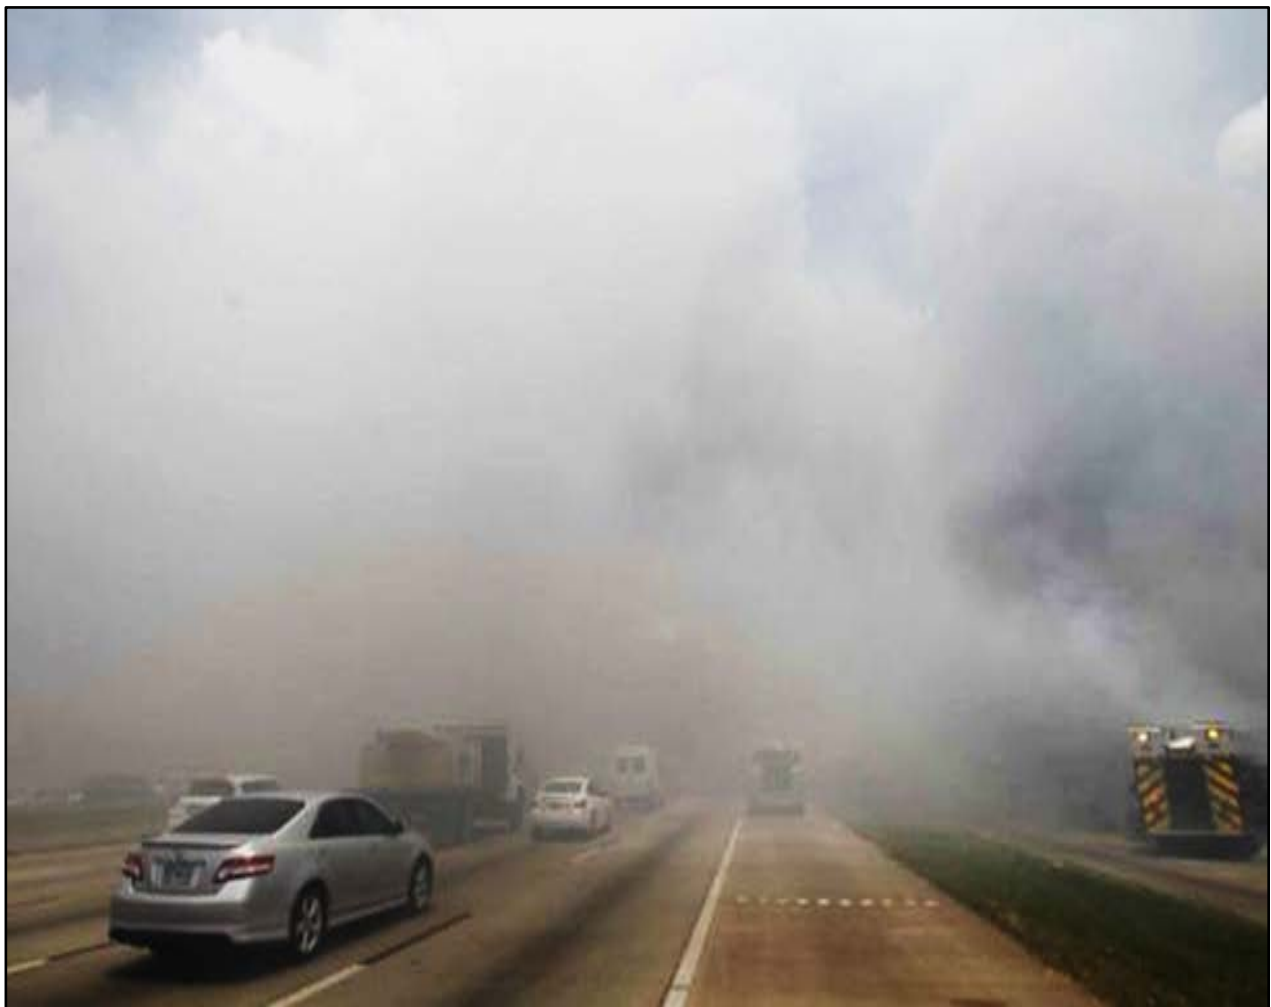
During the initial attack, and well into the rescue, the direction of these strong winds made Division Charlie the intake side of the structure and placed Division Alpha as the exhaust point. The smoke was blowing across the fireground vertically limiting the visibility of members conducting fire attack, ventilation, and rescue. Crews were faced with extreme heat and smoke conditions that would continue to increase and hamper their efforts. (See Photo 5.)

**Photo 5. The smoke conditions encountered by the 1<sup>st</sup> Alarm companies. This picture is looking north on the feeder road and the freeway. E82 is parked on the shoulder of the freeway and Rescue 10 is on scene. The time is approximately 1224 hours.**

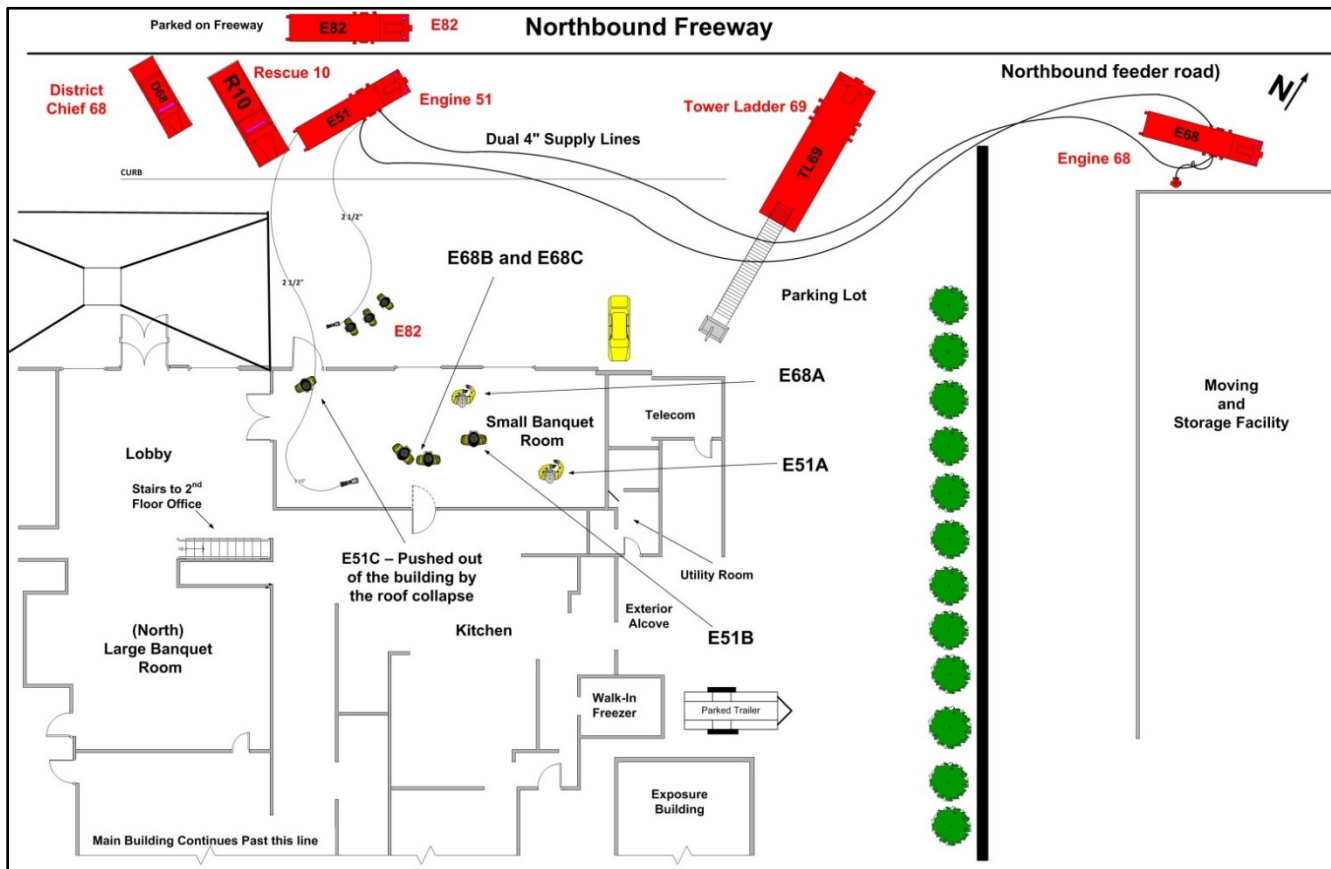
**Diagram 13. The location of the officers and fire fighters of Engine 51 and Engine 68 when the roof collapse occurred in the Small Banquet Room and Kitchen area at 12:23:24 hours.**

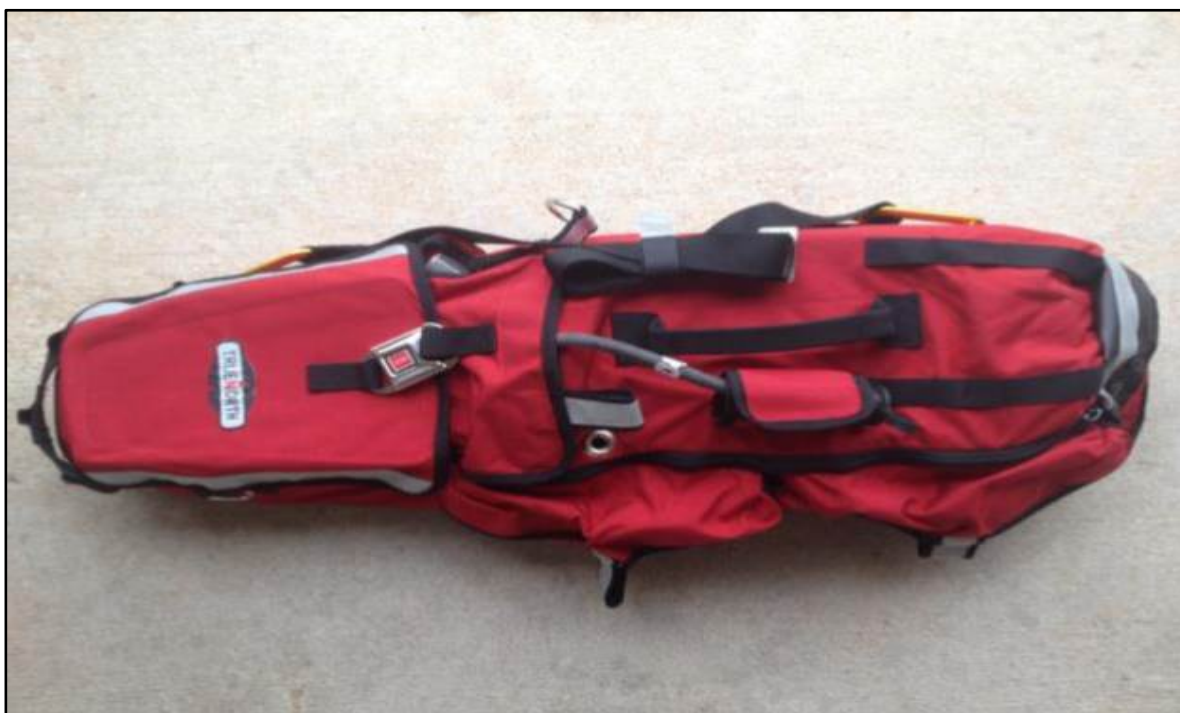
**Photo 8. The RIT Pack that the department has redesigned based upon this incident.**

- New RIT bags or packs were fitted with two air-lines, which can be stored separately and deployed independently or together based upon the needs of the situation.
- Removing miscellaneous tools from the RIT pack;
- A new style quick disconnect couplings were added;
- RIT masks were upgraded by the department’s Mask Service Unit for easier donning with gloved hands;
- All RIT bags were fitted with one hour air cylinders. (See Photo 8.)

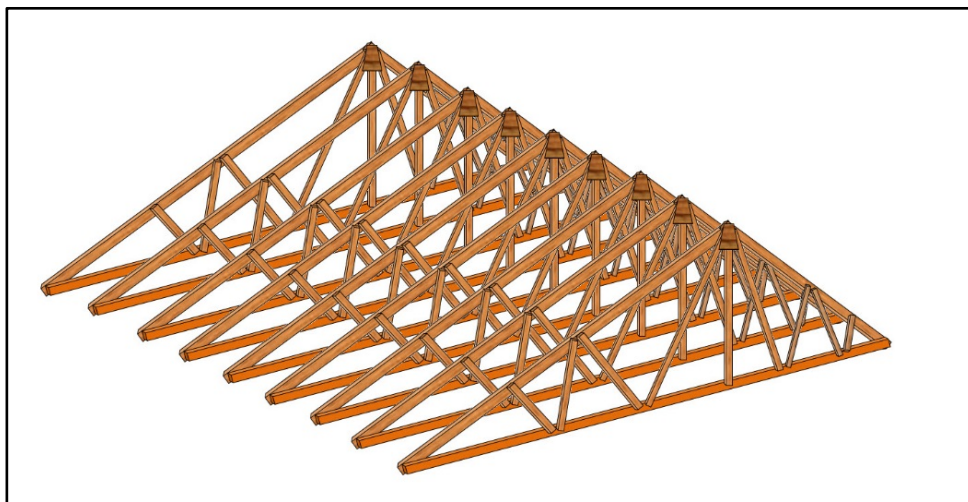
The wood web and nail configuration are as follows for the lap-nailed truss. (See **Diagram 18** and **Diagram 19**.)

**Diagram 17. Lap-Nailed Truss Assembly Configurations (Partial Detail)**  
*(Diagram Courtesy of Buildinasonfire.com)*

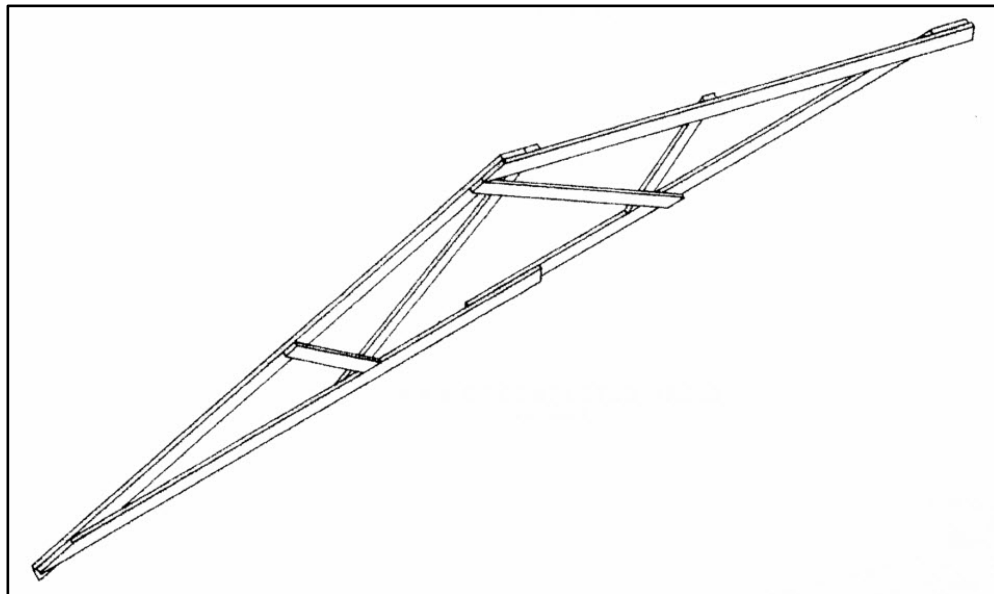
**Diagram 19. Typical Lap-Nailed Truss**  
*(Diagram Courtesy of Buildingsonfire.com)*  
*[Adapted from USDA LSU AgCenter Diagram EX5923 circa 1961]*

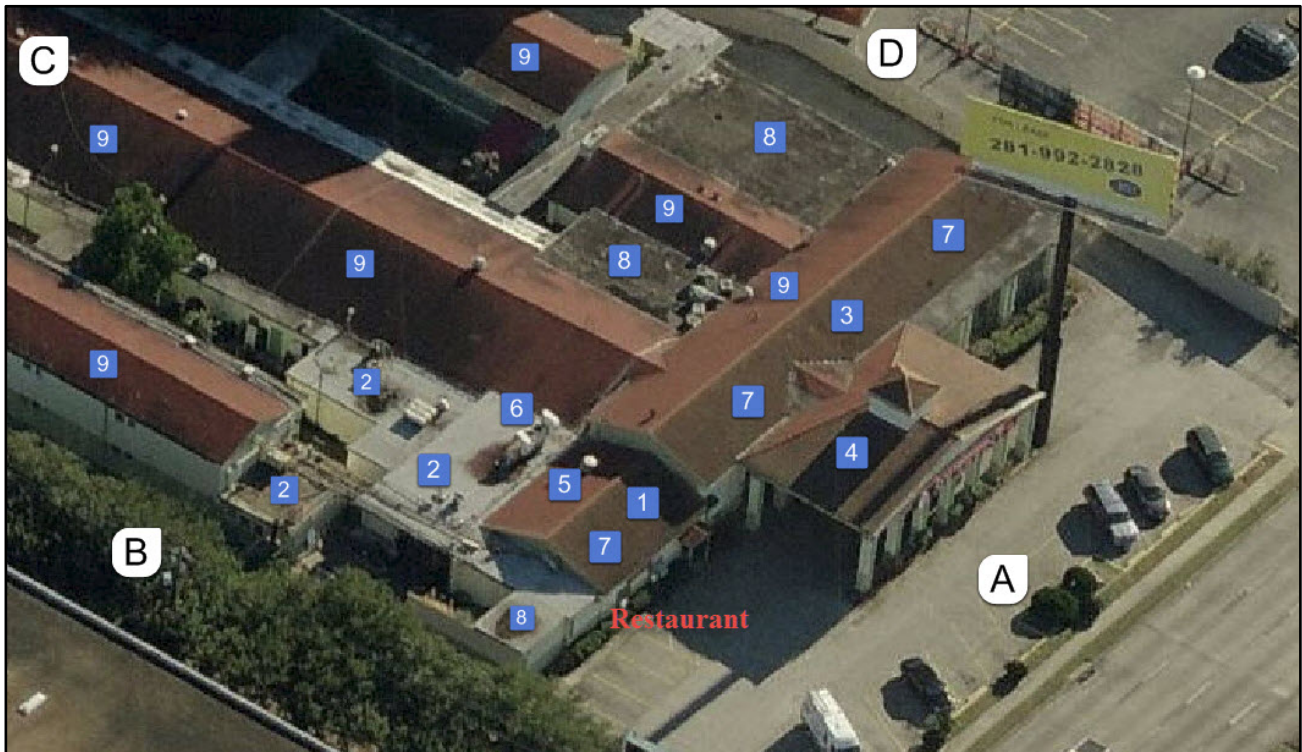
The gable roof profile of the restaurant and the main building can be seen from an aerial view which consists of extruded concrete interlocking roof tiles with shiplap as a roof covering fronting Division Alpha. (See Photo 11).

**Photo 11. Pre-fire Aerial View of Building Complex (North-East Geographical/Division Alpha-Bravo)**  
*(Bing.com Maps/ Diagram Courtesy of Buildingsonfire.com)*
