**REPORT#:** 2014-02

**REPORT DATE:** January 30, 2018

## Laborer, Pipefitter, and Utility Foreman Crushed by Falling Block Wall—Tennessee

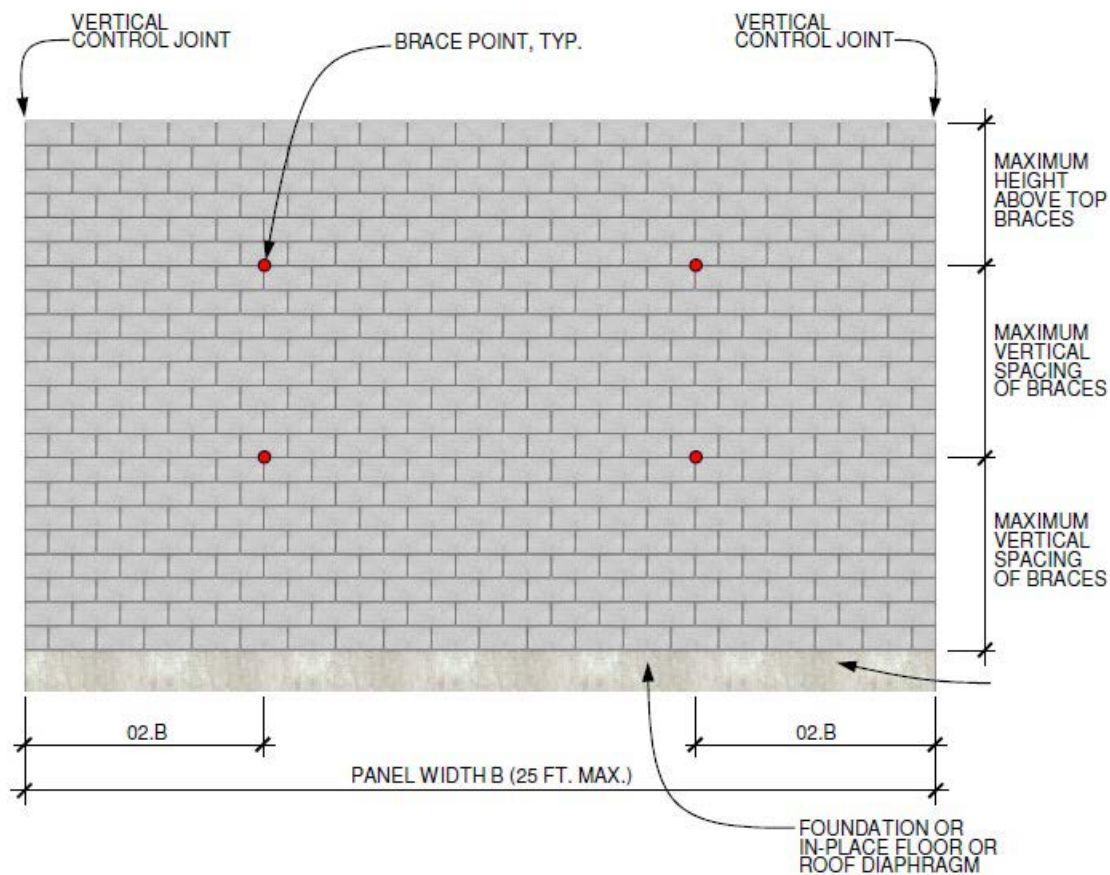
**Figure 1. Wall bracing placement diagram.**  
(Figure courtesy of MCCA [MCCA 2012].)

The MCCA Standard Practice for Bracing Masonry Walls Under Construction recommends that for a 23-foot, 4-inch wall with 8-inch block, reinforced with No. 5 rebar 4 feet on center, the wall should extend no more than 8 feet, 8 inches above the brace and the angle of the inclined brace should be between 35 and 45 degrees. A typical triangle wood bracing system should include a horizontal brace, a vertical brace, a diagonal brace positioned with a cleat on both ends of the brace, and a diagonal stiffener anchored to the wall or footer and nailed to the diagonal brace [[MCCA 2012](#)] (Figures 2 and 3). Michigan OSHA requires the masonry contractor to maintain a copy of the *Masonry Wall Bracing Design Handbook* or other permitted method of bracing on the jobsite [[MIOSHA 2015a](#)].

In this incident, the wall extended more than 8 feet 8 inches above the braces in some instances, and several of the recommended brace system components were missing. If a masonry wall bracing plan had been in place and one of the employers had a trained competent person at the time of the incident, the competent person could have recognized the hazard posed by the unbraced wall and made the appropriate changes to provide a safe bracing system. Since this incident, the masonry subcontractor has trained their employees on proper concrete and masonry wall bracing.

***Recommendation #2: Employers should develop and follow a masonry wall bracing plan, train employees on proper masonry wall bracing, and ensure masonry walls are properly braced throughout the project.***

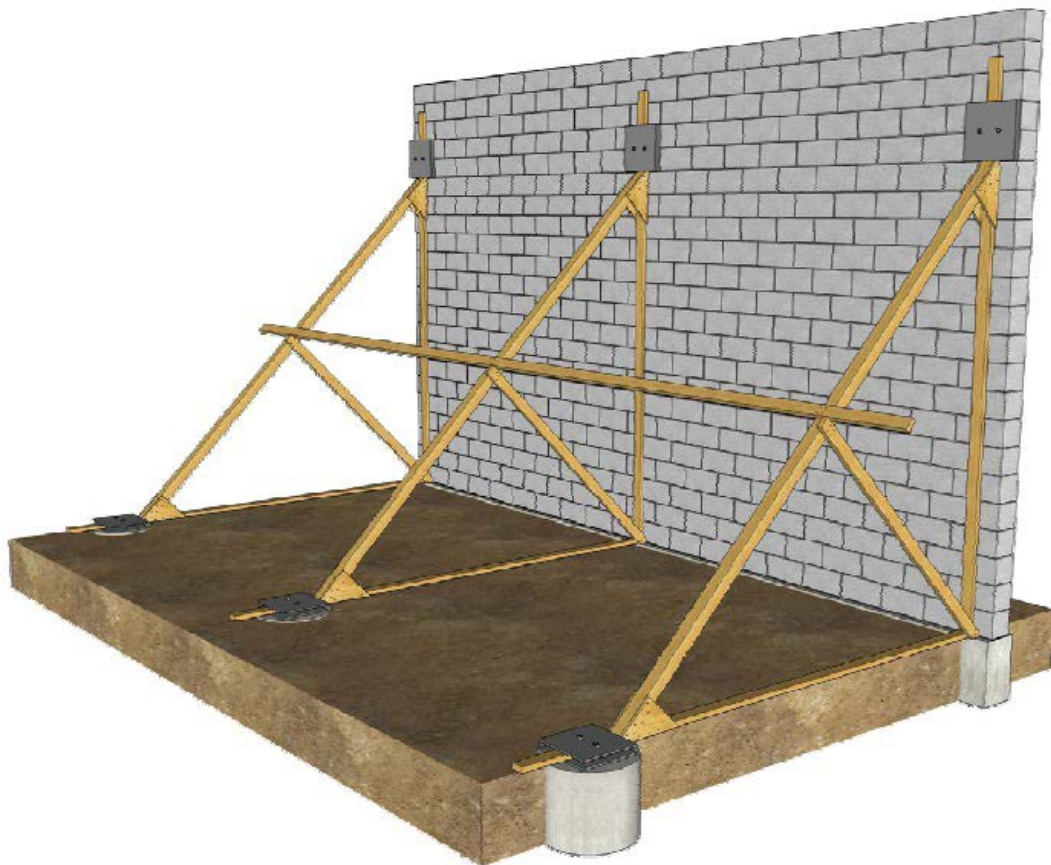
**Figure 2. Wall bracing construction diagram.**  
(Figure courtesy of MCCA [MCCA 2012].)

The wall bracing system used in this incident was a modified triangle system and composed of two scaffold boards. The vertical board was positioned on the wall but not attached to the wall. The vertical board had a 2- by 4-foot cleat across it horizontally (Photo 1 and Photo 3). The inclined brace boards were wedged at an angle that varied between 34 and 41 degrees. A 4-foot length of rebar was driven into the ground; one masonry block was placed over the rebar with the other placed on top of the inclined board (Photo 2 and Photo 3). There was no permanent tie from the ground to the wall brace. The wall extended between 13½ and 15 feet above the brace.

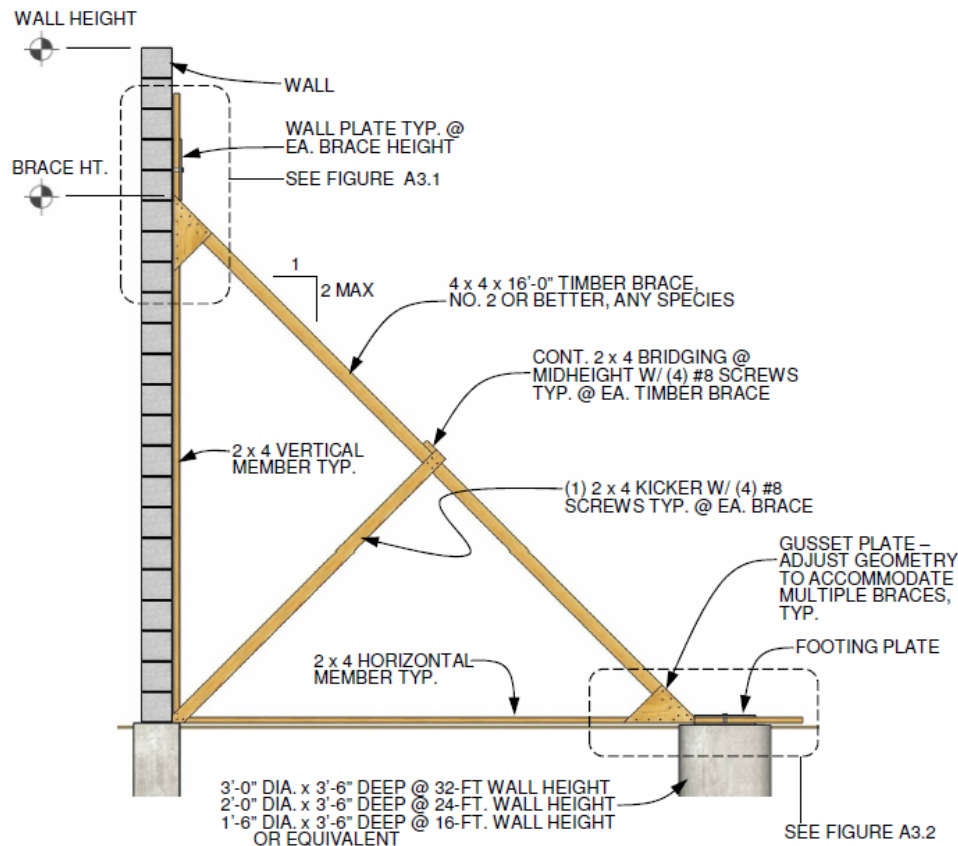
**Figure 3. Wall bracing construction diagram.  
(Figure courtesy of MCCA [MCCA 2012].)**

The maximum length of wood bracing as detailed is 16'-0". This corresponds to a maximum brace height of 14'-4" utilizing the maximum brace angle of 1:2 as shown.

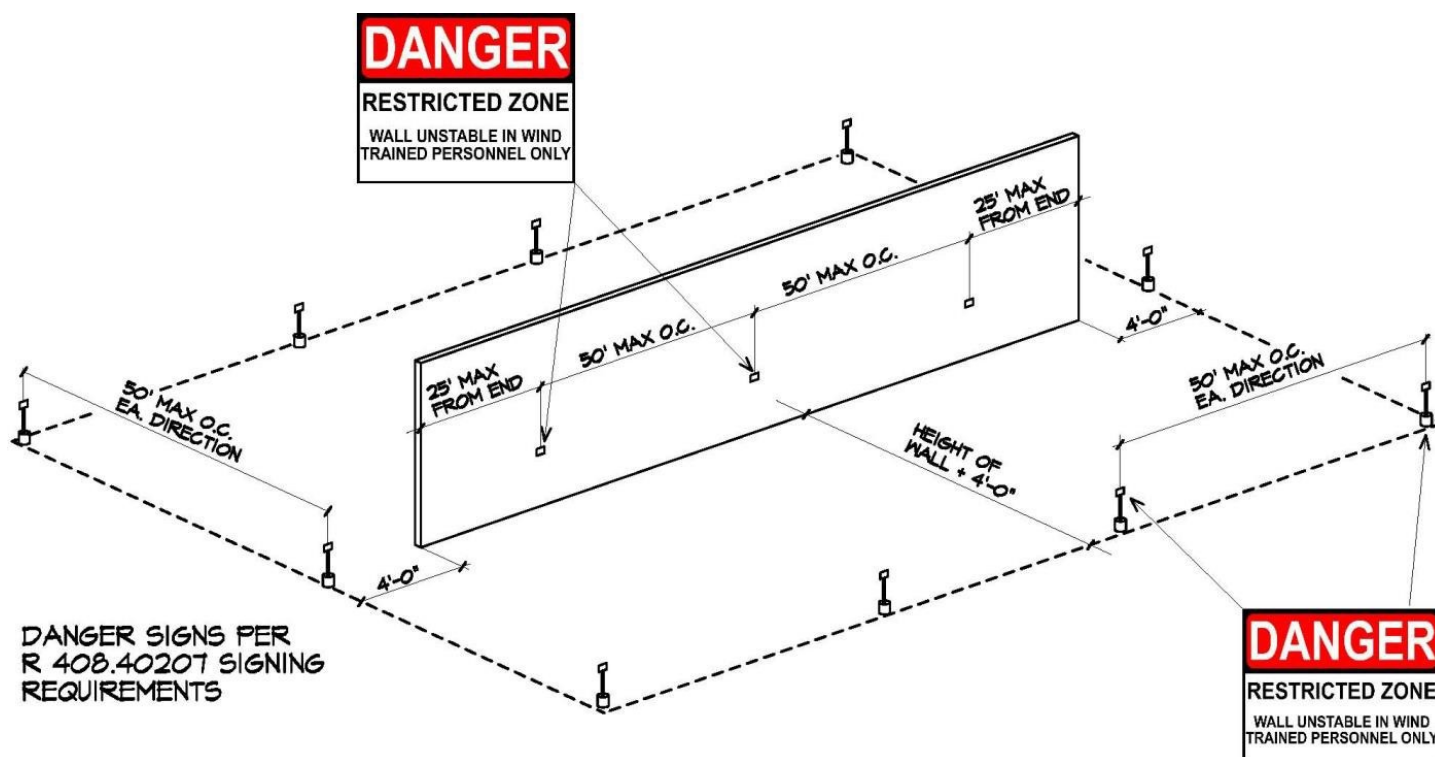
**Figure 4. Restricted/limited access zone diagram.**  
(Figure courtesy of MIOSHA [MIOSHA 2015b].)

Discussion: OSHA regulation 29 CFR 1926.706(a) states that a restricted/limited access zone shall be established whenever a masonry wall is being constructed. The restricted/limited access zone shall conform to the following:

- Be established prior to the start of construction of the wall.
- Be equal to the height of the wall to be constructed plus 4 feet and shall run the entire length of the wall.
- Be established on the side of the wall that will be unscaffolded.
- Be restricted to entry by employees actively engaged in constructing the wall. No other employees shall be permitted to enter the zone.
- Remain in place until the wall is adequately supported to prevent overturning and to prevent collapse unless the height of the wall is over 8 feet, in which case, the restricted/limited access zone shall remain in place until permanent supporting elements of the structure are in place [OSHA 1988].

**Recommendation #3: Employers should develop and implement a restricted/limited access zone.**
