Applied Occupational and Environmental Hygiene

Hard Metal Exposures. Part 1: Observed Performance of Three Local Exhaust Ventilation Systems

Steven E. Guffey,¹ Nancy Simcox,¹ Derrick W. Booth, Sr.,² Richard Hibbard,¹ and Arlene Stebbins³

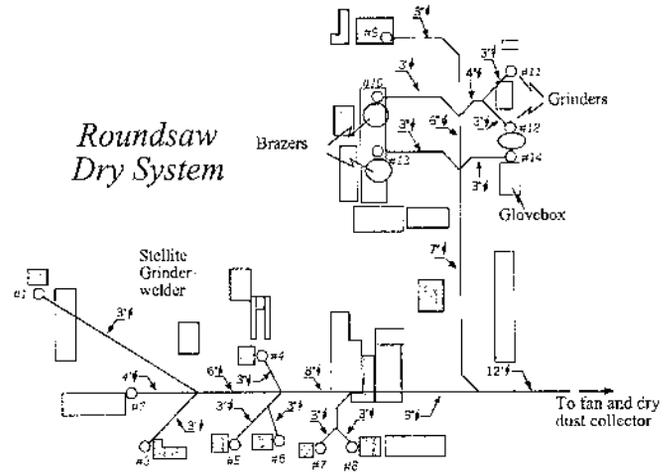
FIGURE 2
Layout of the Roundsaw-Dry system.

8. For Roundsaw-Dry ventilation system (see Figure 2), the estimated total required exhaust flow rate of

3200 cfm with a total static pressure of 7.75 inches water gauge at the collector inlet. A Torit Model 30FB Cyclone with an after-filter section and fan was installed to provide the air flows and pressures. The design transport velocity was 4200 fpm. The system required a dry dust unit similar to the existing collector with an after-filter for dry grinding.

Roundsaw-Dry System Installation (see Figure 2)

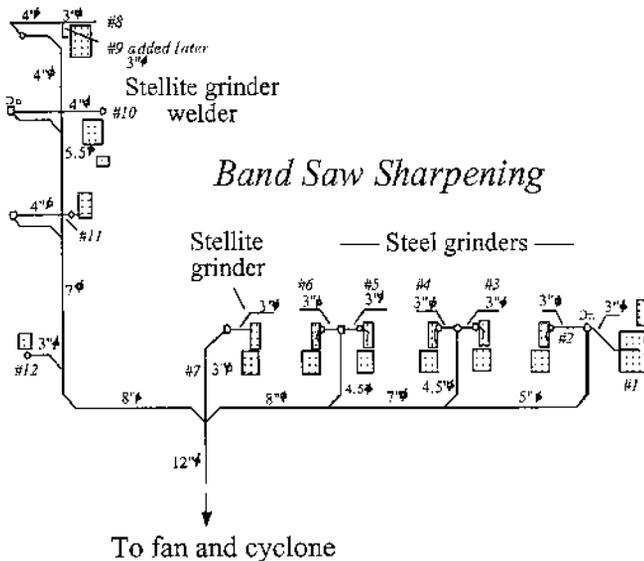
FIGURE 1
Layout of the Bandsaw system.

7. For the Bandsaw ventilation system (see Figure 1), design air flow rates (Q_T) at the grinders were based on criteria from *Industrial Ventilation*,⁽⁷⁾ the physical size of the incorporated exhaust hood of the grinding machine, and the size and speed of the grinding wheels.⁽⁷⁾ The design transport velocity was 4000 fpm. The estimated total required air flow was 3000 cfm and the fan pressure was 7.5 inches water gauge. The system included a dry dust collection system that utilized the existing fan/collector unit. A bag type after-filter was added to the unit to capture the fine dust particles that pass through the cyclone collector.

Bandsaw System Installation (see Figure 1)

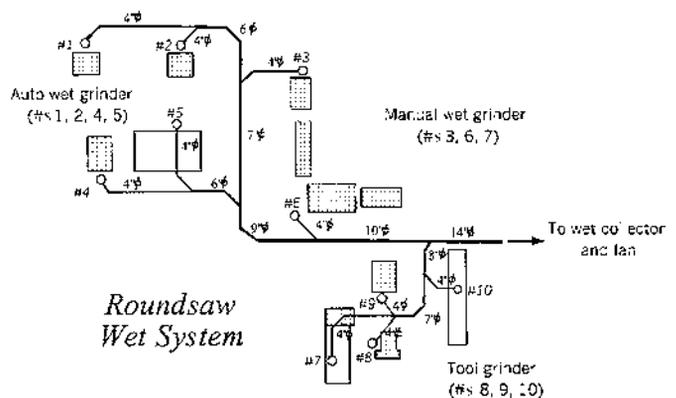
FIGURE 3
Layout of the Roundsaw-Wet system.

9. The Roundsaw-Wet ventilation system (see Figure 3) design transport velocity was 3500 fpm. The estimated total required exhaust flow rate was 3500 cfm with a static pressure of 6.0 inches water gauge at the collector inlet. The wet collector for the system was a Torit Dryflo Model D2 Mist Collector. Because wet grinding operations generally produce a fine airborne mist, enclosures around the grinders were recommended (and actually installed).

Roundsaw-Wet System Installation (see Figure 3)
