Bureau of Mines Information Circular/1976

# Roof-Fall Resupport Accidents, A Study

Information Circular 8723

By Juel H. Stears, John P. Conway, and Robert C. Bates  
Spokane Mining Research Center, Spokane, Wash.

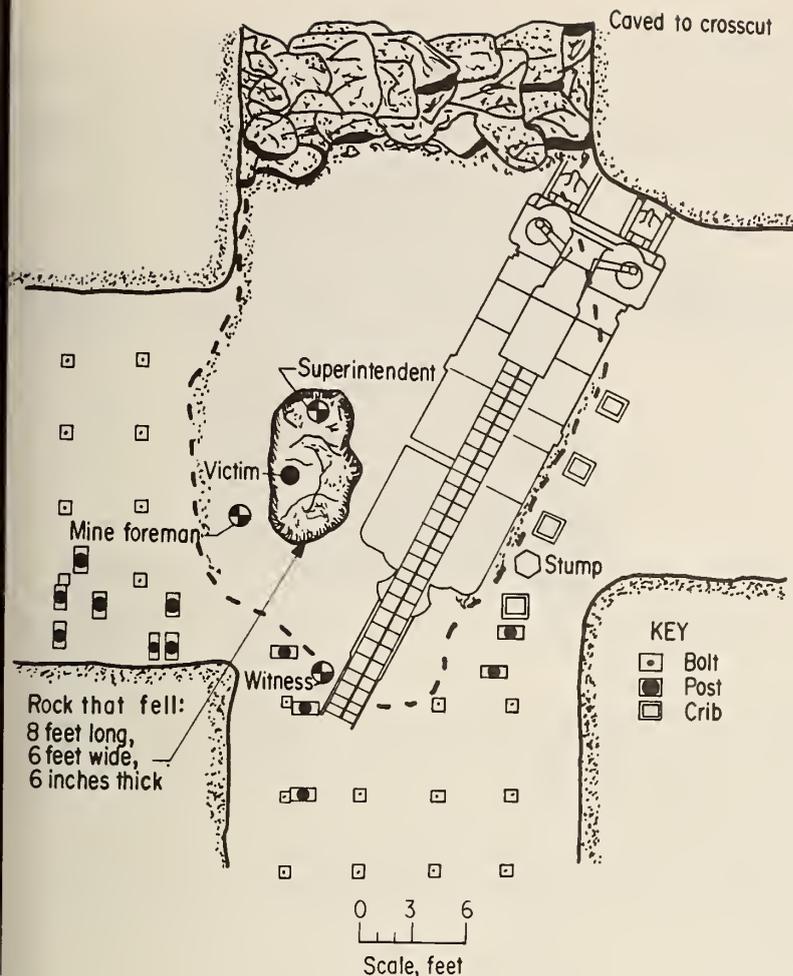
FIGURE A-16. - Accident 17.

miners arrived at the fall area. They examined and scaled the roof with a 12-foot-long drill steel, drilled and blasted rock on top of the miner, manually removed loose material from the miner, and loaded rock with a loading machine. The crew was attempting to pull the miner out with the shuttle car when the roof bumped and fell. The section foreman, mine foreman, and superintendent were also in the fall area with the victim, but managed to escape.

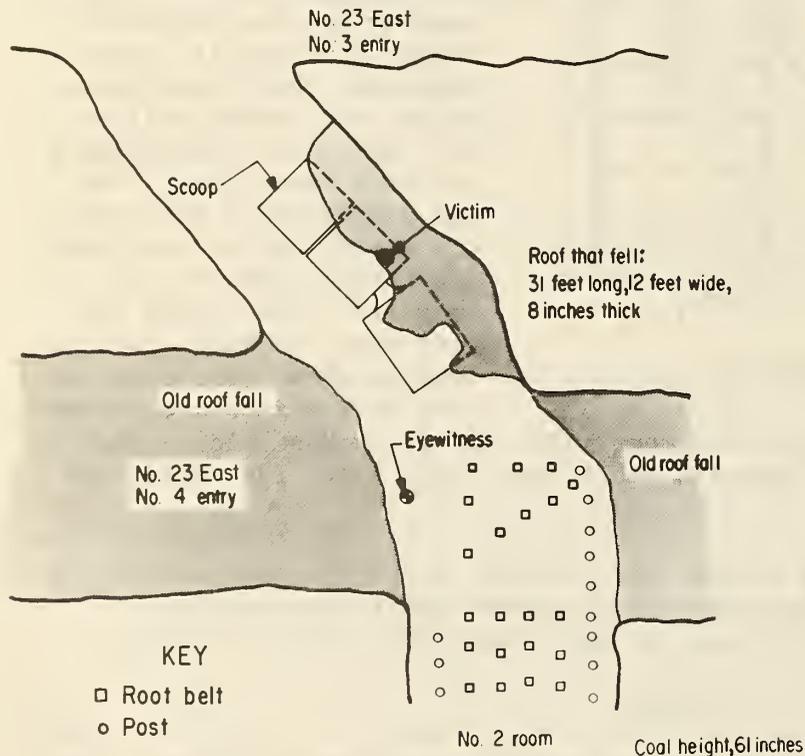
FIGURE A-20. - Accident 21.

A crosscut was being cleaned up to make a roadway to the next barrier pillar (fig. A-20). The victim and another miner were cleaning up fallen rock and installing roof bolts and timbers. The roof had been examined by the foreman and found to be drummy. The victim made a run at the small amount of rock that was left in the crosscut and, in so doing, knocked out some old timbers that had been set when the area was developed. The roof gave a ripping sound along the right side of the crosscut. The victim reversed the scoop, but before he could get in the clear, the roof fell, crushing his head and chest against the frame of the

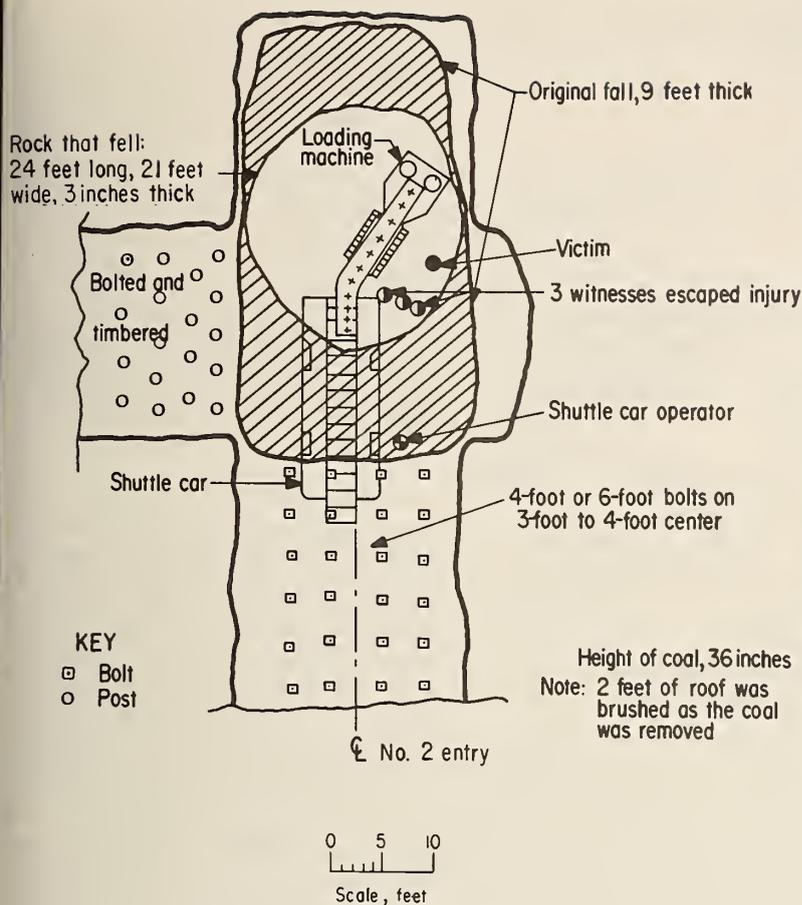
FIGURE A-25. - Accident 26.

loaded for 4 hours. At this time, the general foreman visited the area and, after examining the roof and ribs, directed the blasting of some unsafe rock on the right rib. After blasting, the material in the face "worked" a little but had been quiet for about 30 minutes when loading resumed. The roof was tested and found to be drummy; however, no cracks or other indications of danger were detected. The victim had begun operating the loading machine when the roof fell. The second fall was 24 feet long, 21 feet wide, and 3 inches thick. The victim was 20 feet beyond the last permanent support and no temporary supports had been set in the area.

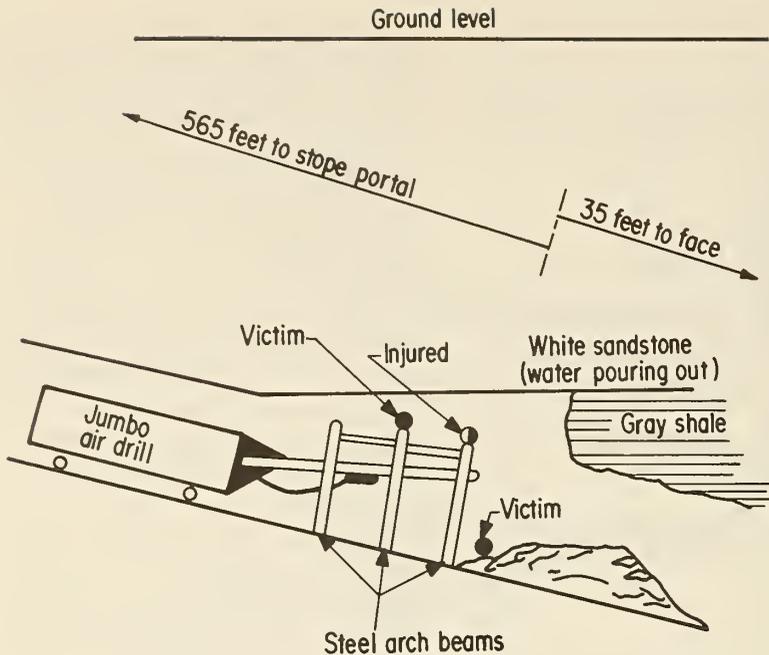
FIGURE A-26. - Accident 27.

approximately 550 feet from the surface, then changed to laminated shale as the face of the slope advanced; the roof in the area where the accident occurred was laminated shale overlain with sandstone. The roof was supported with 4- and 5-foot roof bolts, with steel arches spaced intermittently. The accident occurred approximately 565 feet in by the portal.

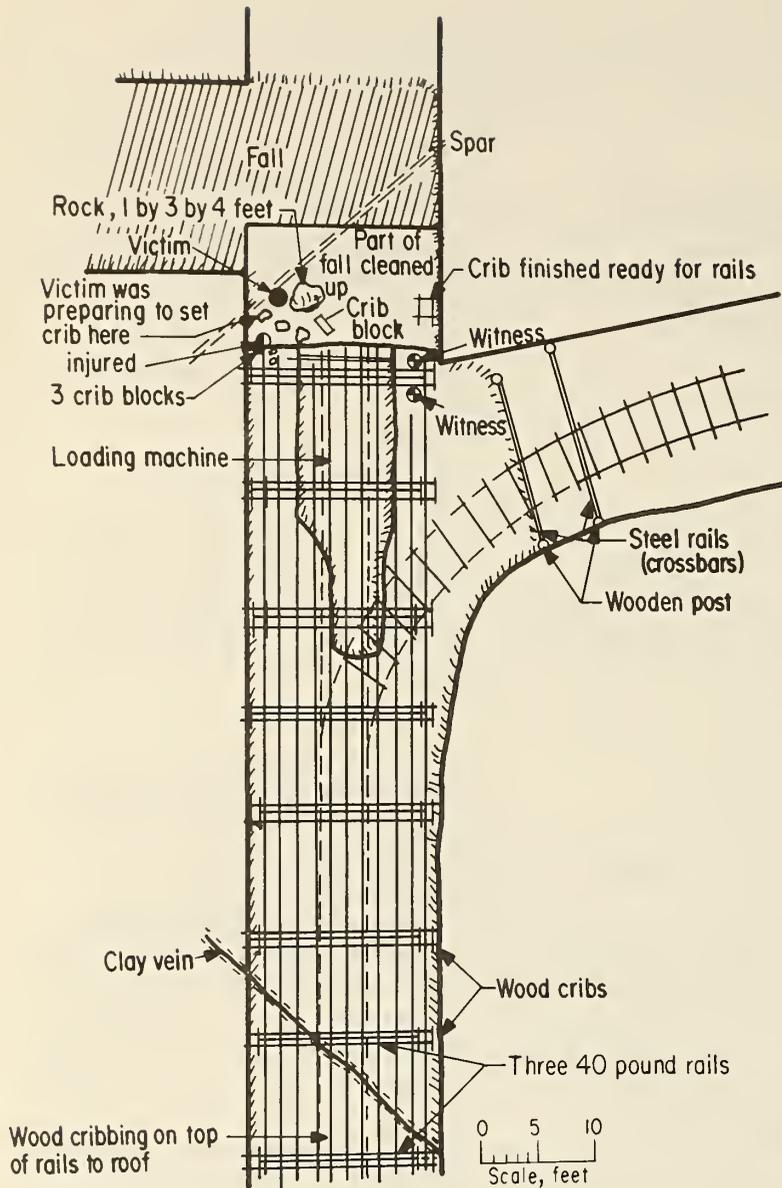
FIGURE A-29. - Accident 30.

The No. 3 Butt Left section had been idle for about 9 months. Rehabilitation work, which included cleaning up a fall of roof, was in progress in the No. 4 entry, a haulage road (fig. A-29). The fall was about 90 feet long and 30 feet high. About 70 feet of the fall had been cleaned up. The victim and the general laborer were cleaning up material along the left rib in preparation for building a crib when the fall occurred. The largest piece of rock that fell was 4 feet long, 3 feet wide, and 12 inches thick. Several smaller pieces of rock also fell, but it could not be determined which pieces struck the workmen. It was obvious that prior to and at the time of the accident, workmen had been and were working under unsupported loose roof and ribs.

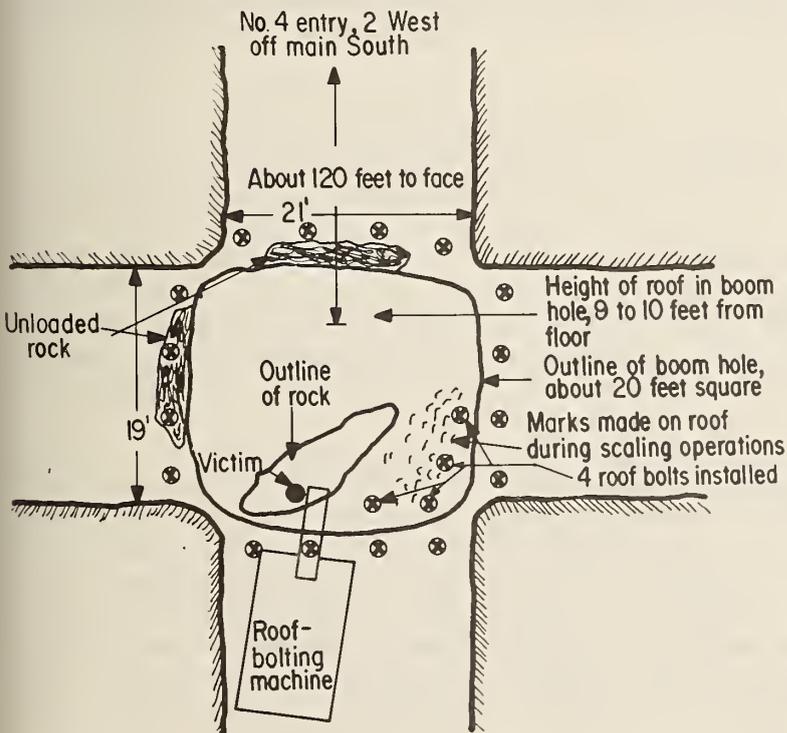
FIGURE A-33. - Accident 34.

The cavity for the belt drive boom hole in the roof had been blasted the previous day. The cavity measured about 20 feet square and about 4 or 5 feet above normal roof plane (fig. A-33). All rock, except for small amounts located at inby and left side of cavity, were loaded out. The victim then tested and scaled the roof and started bolting. No temporary supports were set. Four bolts had been installed on a right-to-left pattern when the victim was instructed by foremen to change to a left-to-right bolting procedure. The victim insisted upon finishing the fifth hole before changing the pattern, and was caught under a fall while finishing the hole. The

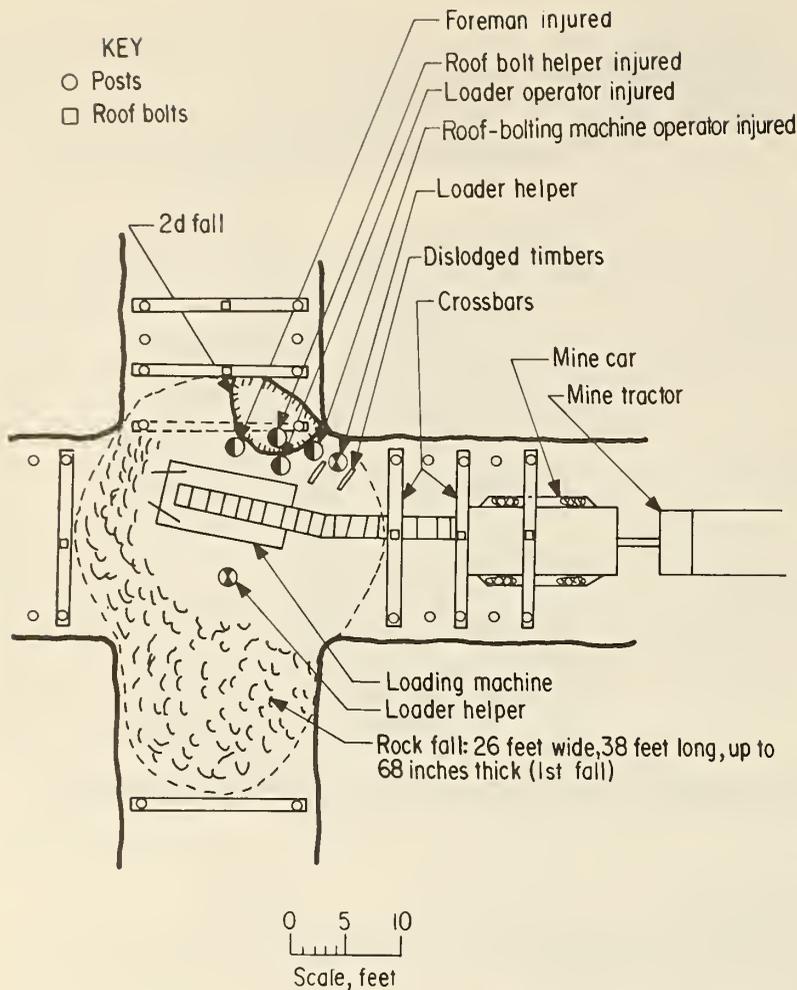
FIGURE A-35. - Accident 36.

The crew was loading out a fall that had occurred in an intersection on the previous day. The fall measured 38 feet long, 26 feet wide, and up to 6 inches thick (fig. A-35). The section foreman and three miners were standing together within a 10-foot circle beneath the edge of a protruding roof brow. The brow was partially supported with half of a crossbar that had a bolt in the center and a post on one end. No temporary supports had been set in the area. The loading machine had just finished loading the 16th car of rock when the roof brow suddenly broke and fell without warning. The second fall measured 6 feet long, 5 feet wide, and 0 to 6 inches thick. The foreman stated that he had tested the roof 15 minutes before the accident by the sound-and-vibration method and had detected no dangerous conditions.

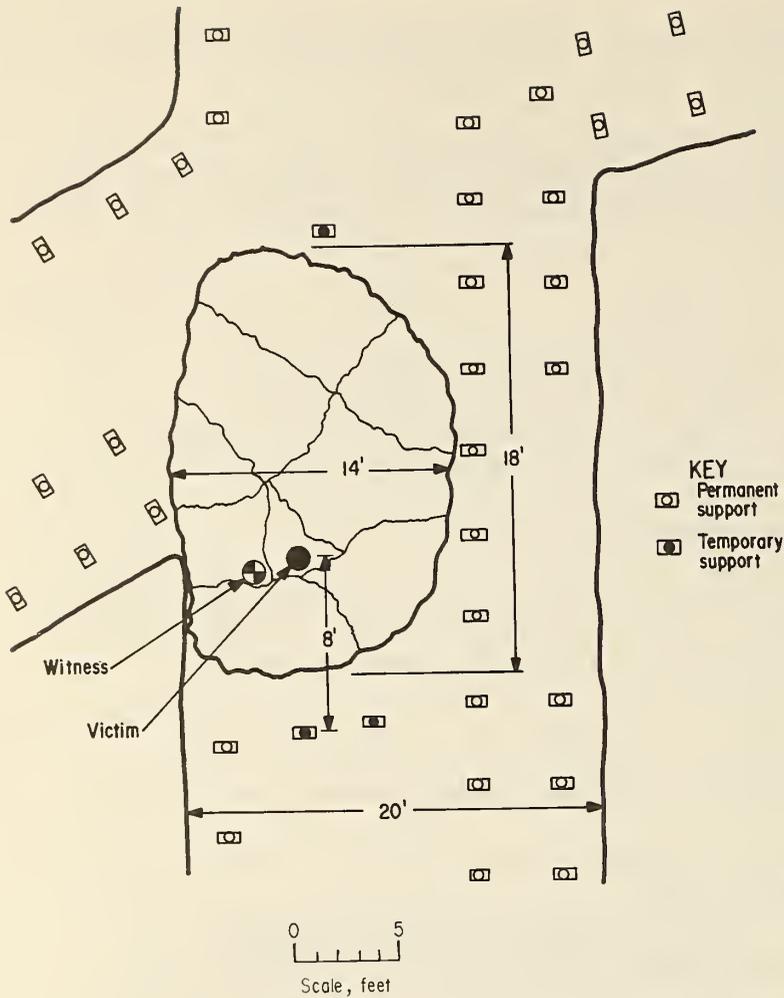
FIGURE A-41. - Accident 42.

Some bone coal had fallen along a haulage entry approximately 500 feet outby the working face. A four-man crew, consisting of the general manager, the victim, and two general laborers, was in the process of removing it (fig. A-41). Two posts were set across the entry just outby the area, and the remaining loose bone coal was barred down. Reportedly, the overlying shale was examined by the sound-and-vibration method and visual observation. Although the shale was broken, it was not considered unsafe. The men then decided to gob the fallen material behind the line posts along the haulageway. The rockfall occurred while the men were preparing to set a crossbar. Apparently, there was some roof action indicating an impending fall because the victim shouted a warning to the other men. Another miner, who was near the victim, was struck by falling rock but managed to escape serious injury. The

other two men were inby the fall area. The rockfall was about 20 feet long, 14 feet wide, and 10 inches thick; it broke into several pieces.

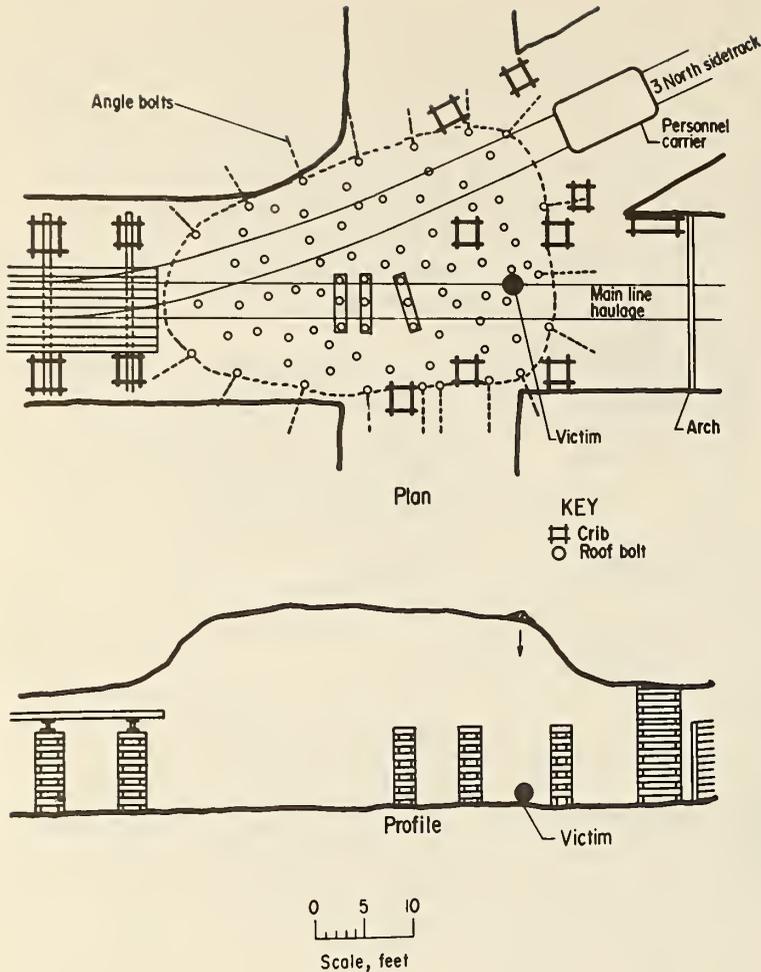
FIGURE A-45. - Accident 46.

reached the main-line track entry, a piece of rock fell from a height of about 30 feet and struck him on the head.

1. Management should support or otherwise adequately control the roof and ribs in all active underground roadways, travelways, and working places to protect persons from falls of roof or ribs.

2. Where miners are exposed to danger from falls of roof, face, or ribs, the
