INFORMATION CIRCULAR/1994

Longwall Gate Road Stability in Four Deep Western U.S. Coal Mines

**By Lance R. Barron, Matthew J. DeMarco,
and Richard O. Kneisley**

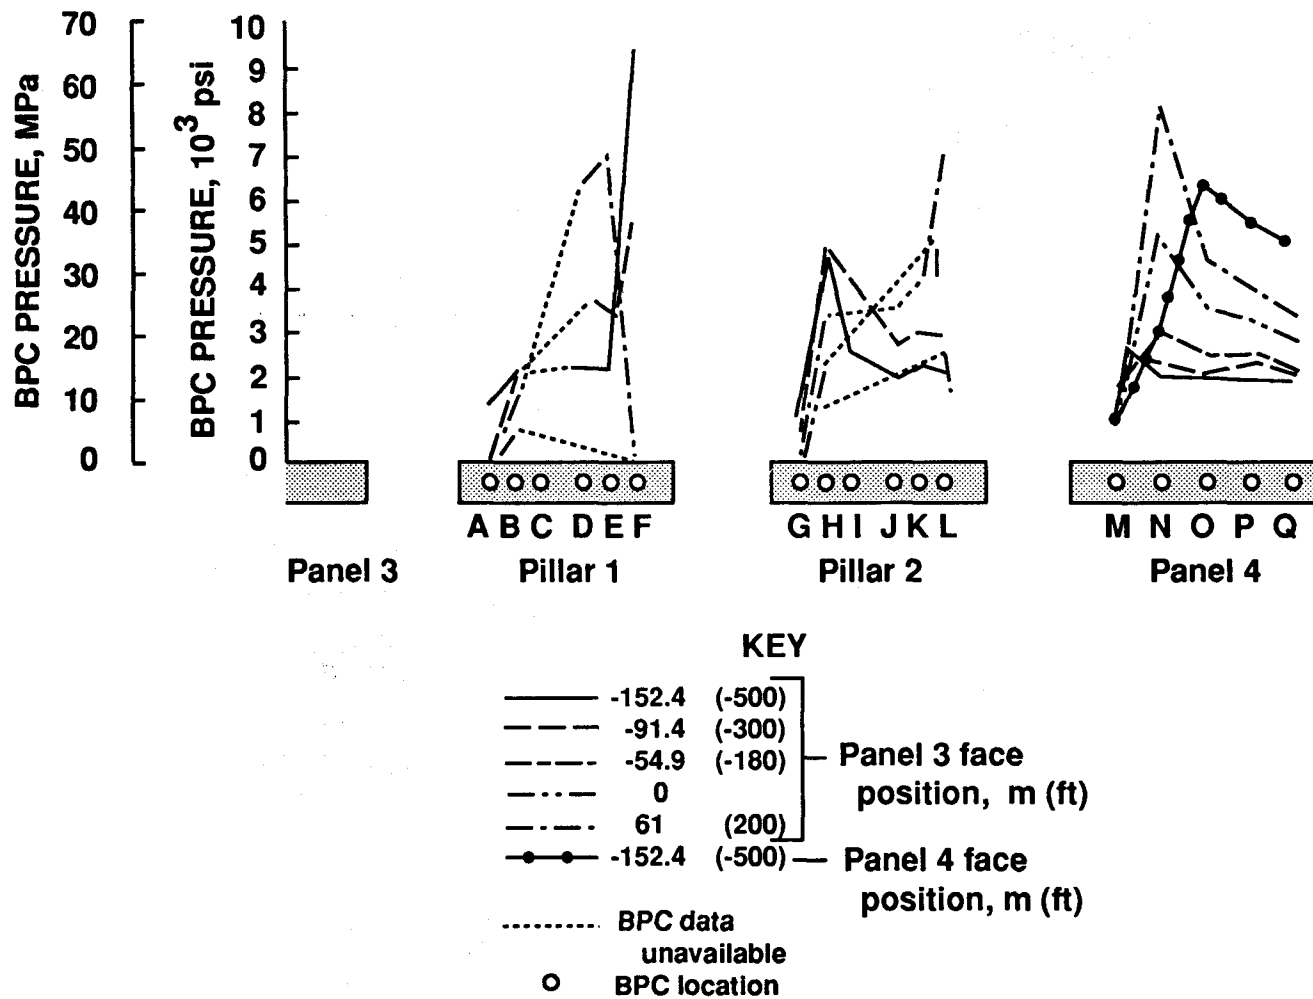
Figure 32

As the panel 3 face approached the site, progressive rib failure occurred in pillar 1 (figure 32), with load transferred to pillar 2 and panel 4; pillar 2 experienced decreased rib loading, indicating narrowing of its confined core. When panel 3 was 152 m (500 ft) inby the site, panel 4 experienced only loads attributable to the nearby

openings. By the time panel 3 had approached to 55 m (180 ft) inby the site, front abutment loading and loads transferred from pillars 1 and 2 created a yield-abutment zone in the first 6 m (20 ft) of panel 4. As the panel 3 face drew even with the site instrumentation (0 face position), decreasing load-bearing capacity of pillars 1 and 2 was reflected by significant increases in the abutment zone width and overall panel loading. Additional panel 4 side abutment loading, observed when the panel 3 face was 61 m (200 ft) outby site 1, showed continued deterioration of the load-bearing capacity of the gate pillars after the face had passed by the site.

Vertical pressure profiles at site 1, Star Point No. 2 Mine.

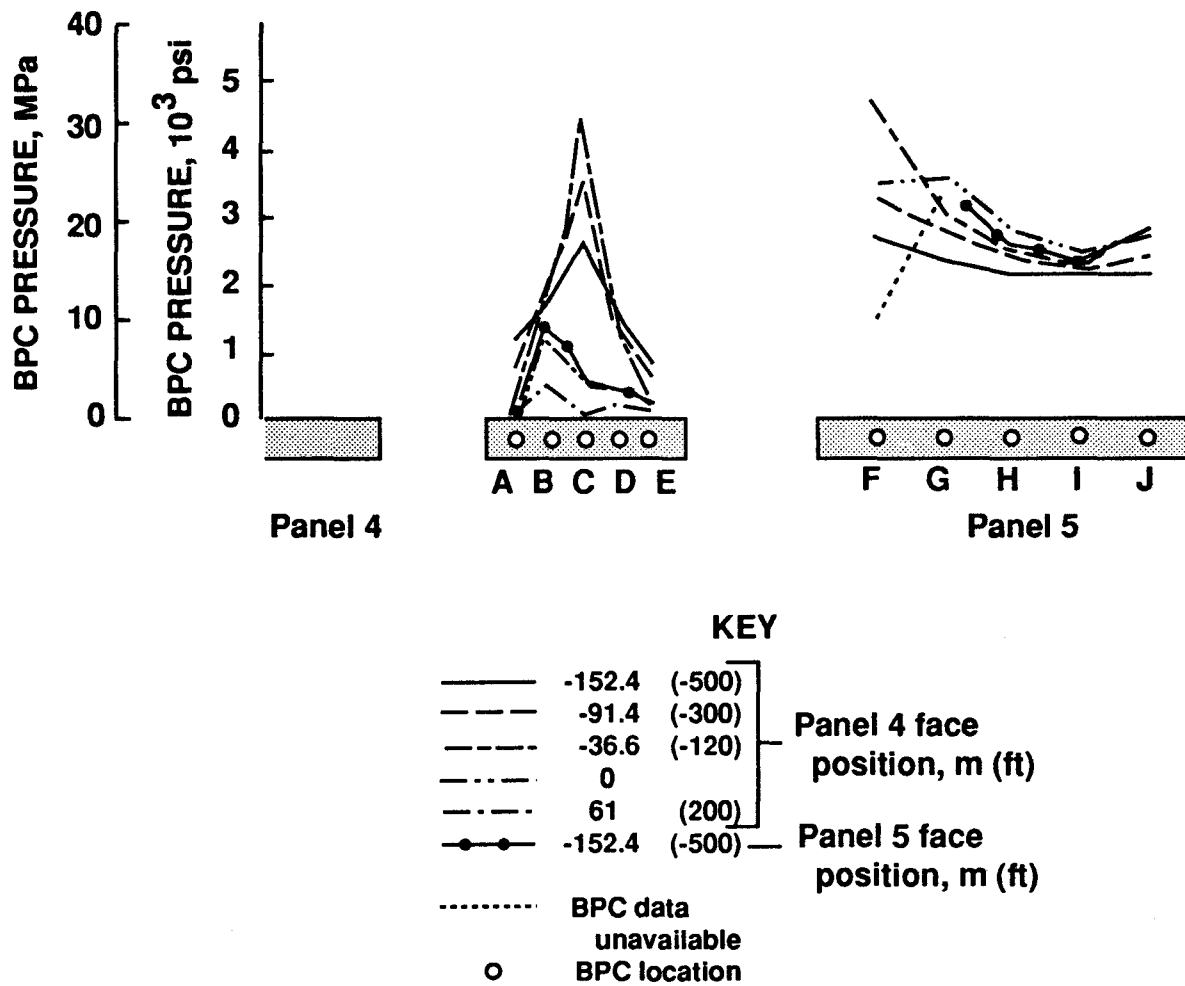
Figure 33

The vertical BPC data shown in figure 33 indicate that the 9-m (30-ft) wide pillar began yielding during or soon after development. The pillar core, which appears confined to the central 3 m (10 ft) of the pillar, retained significant load-bearing capacity until the face of panel 4 drew even with the site instrumentation. As the panel continued outby, total pillar load was steadily reduced by progressive pillar failure and consequent load shifting onto panel 5.

Vertical pressure profiles at site 2, Star Point No. 2 Mine.

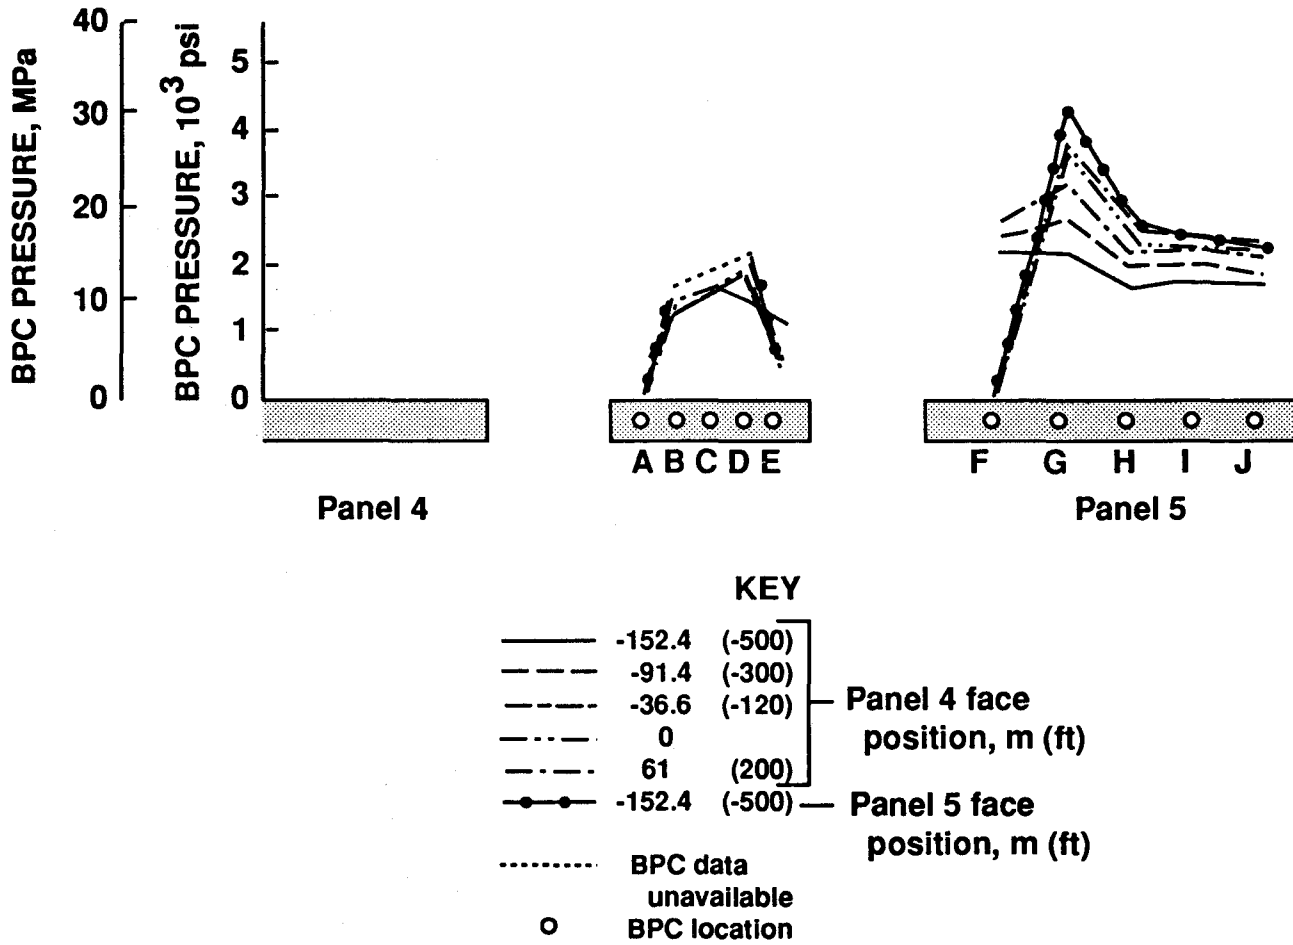
Figure 34

As shown in figure 34, the gate pillar at site 3 had a well-defined pillar core, which did not significantly change in response to mining the adjacent panels 4 and 5. Although the BPC in pillar hole C failed shortly after the panel 4 face passed by the site, preventing further detailed analysis of pillar performance, the load trends of the remaining pillar BPC's indicated no significant change in the pillar-loading profile.

Vertical pressure profiles at site 3, Star Point No. 2 Mine.

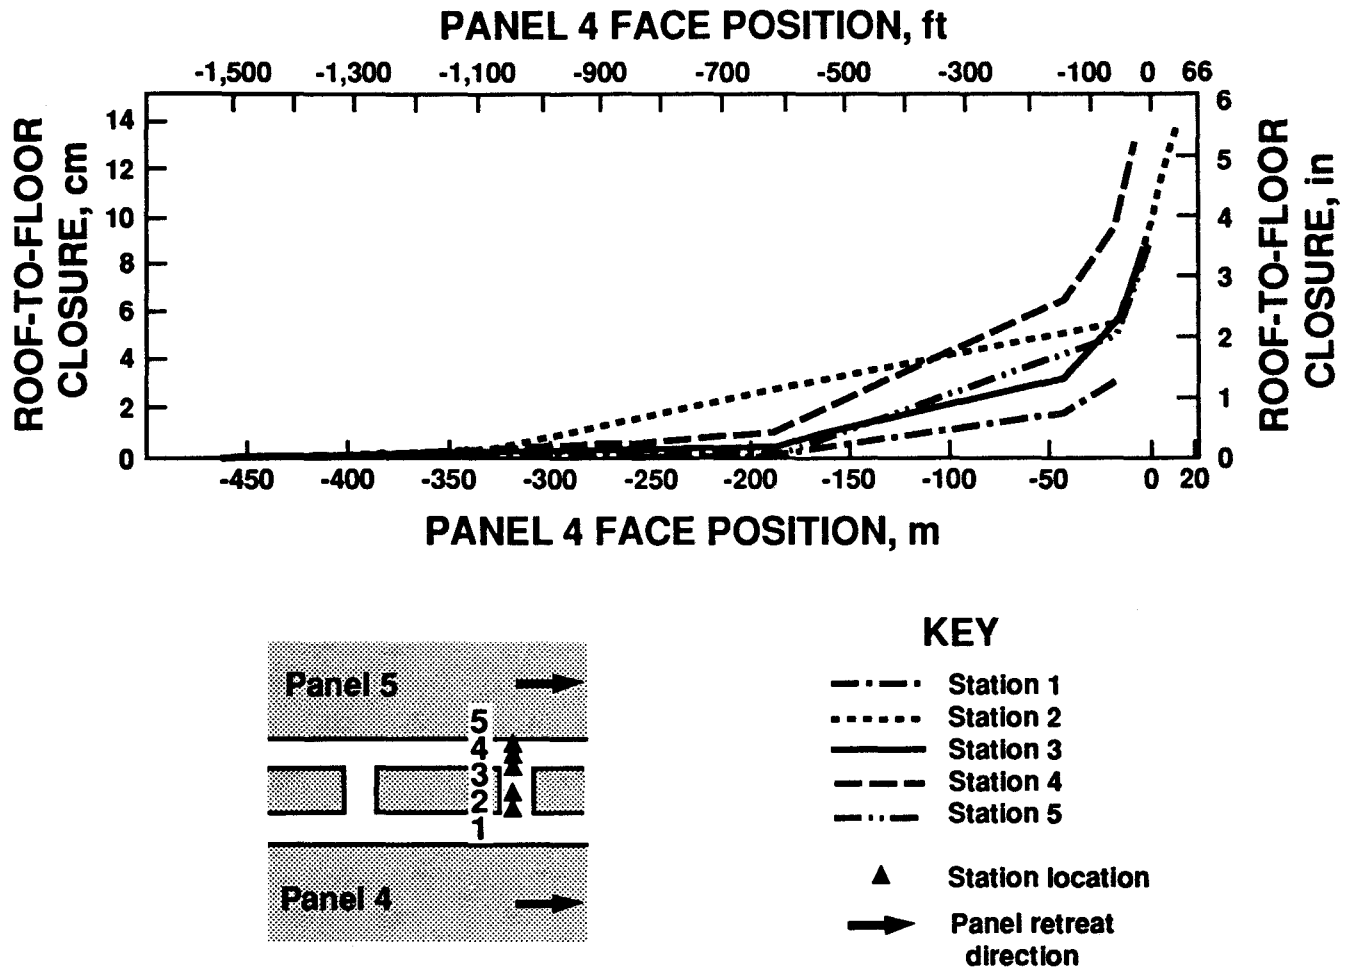
Figure 37

Because closure measurements in the 5th Left gate road could be initiated well in advance of the approach of the panel 4 face, more complete closure records were obtained for sites 2 and 3, (figures 36-37). At both sites, the onset of front abutment loading began when the panel 4 face was approximately 152 to 183 m (500 to 600 ft) inby the site, with significant closure rate increases when the face was about 61 m (200 ft) inby and again when the face had approached within 30 m (100 ft) of the site. These data are corroborated by the pressure profiles for sites 2 and 3. When pillar pressures decreased and/or panel abutment loading shifted deeper into the rib, indicating pillar yielding and/or development of the yield zone along the panel rib, closure rates increased. Together, limited site 1 roof sag measurements, showing approximately 2.5 cm (1 in) maximum sag, and visual observations of roof and floor conditions during panel retreat indicated that floor heave accounted for most of the measured closure. No roof sag data were gathered at sites 2 and 3.

Entry closure relative to panel 4 face position at site 3, Star Point No. 2 Mine.

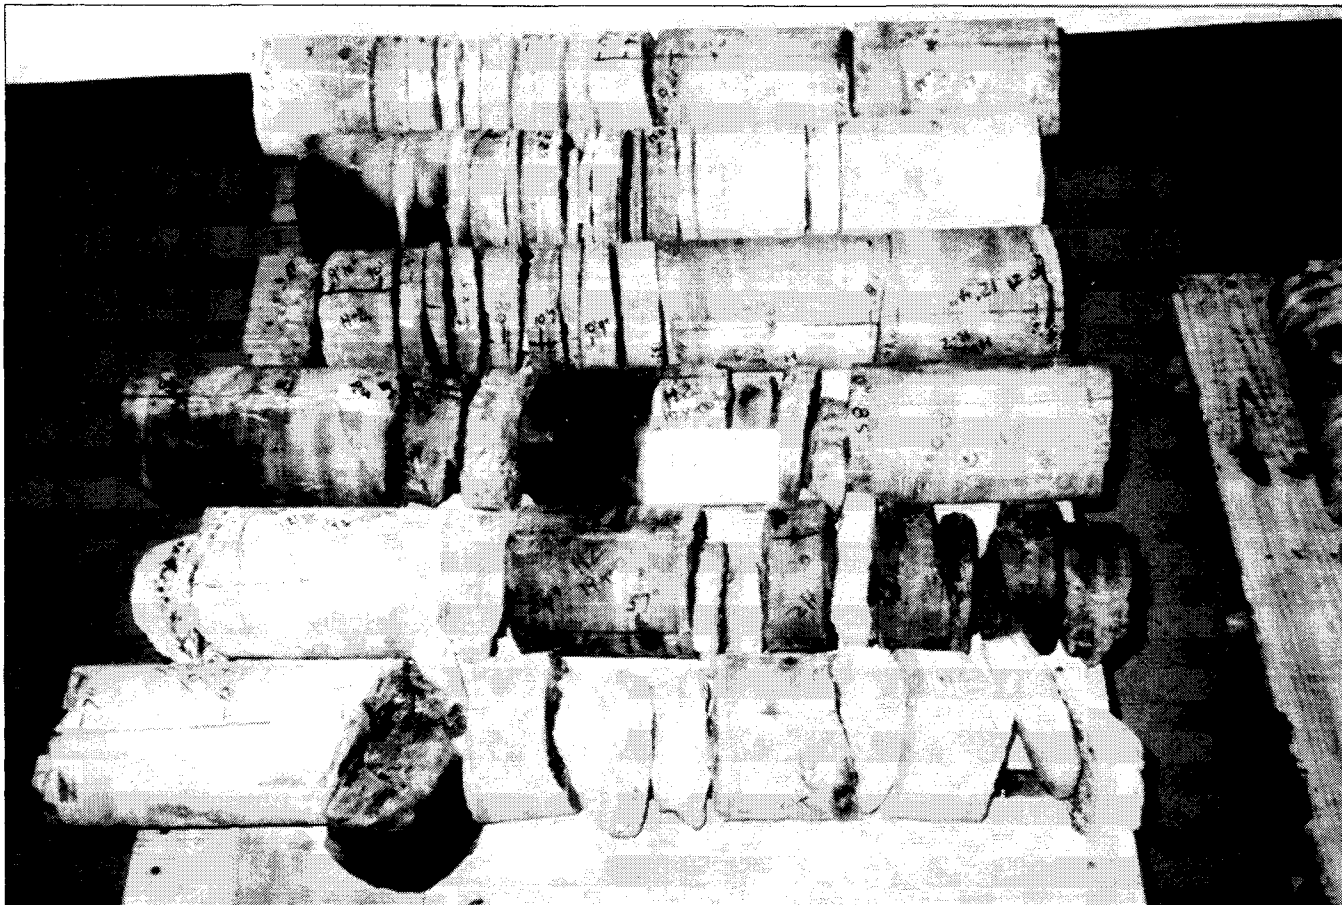
Figure 46

Core taken from immediate roof of Castle Gate No. 3 Mine. Lithologic variation of this mine roof is exhibited by numerous interbedded layers of sandstone, siltstone, mudstone, and coal in first 6.1 m (20 ft) of strata overlying Sub-3 Seam. Numerous, closely spaced bedding plane fractures make this roof very difficult to support. Frequent core diskings probably indicates presence of horizontal confining stresses in mine roof.

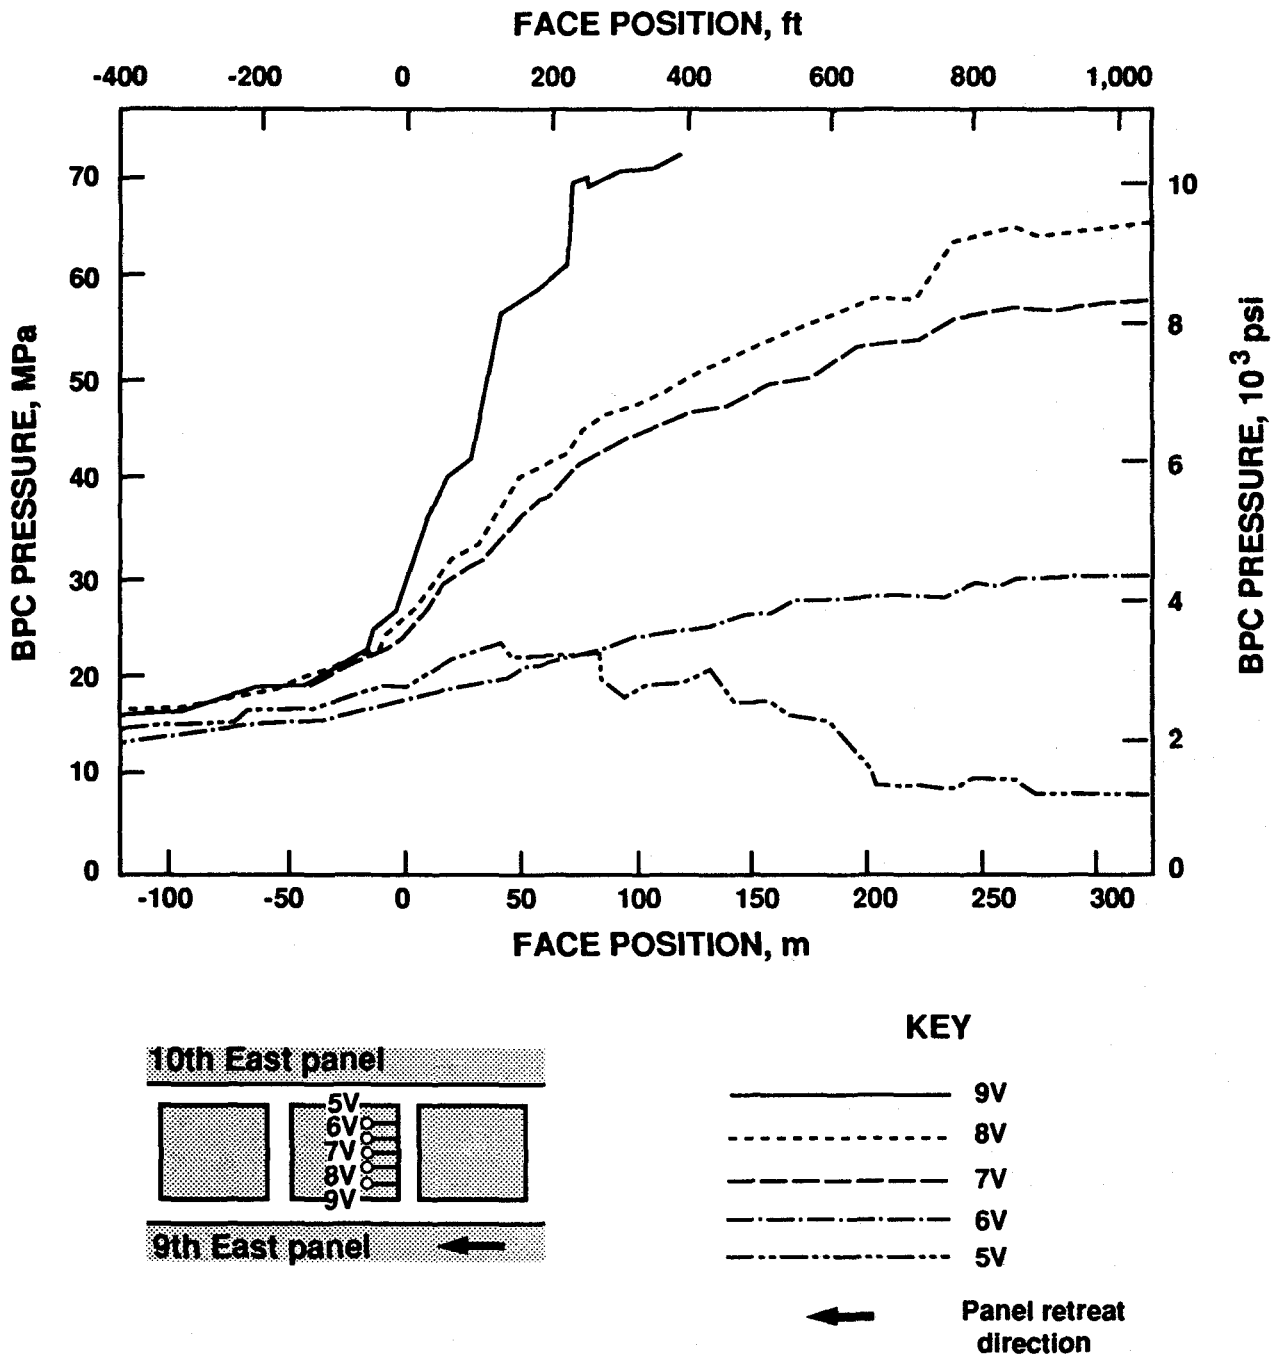
Figure 53

Vertical load response of the row of cells across the midsite pillar is shown in figure 53. The hydraulic tubing for cell 5V was damaged by mobile equipment when the face was about 30.4 m (100 ft) outby the BPC location, and 6V did not respond to ground loads in the same way as other cells the same distance from the active panel (possibly because the 6V cell may have been emplaced in the hard siltstone midseam parting). The cells in this pillar, nevertheless, indicated forward and side abutment loadings similar to those in the other pillars; i.e., the cells nearest the active 9th East panel (9V, 8V, and 7V) showed steeper loading rates and greater total load changes than the cells farther from mining (6V and 5V). Although the pillar was subjected to high-magnitude loading, over 69 MPa (10,000 psi) for cell 9V, no yielding or sloughage of the pillar ribs occurred, indicating high lateral confinement

Vertical pressure relative to 9th East panel face position at midsite pillar, Castle Gate No. 3 Mine.

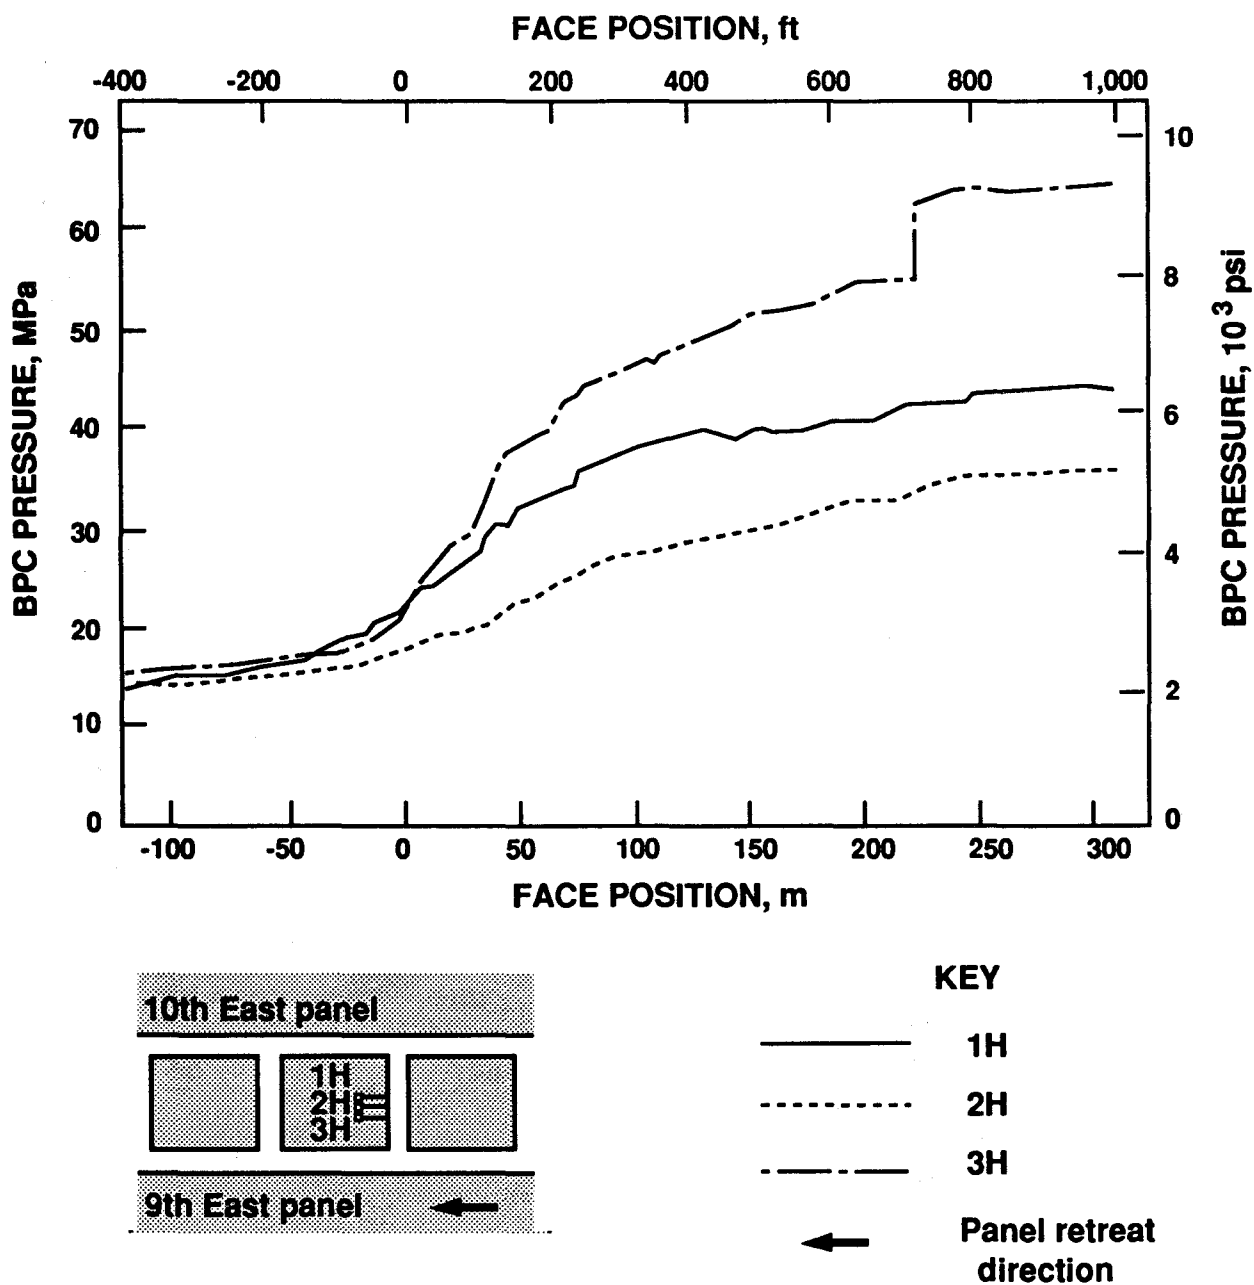
Figure 54

of the pillar. This premise was corroborated by the high horizontal confining loads indicated by cells 1H, 2H, and 3H (figure 54).

Horizontal pressure relative to 9th East panel face position at midsite pillar, Castle Gate No. 3 Mine.

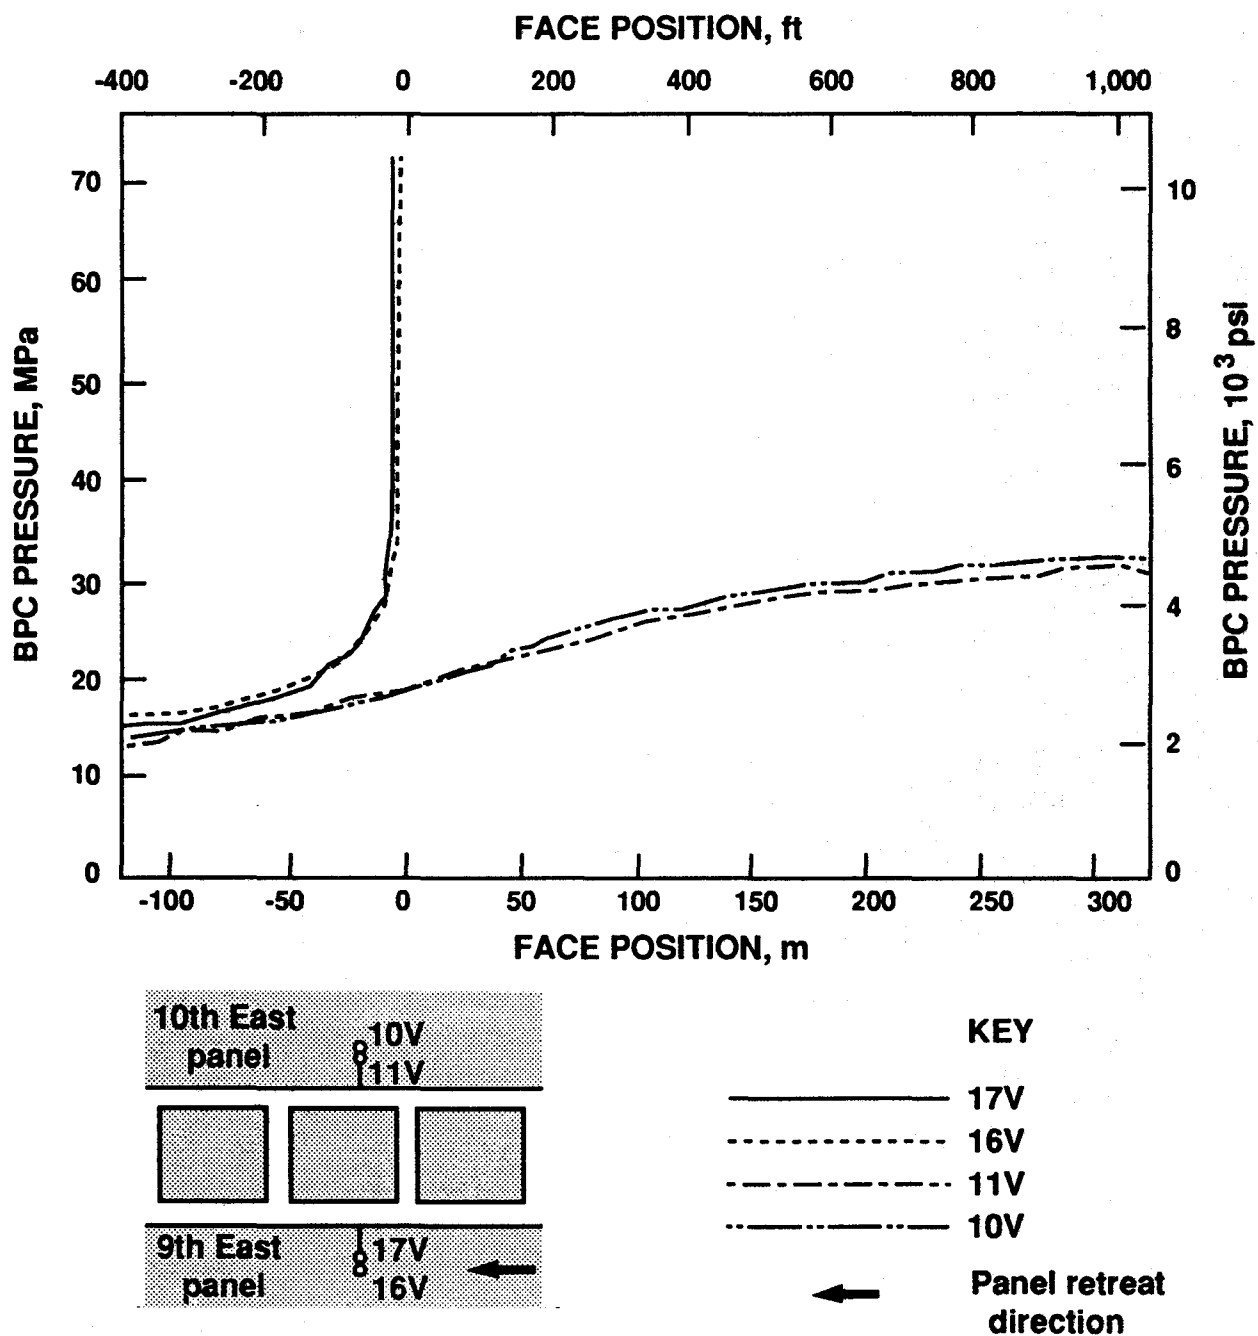
Figure 55

The cells in the active panel headgate rib (16V and 17V) indicated dramatic increases in both loading rate and total load as the face approached the cells, the greatest loading taking place within 6.1 m (20 ft) of the face (figure 55). The data were corroborated by observations that holes drilled into the tailgate panel rib showed no crushing or deformation until the face had approached to within 6.1 m (20 ft) of each hole. As the face approached within 2.4 m (8 ft) of cells 16V and 17V, the indicated loads exceeded 69 MPa (10,000 psi) (off-scale on the pressure recorder chart) and remained at that level until the cells were cut out by the shearer, indicating that no coal yielding occurred in advance of the face. The absence of any face yield zone and concentration of the forward abutment load at the face indicate high confinement across the seam,

Override of the headgate pillar by the side abutment load was demonstrated by the gradual load response of cells 10V and 11V (figure 55) placed at 9.1 m (30 ft) and 12.2 m (40 ft) into the tailgate rib of the next (10th East) panel.

Vertical pressure relative to 9th East panel face position at 9th and 10th East panel ribs, Castle Gate No. 3 Mine.

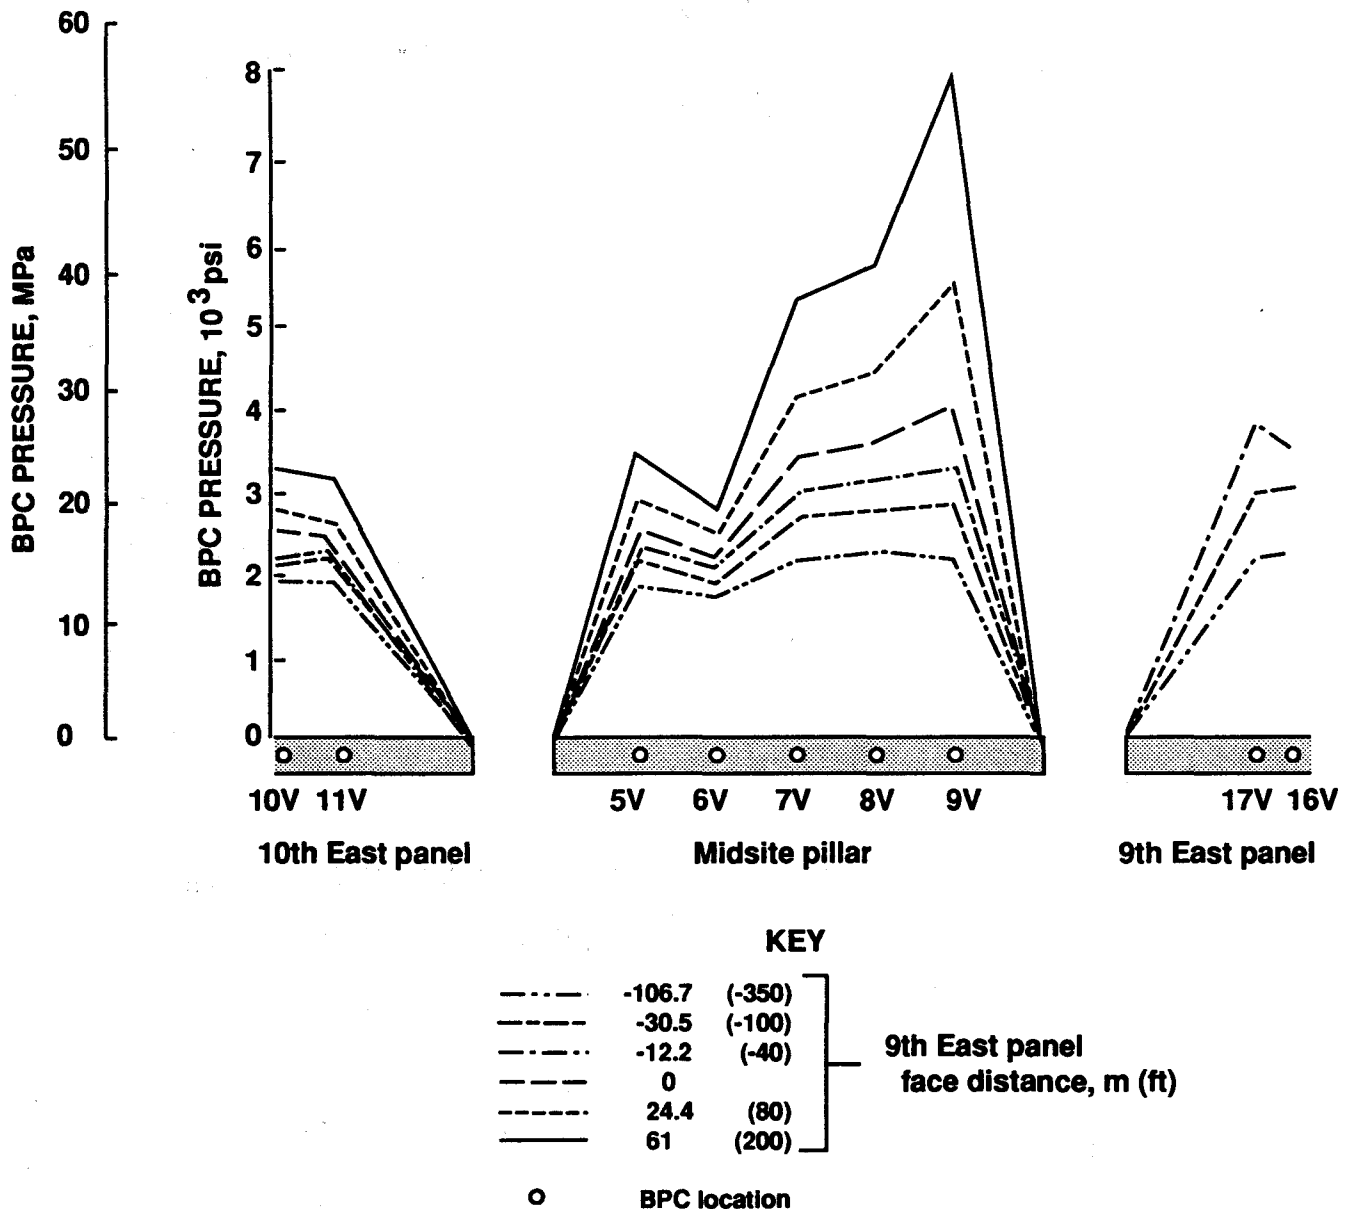
Figure 56 profiles the load configurations across the midsize pillar and adjacent panel ends for several face positions and clearly shows the high-magnitude asymmetrical loading across the pillar and load carryover onto the 10th East panel.

Vertical pressure profiles at midsite pillar, Castle Gate No. 3 Mine.

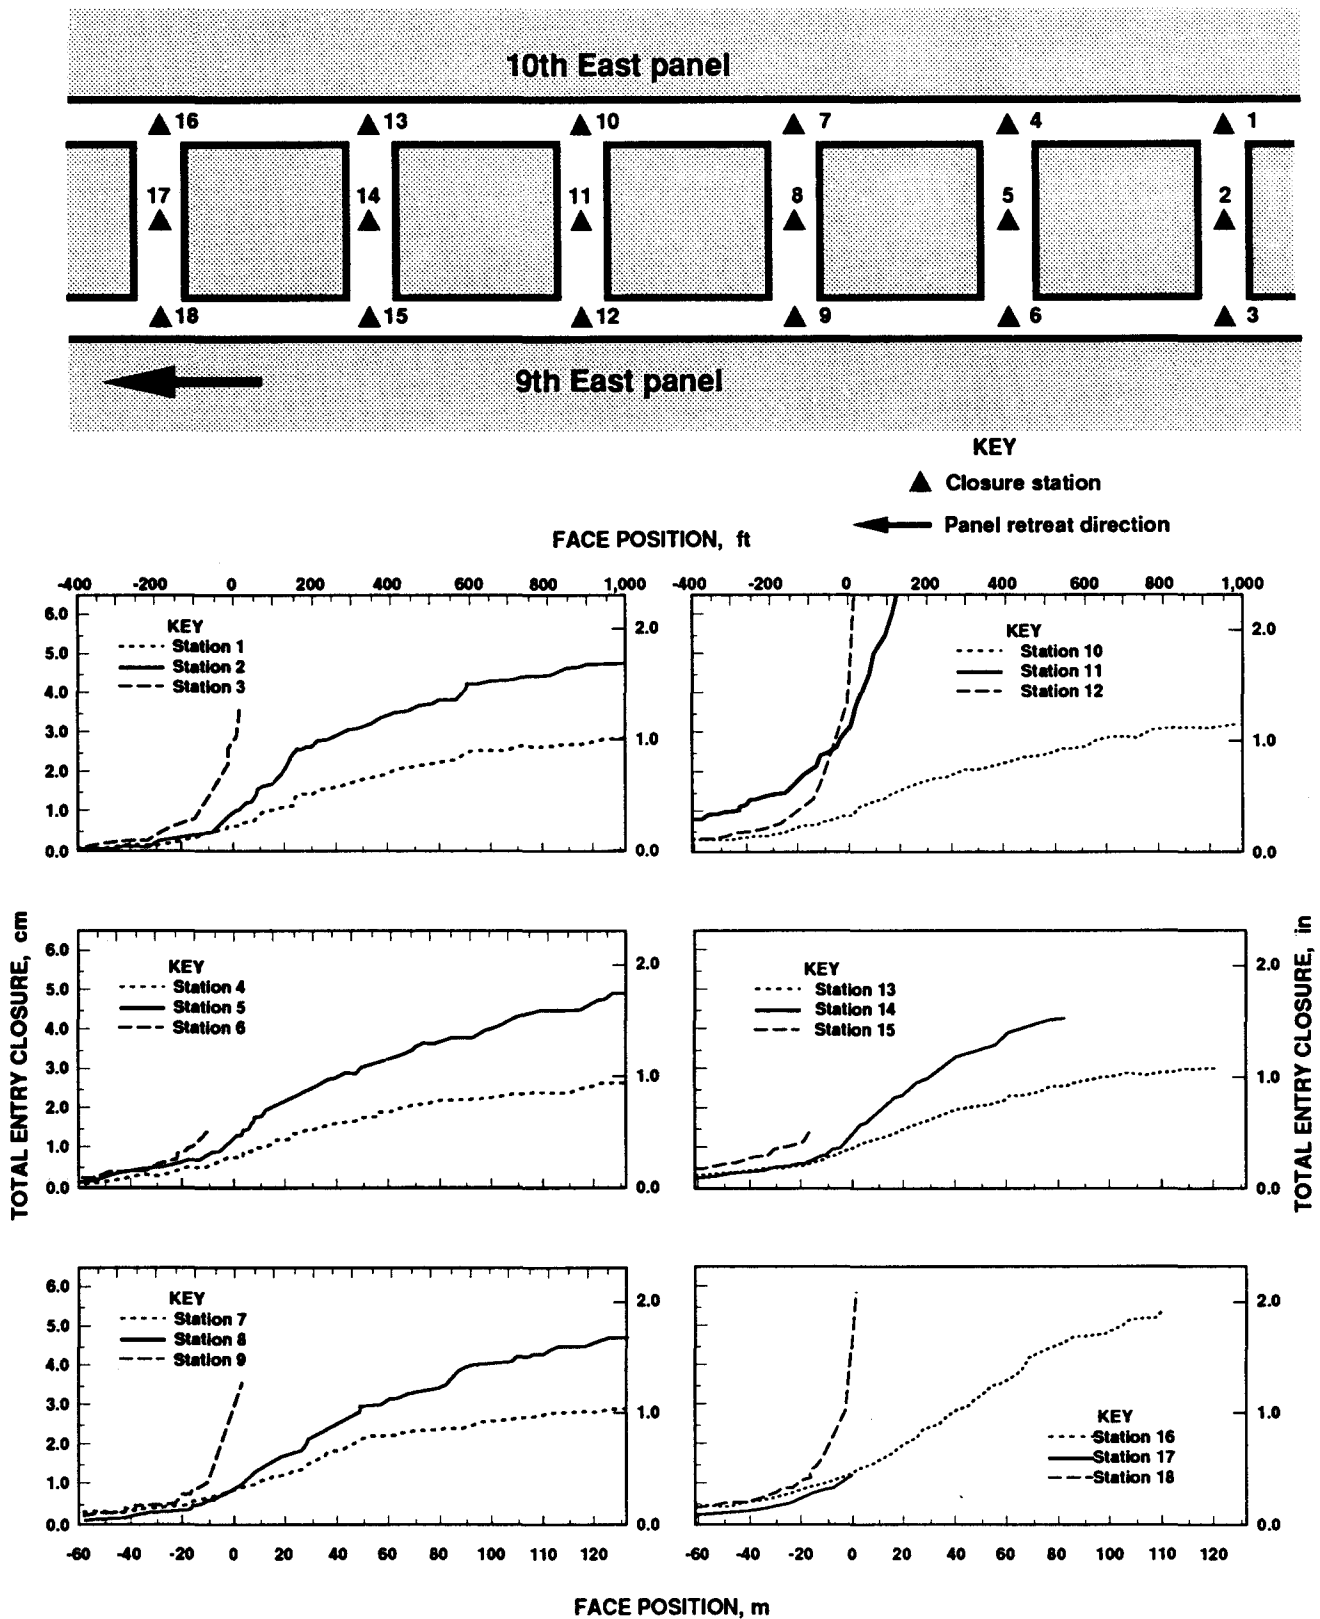
Figure 58

falls, and passage of the face destroyed the stations in the entry nearest the active panel, the closure data (figure 58) indicate the same overall trends as the load cell data—the stations closest to the active 9th East (sixth) panel experienced earlier closure onset, higher closure rates, and greater total closure than the stations nearer the 10th East panel. Sudden changes in closure rate correlated well with observed roof deterioration and slabbing.

Entry closure relative to 9th East panel face position, Castle Gate No. 3 Mine.
