A Minerals Research contract report
December 1981

AN APPLICATION OF THE DEDICATED WIRE TECHNIQUE TO IMPROVE COAL MINE TROLLEY CARRIER PHONE COMMUNICATIONS

Bureau of Mines Open File Report 203-82

Contract J0308036
Arthur D. Little, Inc.

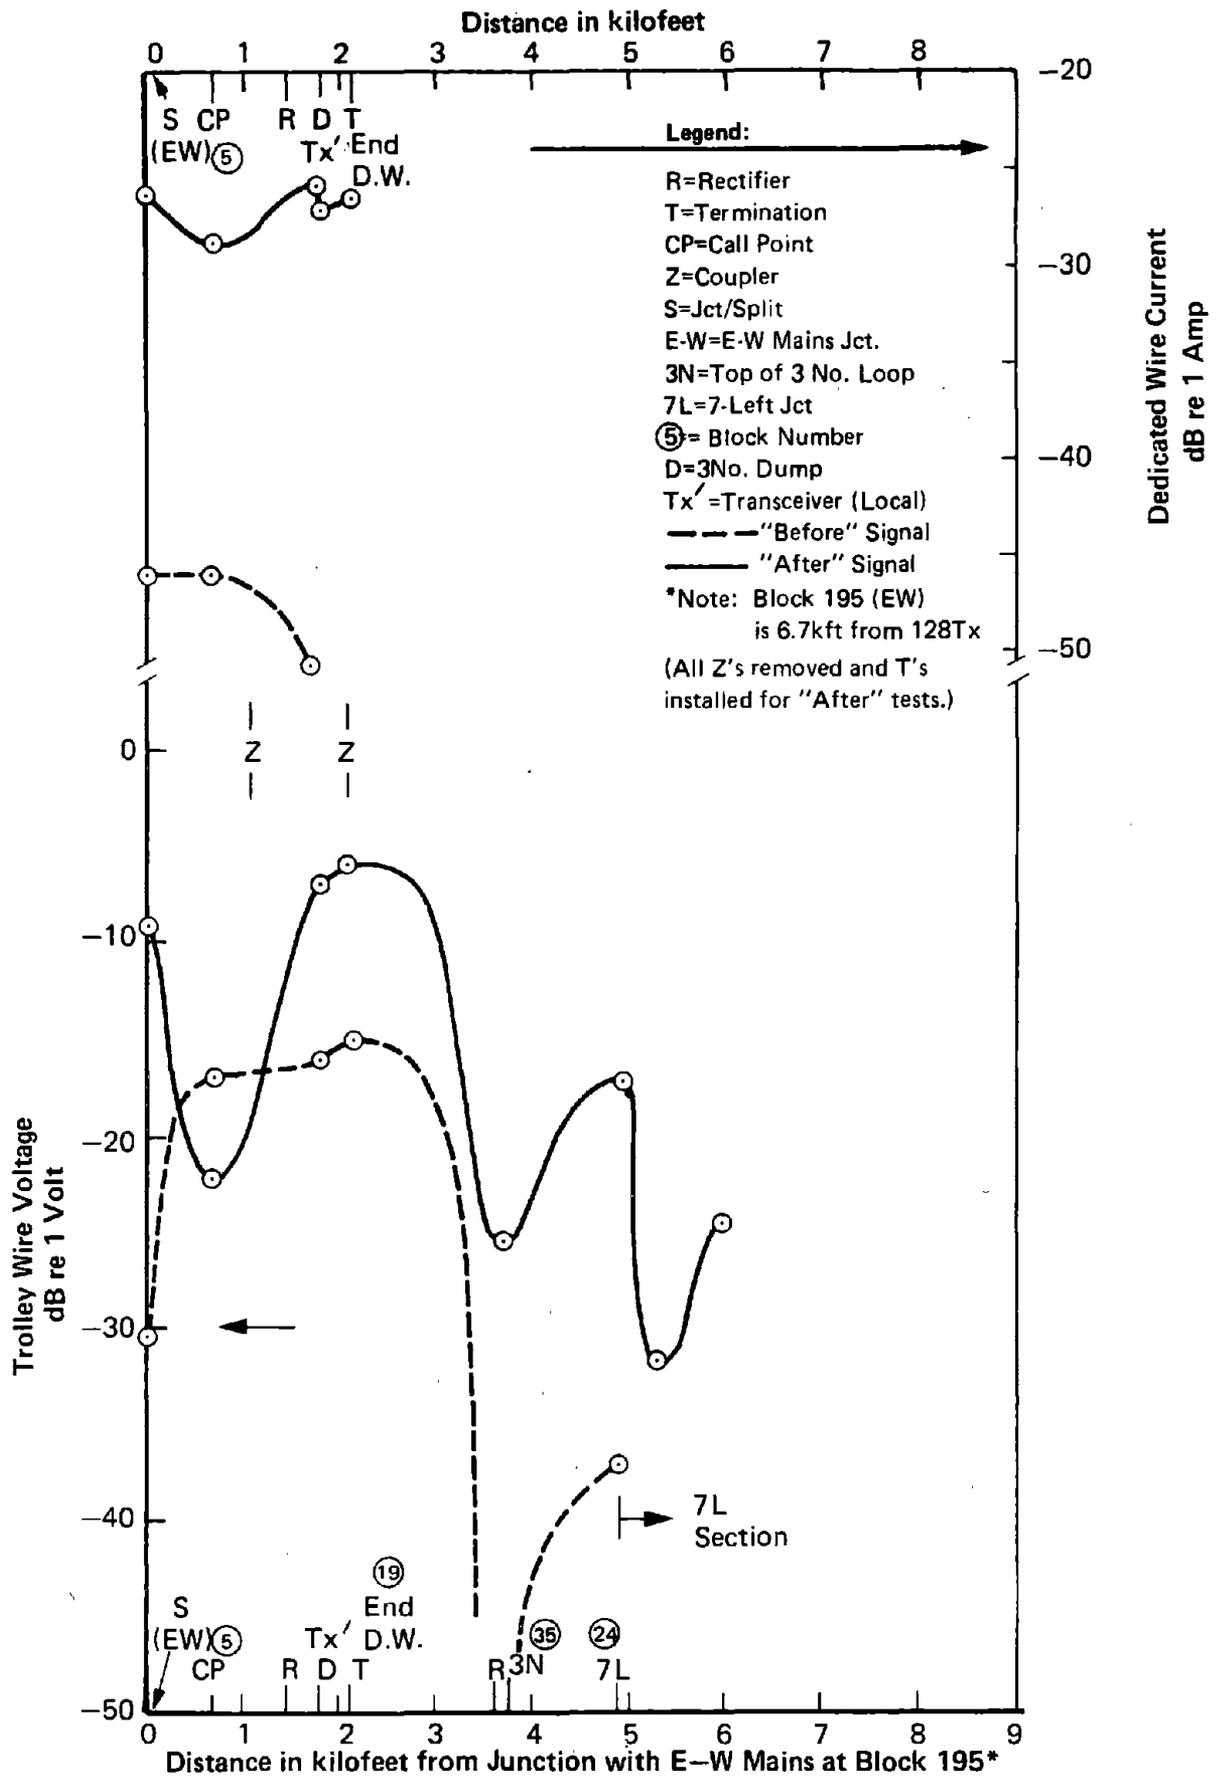
FIGURE 18 COMPARISON OF "BEFORE" AND "AFTER" CARRIER PHONE SIGNALS FOR 3-NORTH, FROM E-W MAINS JUNCTION INTO 3 NORTH LOOP

The 3-North area is depicted relative to the rest of the mine's rail and dedicated wire networks in Figures 4 and 11, and in detail in Figure 6. The area contains several active longwall sections with their supply tracks, train loading loops, and dump load point. Figure 18 compares the "before" and "after" signals to this part of the mine. The figure reveals a large increase in the strength of the dedicated-wire current, and significant increases in trolley wire voltage in several locations; viz., along the rail network beyond the dedicated-wire termination, at the junction of 3-North with West Mains, and at the top of the 3-North loop. In addition, a strong signal of close to 80 millivolts has been maintained at the 6-block call point.

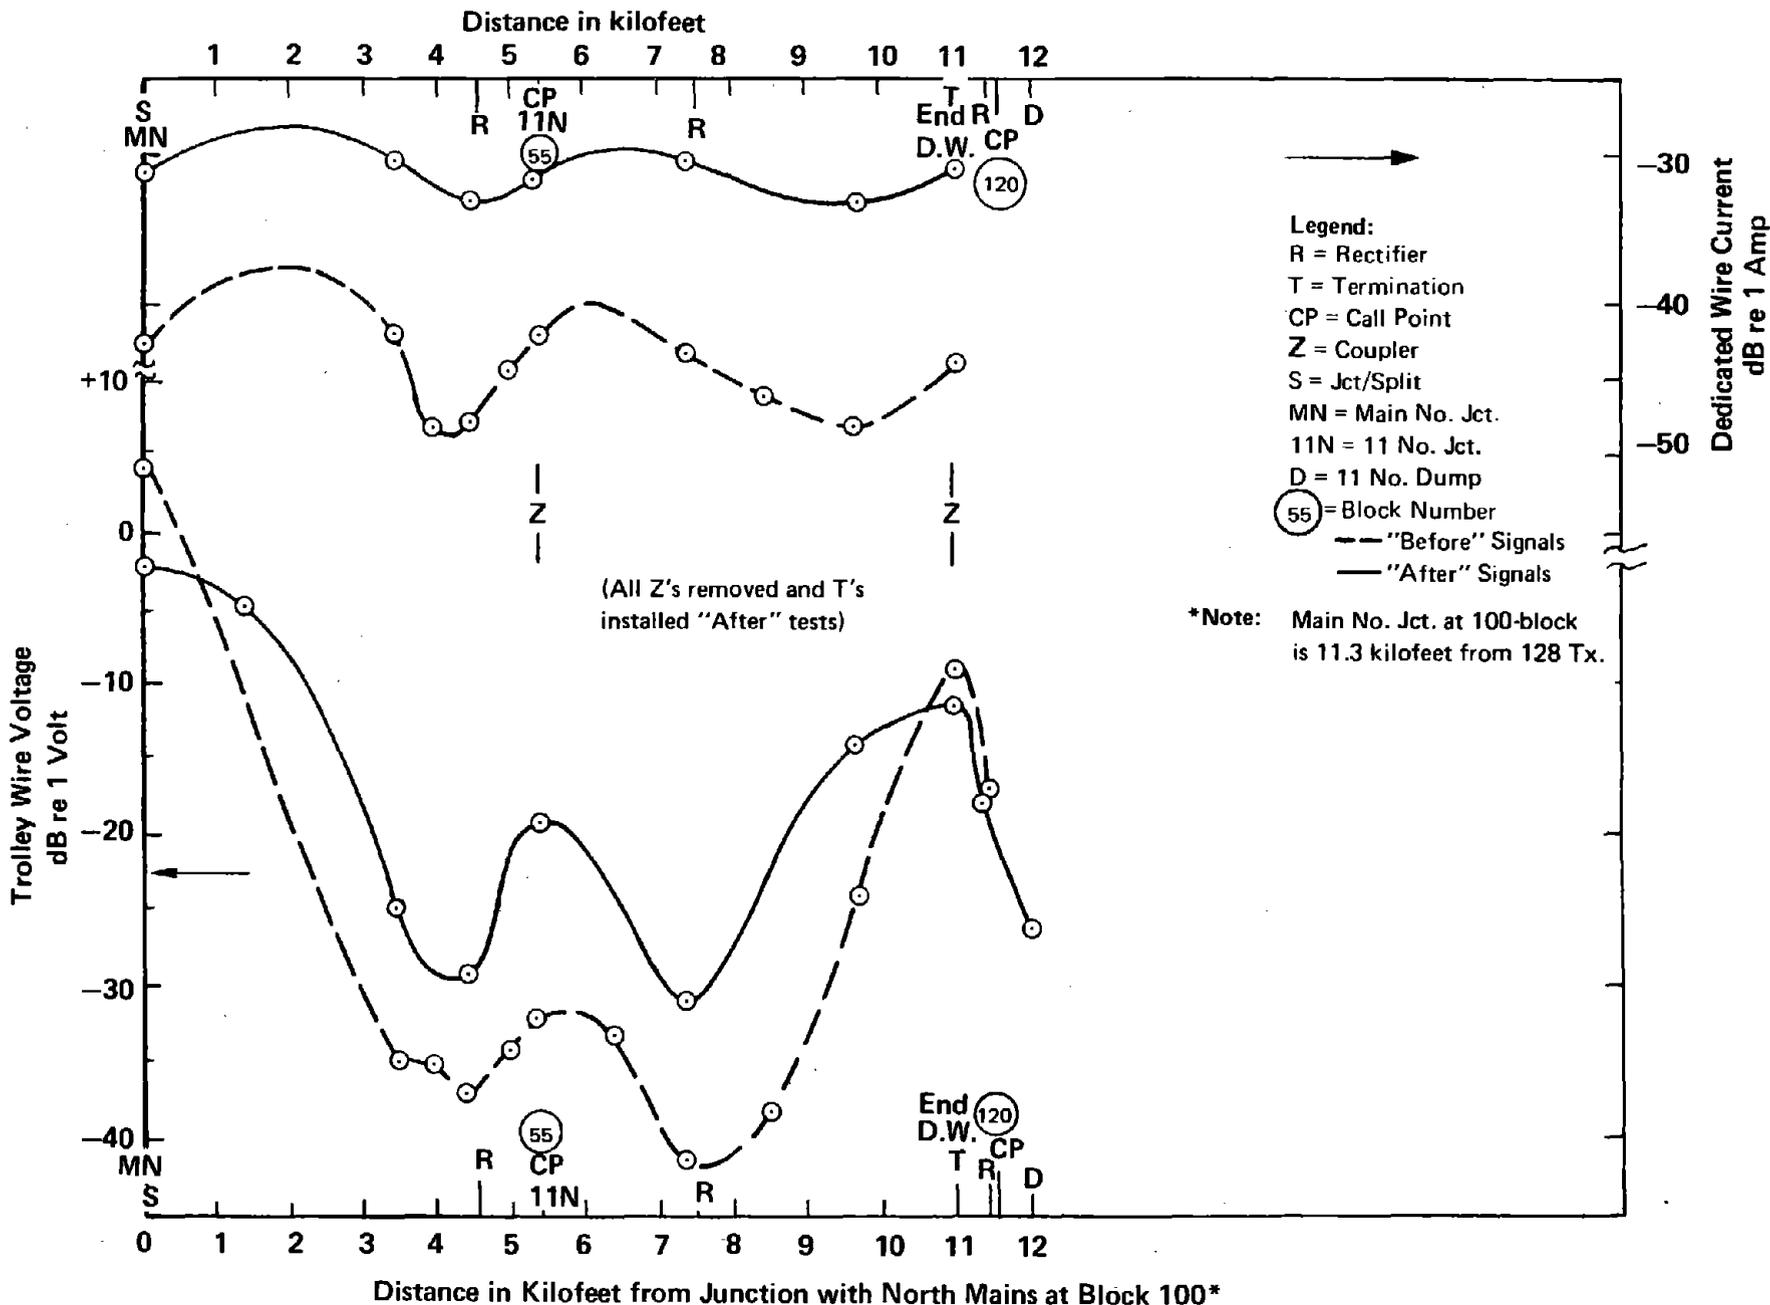
FIGURE 20 COMPARISON OF "BEFORE" AND "AFTER" CARRIER PHONE SIGNALS FOR NORTHEAST MAINS, NORTH MAINS JUNCTION TO 11 NORTH DUMP

The Northeast Mains dedicated wire segment runs 11 kft from the 100-block junction signal split on North Mains to the 11 North dump, as shown in Figures 4 and 11. Since the 100-block junction is 11.3 kft from the 128-block transceiver, the 11 North dump is the farthest location from the dispatcher's main transceiver at 128-block on East Mains. Figure 20 presents the "before" and "after" signal plots for this segment of the dedicated wire.

Finally, Figure 20 shows that a standing wave is still present in the "after" dedicated-wire current. This is not surprising, considering the relatively unmaintained condition of the dedicated-wire installation for long stretches along the old and wet Northeast Mains. Along these stretches, the position of the wire in the tunnel, the wire's support, and its amount of tension are variable in the extreme. Conducting measurements along such a segment of dedicated wire proved fortunate, because the favorable performance results provide strong testimony to the robust character and practicality of the dedicated-wire technique under the difficult operating conditions found in many U.S. coal mines.
